Triangle Pond Management
 405 S Rogers Ln
 Raleigh, NC 27610
 (919)398-3221
 Office@TrianglePondManagement.com
 www.TrianglePondManagement.com
Maintenance Service Report

Customer Name:		Date:	
Chandler Woods MOA		7/30/2024	
Address:			
214 Abbot Pl			
Aquatic Technician:			
Dylan Cash			
Time of Arrival:	Time of Departure:	Drive Time:	
7:36 AM	11:05 AM	46 min	
Type of Device(s) Maintained:			
BMP 1, BMP 2, BMP 3

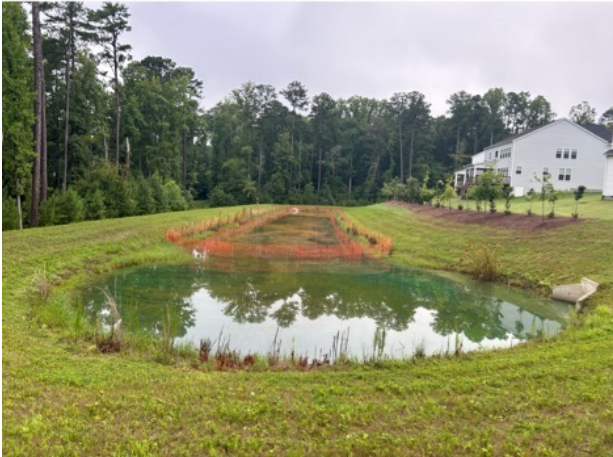
BMP1 Overview	BMP1 Overview
Photo 3:	Photo 4:

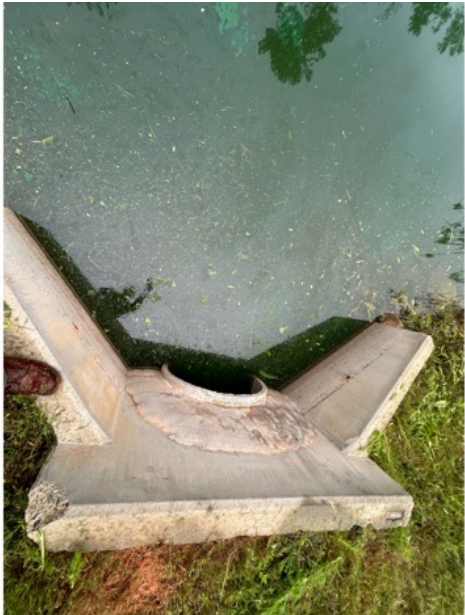
BMP1 Inlet	BMP1 Riser exterior

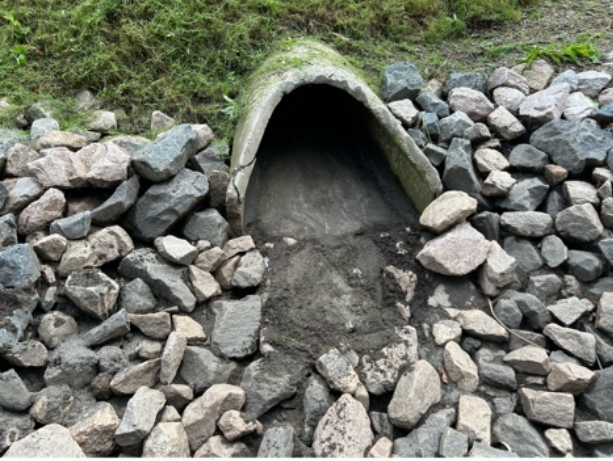
BMP3 Inlet	BMP3 Riser exterior
Photo 19:	Photo 20:

Additional Notes:
<p>Each device was walked and all trash was removed.</p> <p>Mowing and string trimming services were completed.</p> <p>Unwanted planktonic algae was controlled with an approved algaecide.</p> <p>Sediment buildup in the inlet of BMP3 was removed.</p> <p>Water level was appropriate and each device was draining properly.</p> <p>All other components were functioning properly.</p> <p>Please contact our office with any additional questions, concerns, or to schedule repairs.</p>

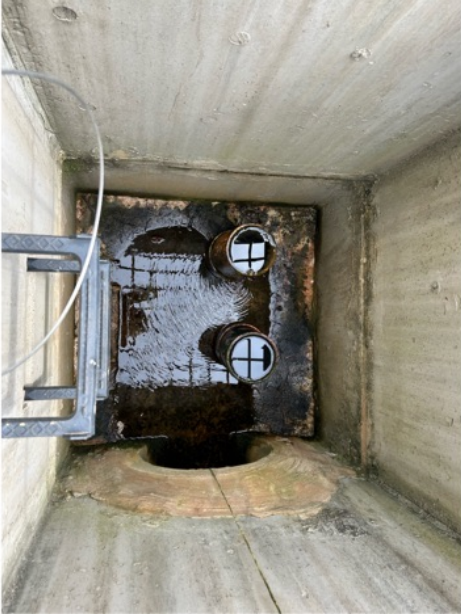
BMP3 Riser interior
