Triangle Pond Management
 405 S Rogers Ln
 Raleigh, NC 27610
 (919)398-3221
 Office@TrianglePondManagement.com
 www.TrianglePondManagement.com
Maintenance Service Report

Customer Name:		Date:	
Chandler Woods MOA		1/26/2023	
Address:			
214 Abbot Pl			
Aquatic Technician:			
Justin Tripp			
Time of Arrival:	Time of Departure:	Drive Time:	
7:05 AM	8:58 AM	15 min	
Type of Device(s) Maintained:			
BMP 1, BMP 2, BMP 3

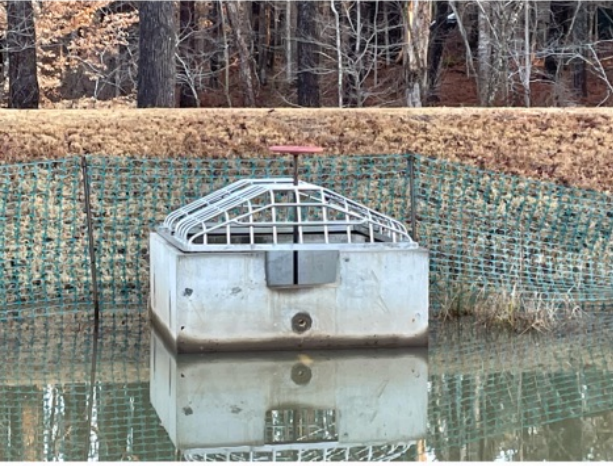
BMP2 riser	BMP2 inlet
Photo 11:	Photo 12:

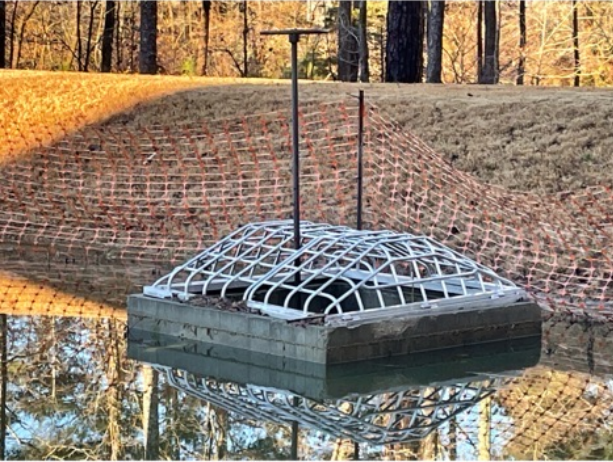
Repairs?	Comment:
Are repairs required? Yes	Leaks in riser

BMP3 riser	BMP3
Photo 19:	Photo 20:

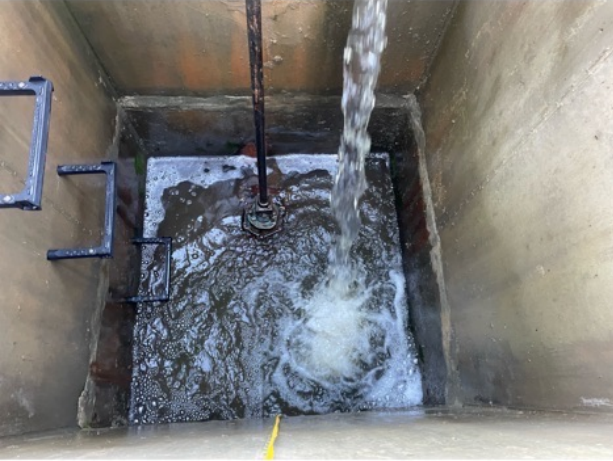
BMP3 inside riser	BMP3 outlet
