**Triangle Pond Management**  
 405 S Rogers Ln  
 Raleigh, NC 27610  
 (919)398-3221  
 Office@TrianglePondManagement.com  
 www.TrianglePondManagement.com  
**Maintenance Service Report**

| Chandler Woods MOA | | 8/13/2026 | |
| 214 Abbot Pl | | | |

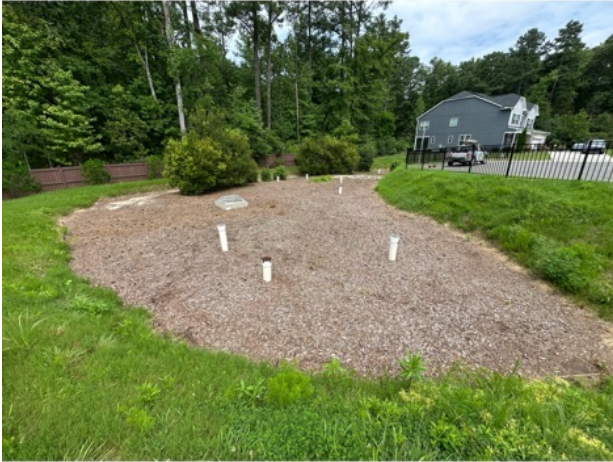
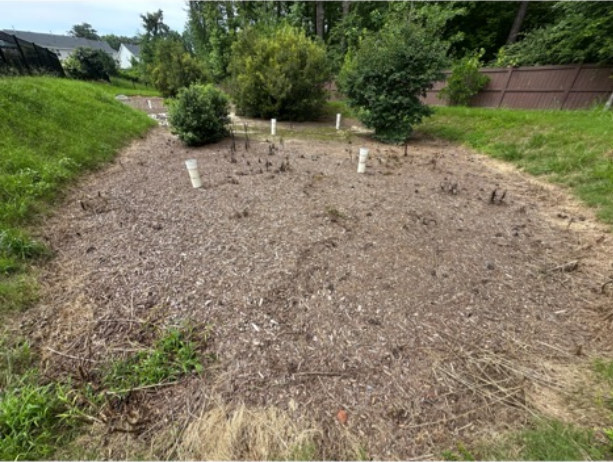
| Photo 1: | Photo 2: |

| Photo 1: | Photo 2: |
|---|---|
| BR1 overview | BR1 overview |

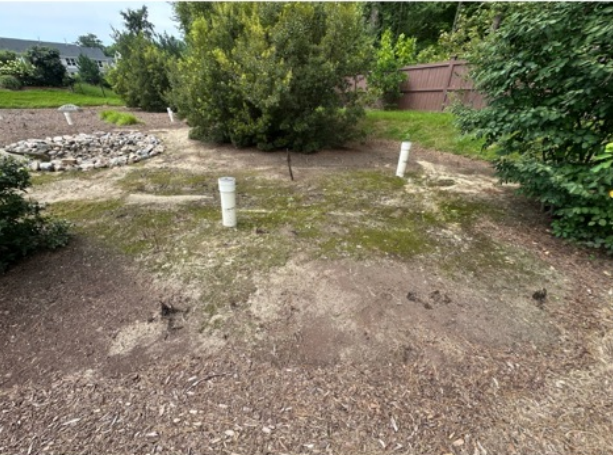
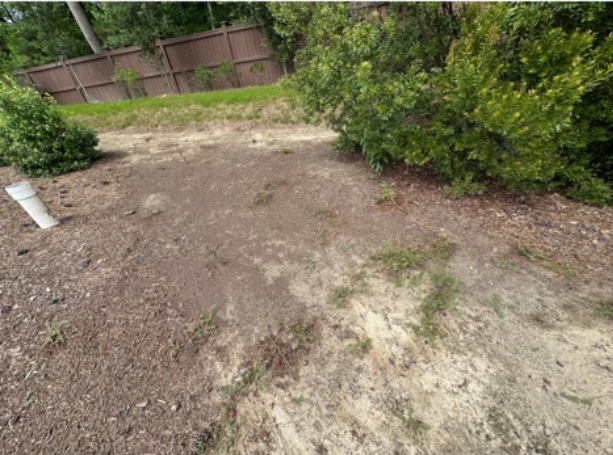
| Photo 1: | Photo 2: |
|---|---|
| Photo 3: | Photo 4: |

| Additional Notes: |
|---|
| <p>Devices were walked. Accessible trash and debris were removed.</p> <p>Unwanted vegetation in the basin of BR1 was treated with an approved herbicide.</p> <p>Observed areas lacking sufficient mulch in BR1. - <u>May require re-mulching.</u></p> <p>Observed large fallen tree in WP2. - <u>Recommend removal.</u></p> <p>Unwanted woody vegetation was treated in the littoral zone of WP3.</p> <p>All other components functioning properly.</p> <p>Please contact our office with any additional questions, concerns, or to schedule repairs.</p> |

| Photo 1: | Photo 2: |
|---|---|
| Bare areas | Bare areas |

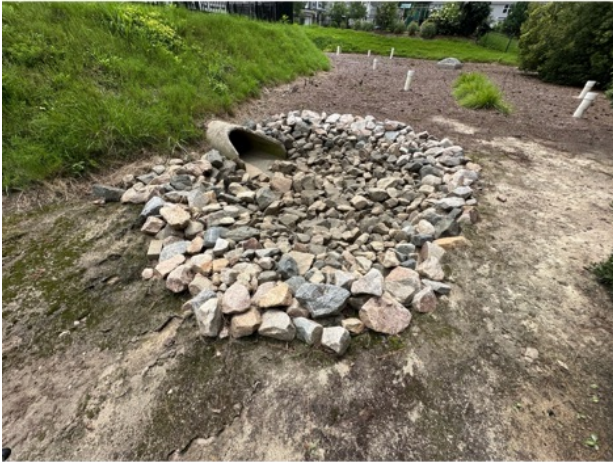
| Photo 5: | Photo 6: |
|---|---|
| Inlet | Riser |

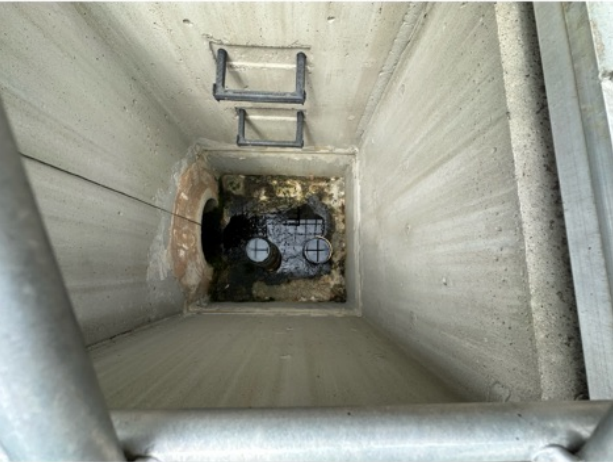
| Photo 5: | Photo 6: |
|---|---|
| Riser interior | WP2 overview |

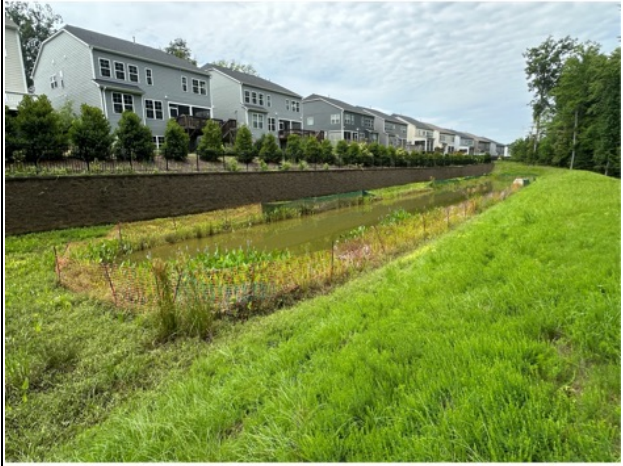
| Photo 9: | Photo 10: |
|---|---|
| WP2 overview | WP2 fore bay overview |

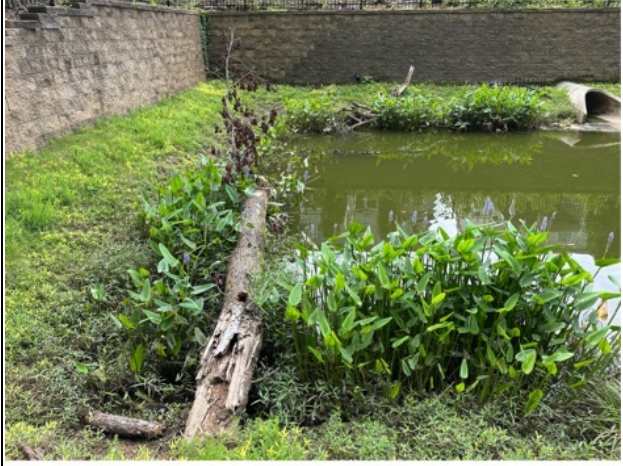
| Photo 9: | Photo 10: |
|---|---|
| Fallen tree | Back of dam |

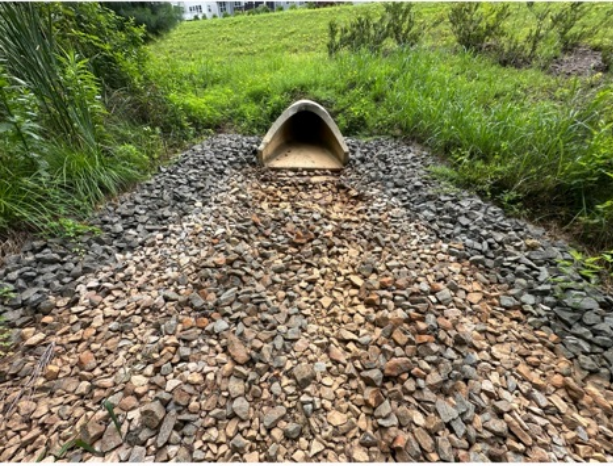
| Photo 13: | Photo 14: |
|---|---|
| Outlet | WP3 overview |

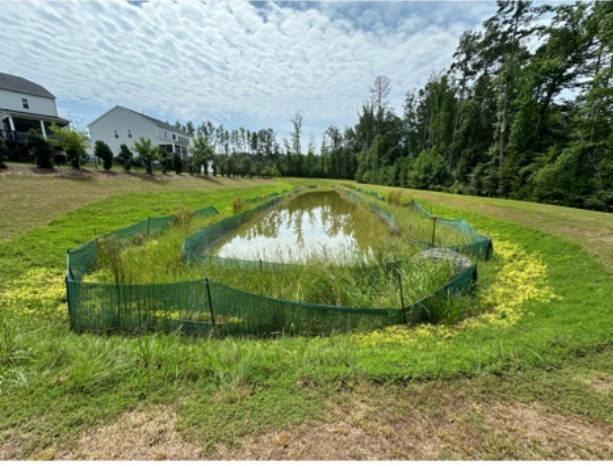
| Photo 13: | Photo 14: |
|---|---|
| WP3 overview | Inlet |

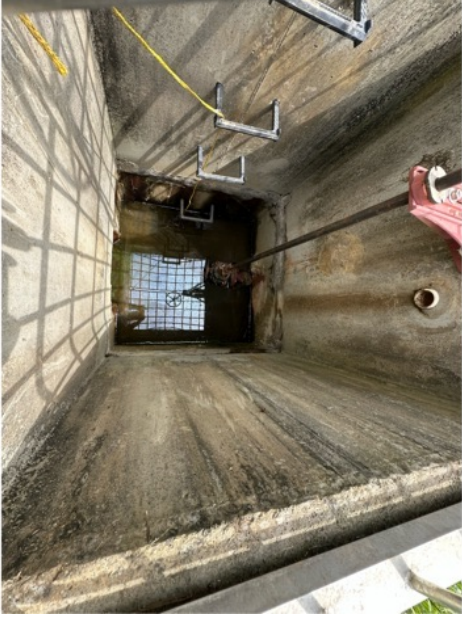
| Photo 17: | Photo 18: |
|---|---|
| Riser interior | Outlet |
