Triangle Pond Management
 405 S Rogers Ln
 Raleigh, NC 27610
 (919)398-3221
 Office@TrianglePondManagement.com
 www.TrianglePondManagement.com
Maintenance Service Report

Customer Name:		Date:	
Chandler Woods MOA		11/15/2025	
Address:			
214 Abbot Pl			
Aquatic Technician:			
Jonathan Johnson			
Time of Arrival:	Time of Departure:	Drive Time:	
8:20 AM	11:20 AM	1hr 20min	
Type of Device(s) Maintained:			
BMP 1, BMP 2, BMP 3

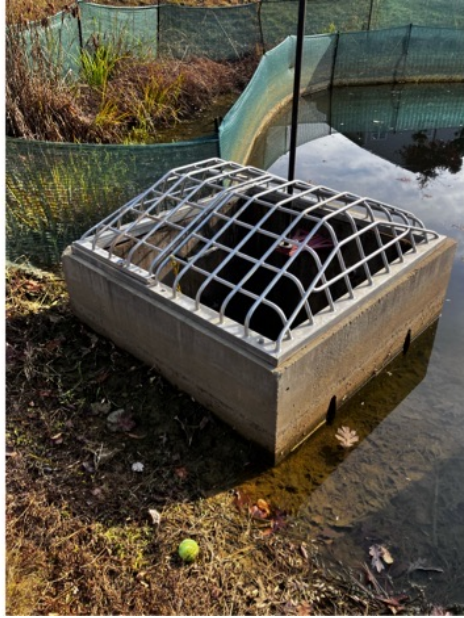
<p>A close-up photograph of a concrete riser structure with a metal grate cover, situated in a grassy area next to a body of water.</p>
BMP1 overview	BMP1 riser
Photo 3:	Photo 4:

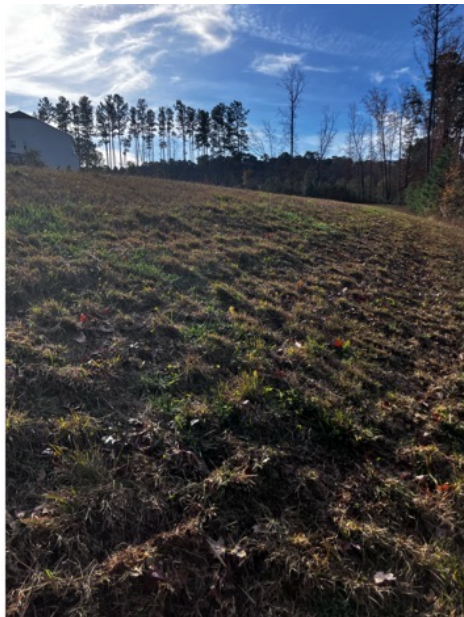
<p>A wide-angle photograph of a grassy field with a small, rectangular, concrete-lined pond or detention basin, similar to Photo 1.</p>
BMP1 inside riser	BMP1 overview

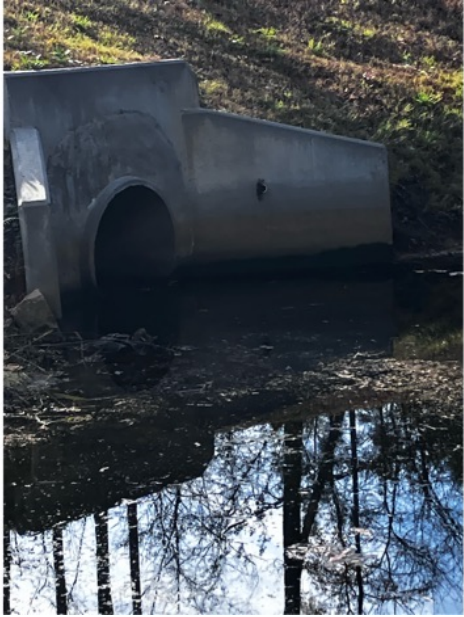
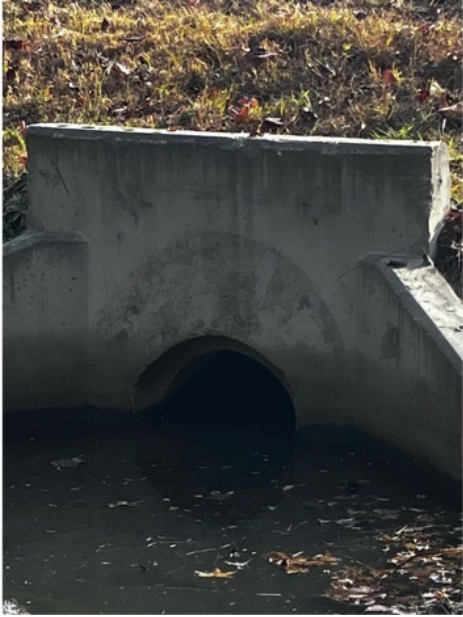
BMP1 inlet	BMP1 outlet
Photo 7:	Photo 8:

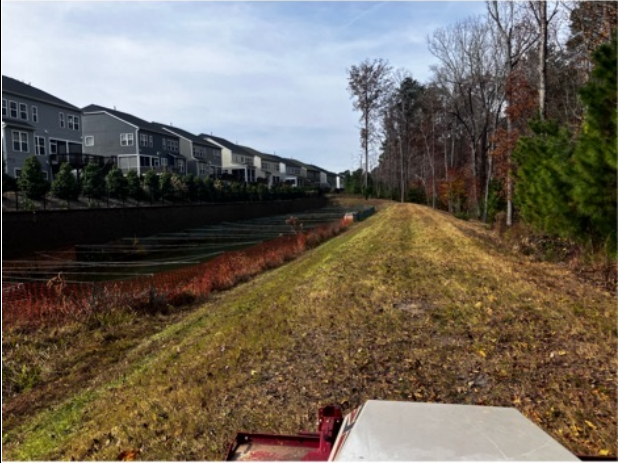
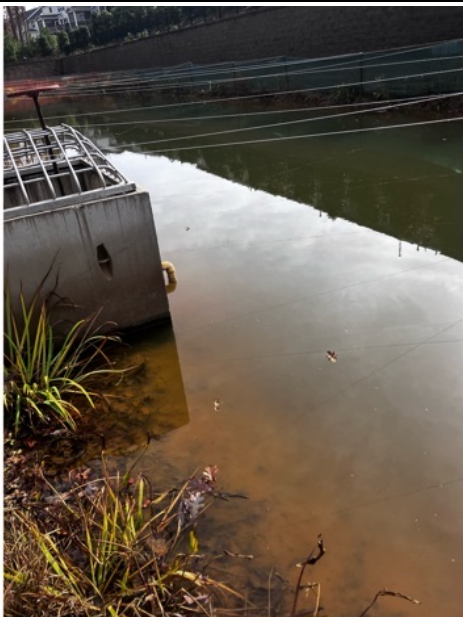
BMP2 overview	BMP2 riser

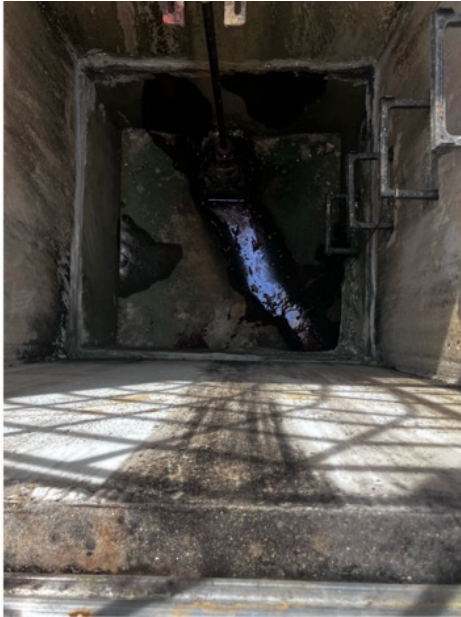
Photo 9:

BMP2 inside riser

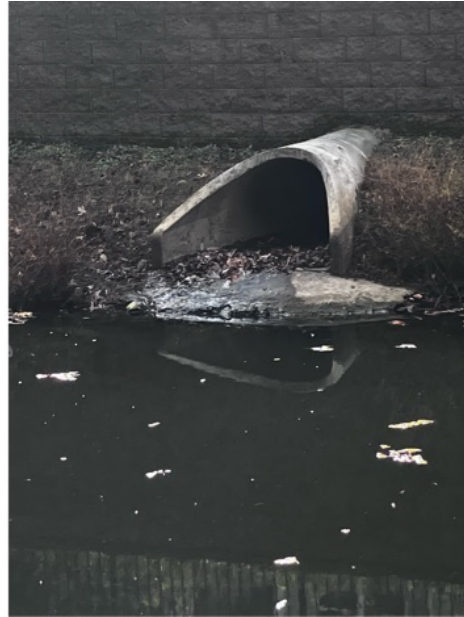
Photo 10:

BMP2 inlet

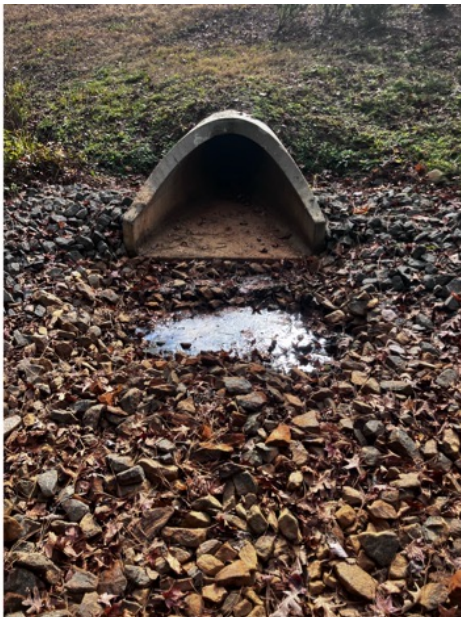
Photo 11:

BMP2 outlet

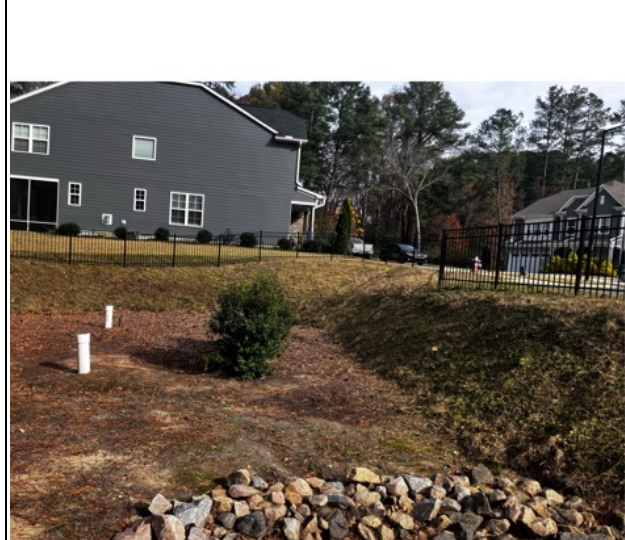
Photo 12:

BMP3 overview

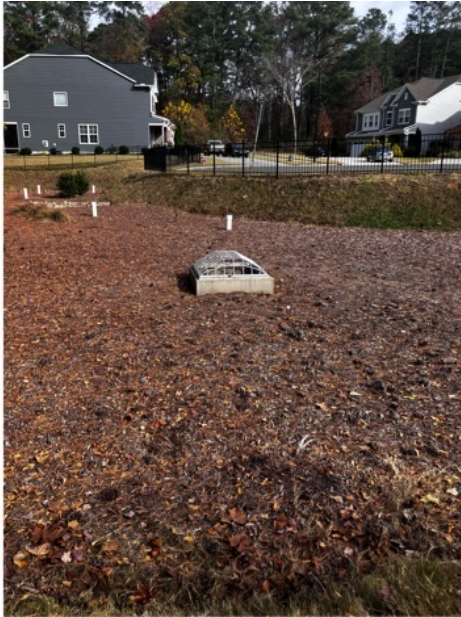
Photo 13:

BMP3 riser

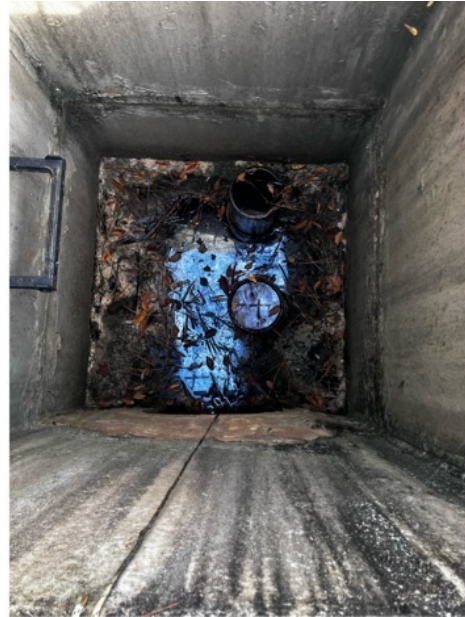
Photo 14:

BMP3 inside riser

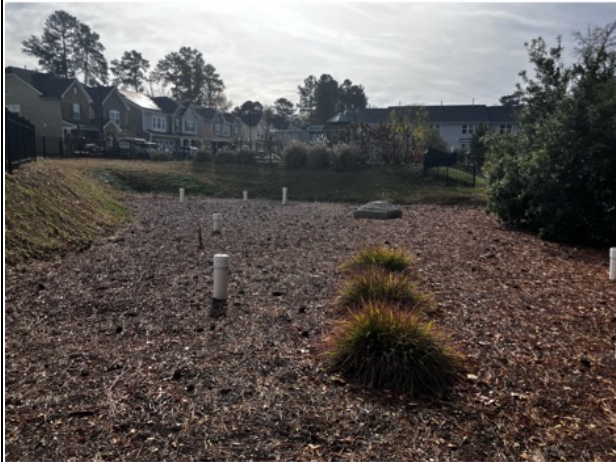
Photo 15:

BMP3 overview

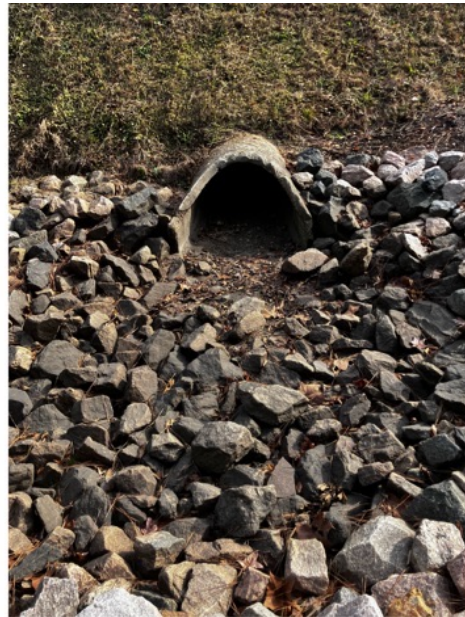
Photo 16:

BMP3 inlet
