**Triangle Pond Management**  
 405 S Rogers Ln  
 Raleigh, NC 27610  
 (919)398-3221  
 Office@TrianglePondManagement.com  
 www.TrianglePondManagement.com  
**Maintenance Service Report**

<b>Customer Name:</b>		<b>Date:</b>	
Chandler Woods MOA		11/7/2023	
<b>Address:</b>			
214 Abbot Pl			
<b>Aquatic Technician:</b>			
Dylan Cash			
<b>Time of Arrival:</b>	<b>Time of Departure:</b>	<b>Drive Time:</b>	
9:18 AM	11:35 am	21 min	
<b>Type of Device(s) Maintained:</b>			
BMP 1, BMP 2, BMP 3

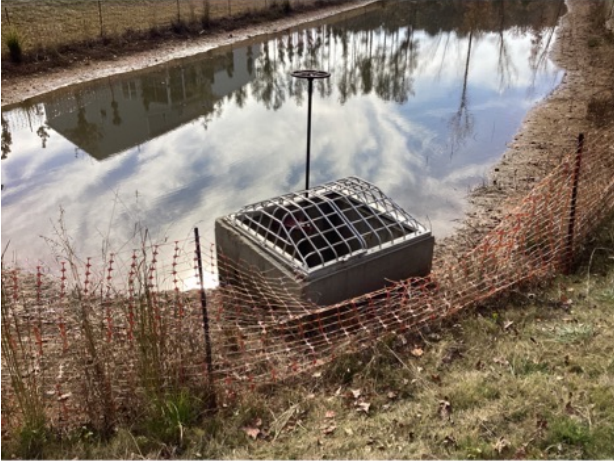
Photo 1:	Photo 2:

BMP 1 overview	BMP 1 riser
Photo 3:	Photo 4:

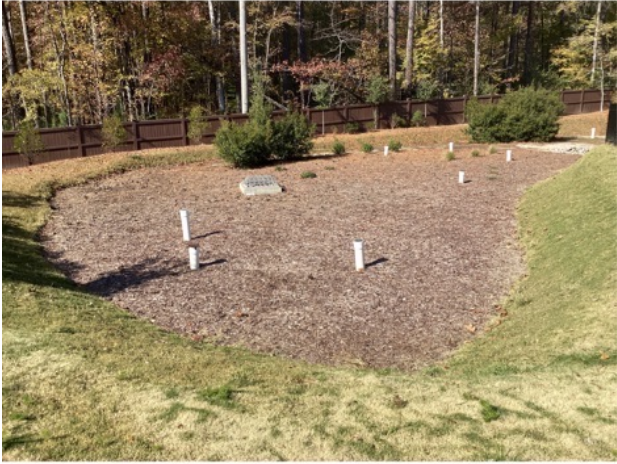
Photo 9:	Photo 10:

BMP 3 overview	BMP 3 riser
Photo 11:	Photo 12:

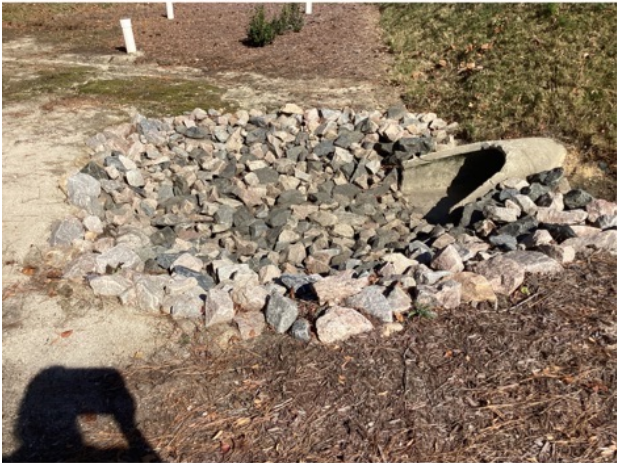
BMP 3 inlet
