**Triangle Pond Management**  
 405 S Rogers Ln  
 Raleigh, NC 27610  
 (919)398-3221  
 Office@TrianglePondManagement.com  
 www.TrianglePondManagement.com  
**Maintenance Service Report**

<b>Customer Name:</b>		<b>Date:</b>	
Chandler Woods MOA		4/19/2023	
<b>Address:</b>			
214 Abbot Pl			
<b>Aquatic Technician:</b>			
Justin Tripp			
<b>Time of Arrival:</b>	<b>Time of Departure:</b>	<b>Drive Time:</b>	
6:34 AM	8:04 AM	15 min	
<b>Type of Device(s) Maintained:</b>			
BMP 1, BMP 2, BMP 3

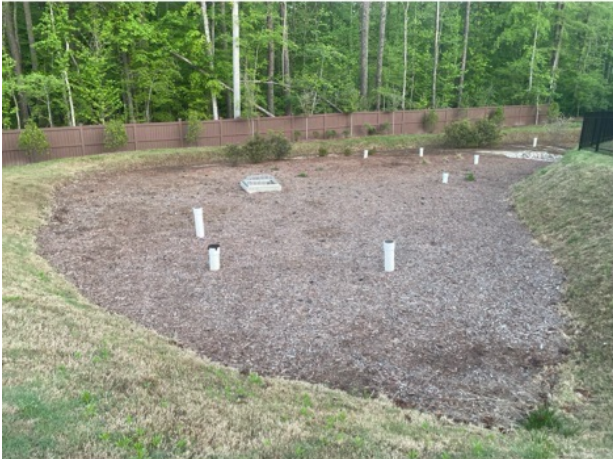
Photo 1:	Photo 2:

BMP3	BMP3 inlet
Photo 3:	Photo 4:

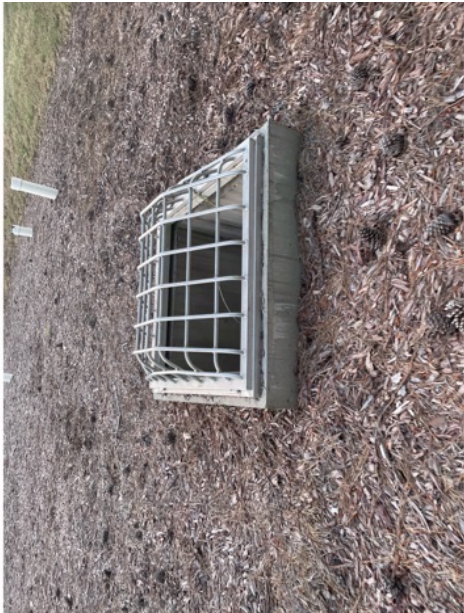
Additional Notes:
<p>The devices were walked and all trash was removed.</p> <p>Unwanted/invasive vegetation throughout each device was controlled.</p> <p>The devices could possibly be lacking beneficial vegetation. Recommend adding.</p> <p>There appears to be leaks within the BMP1 and BMP3 riser structures. Recommend repairing.</p> <p>Observed bare areas throughout BMP3. Recommend adding additional mulch.</p> <p>All other components were functioning properly with no major issues observed.</p> <p>Please contact our office with any additional questions, concerns, or to schedule repairs.</p>

BMP3 riser	BMP3 inside riser

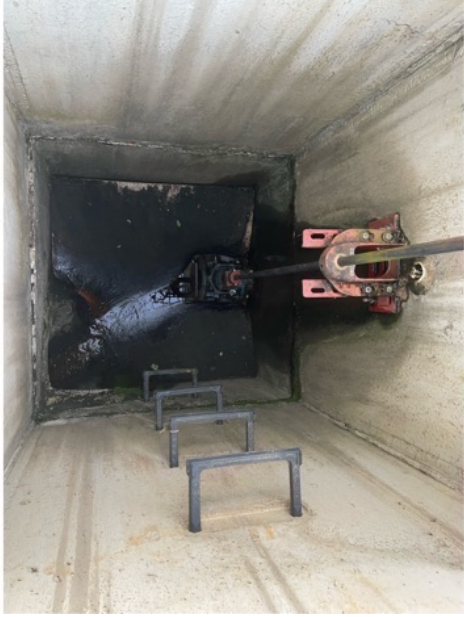
Photo 9:	Photo 10:

BMP2 riser	BMP2 inside riser
Photo 11:	Photo 12:
