Triangle Pond Management
 405 S Rogers Ln
 Raleigh, NC 27610
 (919)398-3221
 Office@TrianglePondManagement.com
 www.TrianglePondManagement.com
Maintenance Service Report

Customer Name:		Date:	
Chandler Woods MOA		1/25/2024	
Address:			
214 Abbot Pl			
Aquatic Technician:			
Dylan Cash			
Time of Arrival:	Time of Departure:	Drive Time:	
8:53 AM	11:20 am	6 min	
Type of Device(s) Maintained:			
BMP 1, BMP 2, BMP 3

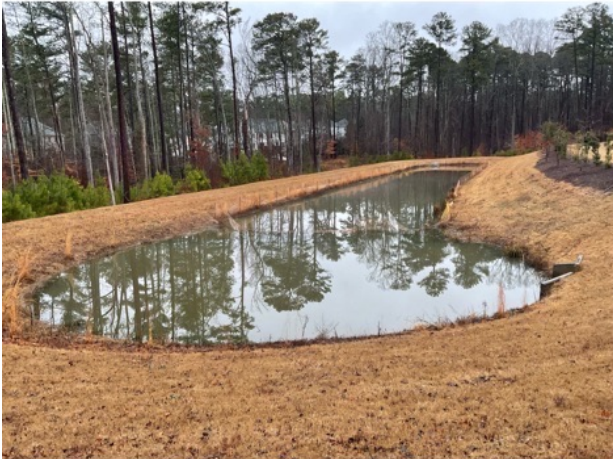
Photo 1:	Photo 2:

BMP 1 overview	BMP 1 inlet
Photo 3:	Photo 4:

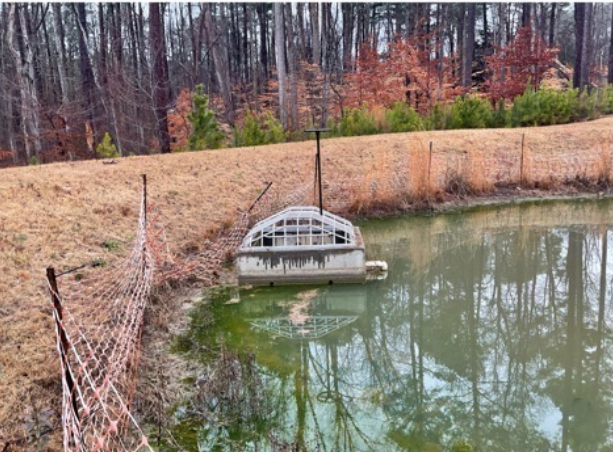
BMP 1 riser	BMP 1 outlet
