Triangle Pond Management
 405 S Rogers Ln
 Raleigh, NC 27610
 (919)398-3221
 Office@TrianglePondManagement.com
 www.TrianglePondManagement.com
Maintenance Service Report

Customer Name:		Date:	
Chandler Woods MOA		9/26/2023	
Address:			
214 Abbot Pl			
Aquatic Technician:			
Ryan Welch & Dylan Cash			
Time of Arrival:		Time of Departure:	
8:36 AM		10:51 AM	
Drive Time:			
1 hour 11 minutes			
Type of Device(s) Maintained:			
BMP 1, BMP 2, BMP 3

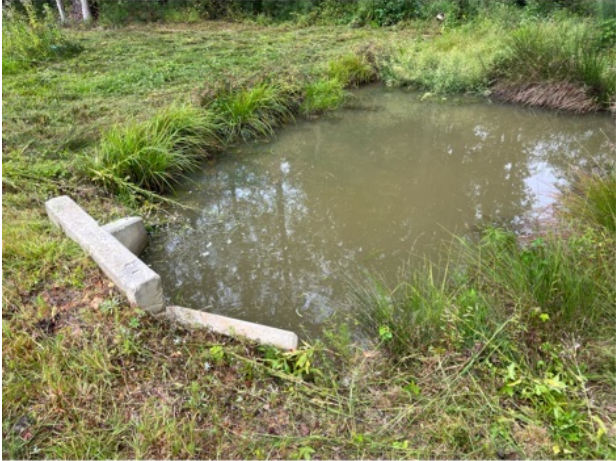
Photo 1:	Photo 2:

Outlet of BMP1	Riser of BMP1
Photo 3:	Photo 4:

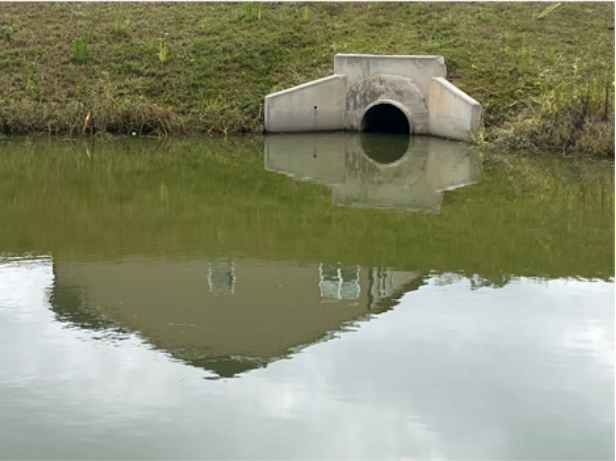
Inlet of BMP1	Overall view of BMP1

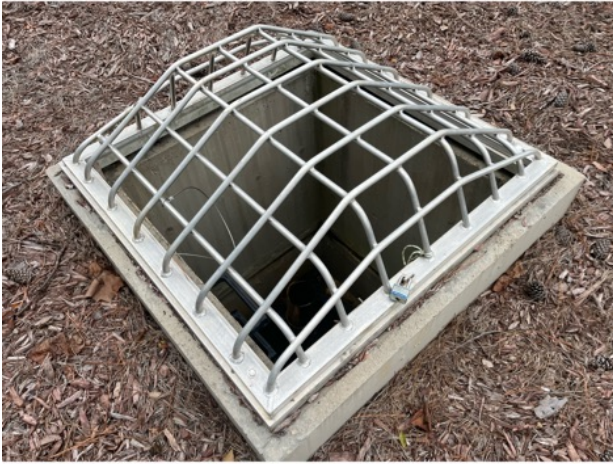
Photo 5:

Riser of BMP3

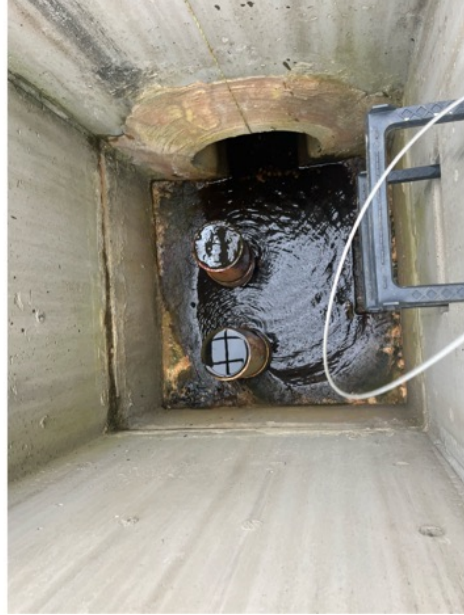
Photo 6:

Inside riser of BMP3

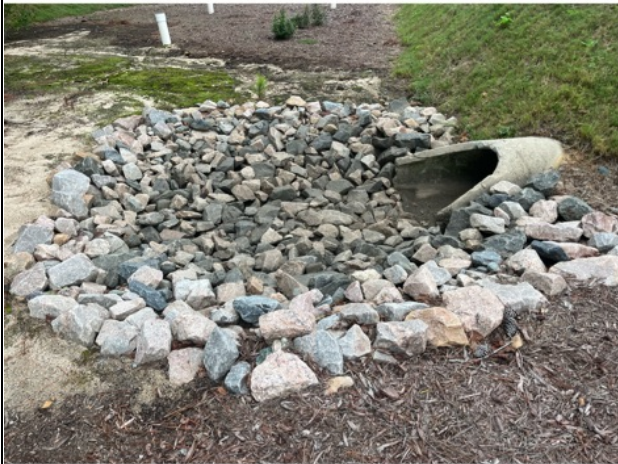
Photo 7:

Inlet of BMP3

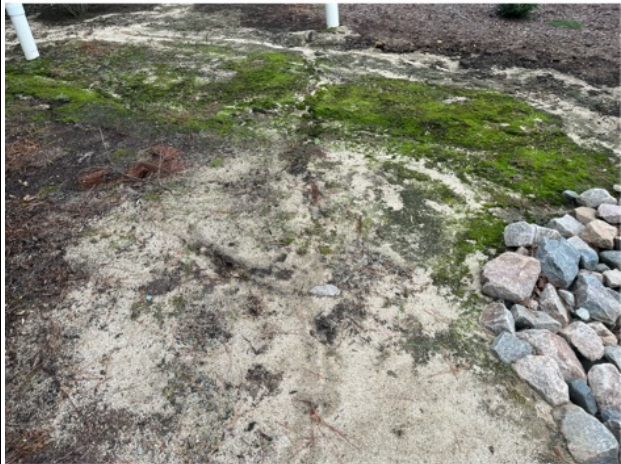
Photo 8:

The devices were walked and all trash was removed.
Mowing and string trimming services were completed.
Debris was cleared from the trash racks.
Minor unwanted vegetation within the basin of BMP3 was hand removed.
The devices are draining properly with no major issues observed.

Bare areas at BMP3 basin

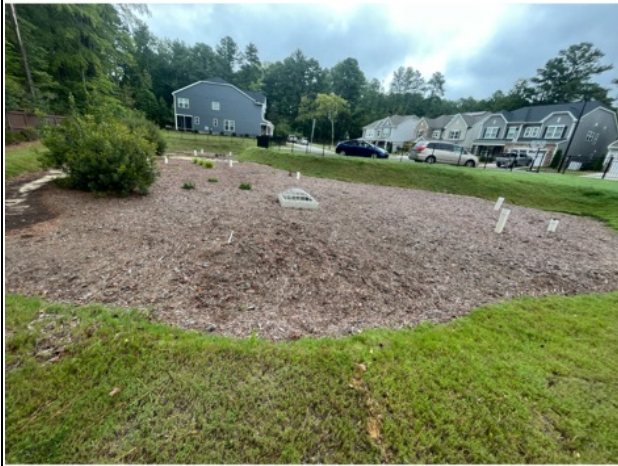
Photo 9:

Overall view of BMP3

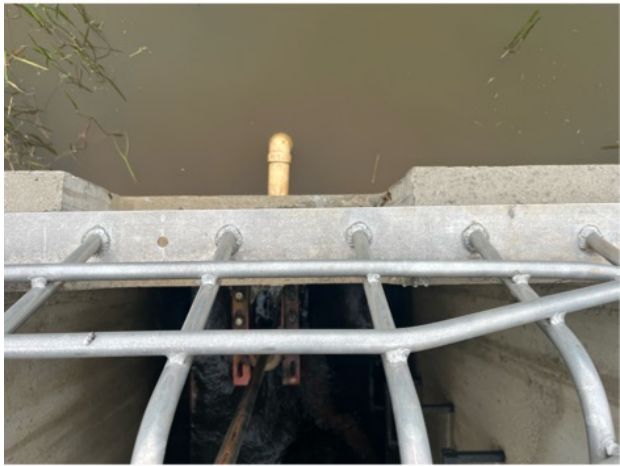
Photo 10:

Orifice of BMP2

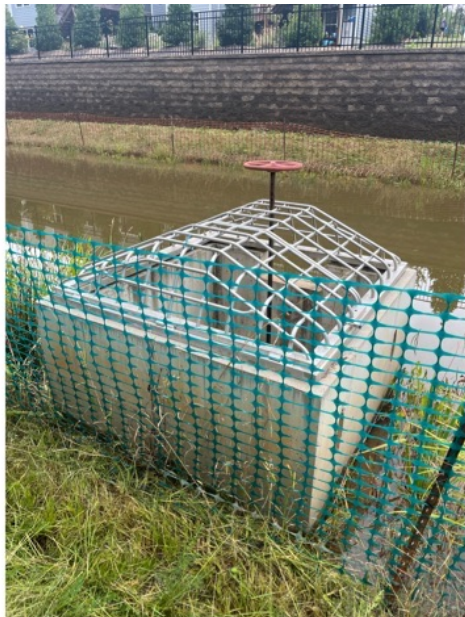
Photo 11:

Riser of BMP2

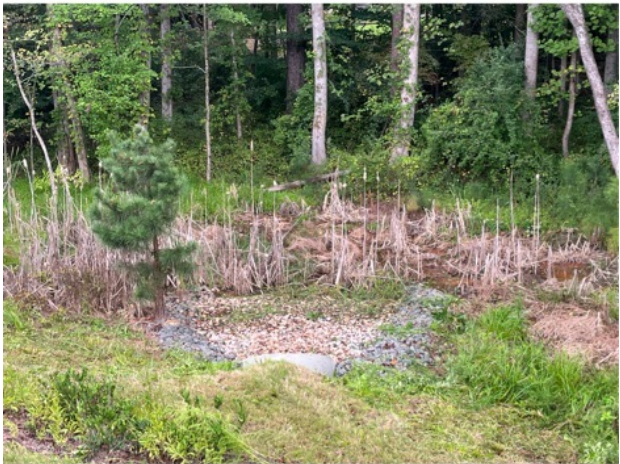
Photo 12:

Outlet of BMP2
