**Triangle Pond Management**  
 405 S Rogers Ln  
 Raleigh, NC 27610  
 (919)398-3221  
 Office@TrianglePondManagement.com  
 www.TrianglePondManagement.com  
**Maintenance Service Report**

<b>Customer Name:</b>		<b>Date:</b>	
Chandler Woods MOA		12/30/2024	
<b>Address:</b>			
214 Abbot Pl			
<b>Aquatic Technician:</b>			
Dylan Cash			
<b>Time of Arrival:</b>	<b>Time of Departure:</b>	<b>Drive Time:</b>	
10:07 AM	1:00 PM	38 min	
<b>Type of Device(s) Maintained:</b>			
BMP 1, BMP 2, BMP 3

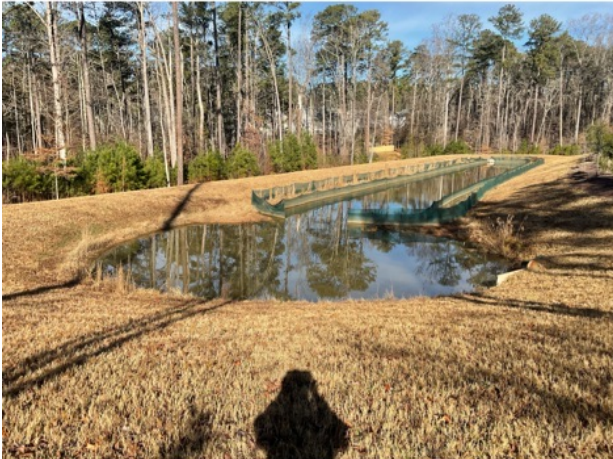
Photo 1:	Photo 2:

BMP 1 overview	BMP 1 overview
Photo 3:	Photo 4:

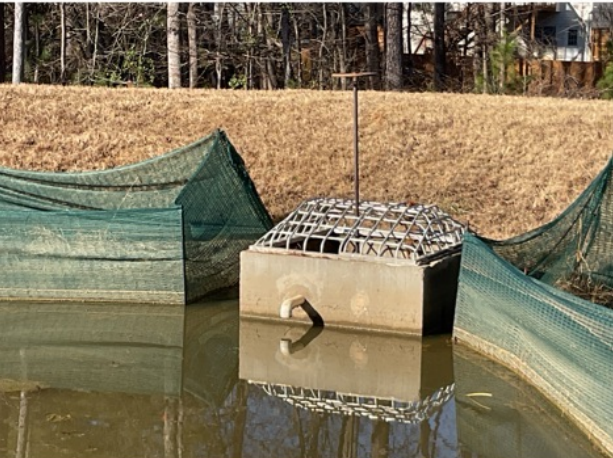
BMP 1 riser	BMP 1 inside the riser

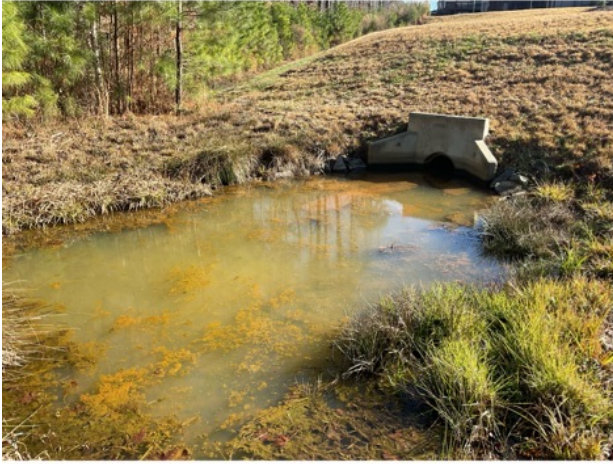
Photo 5:	Photo 6:

BMP 1 outlet	BMP 1 inlet
Photo 7:	Photo 8:

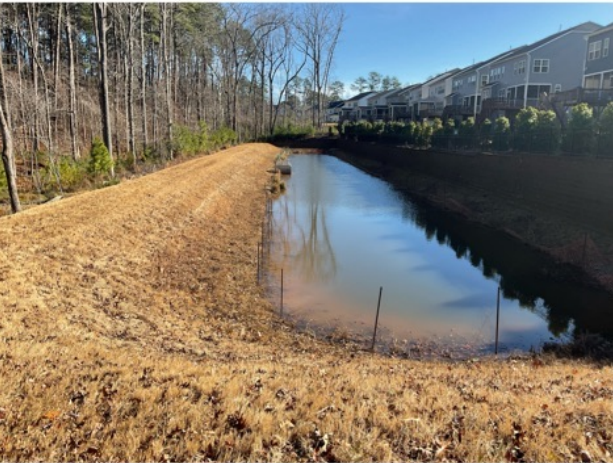
BMP 2 overview	BMP 2 overview

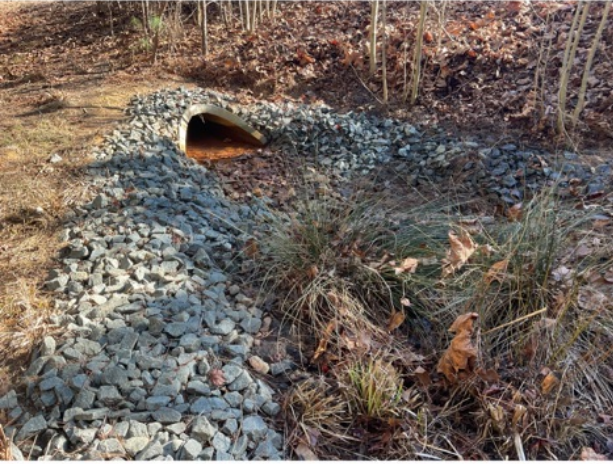
Photo 17:	Photo 18:

BMP 3 outlet	BMP 3 inlet
Photo 19:	Photo 20:
