Triangle Pond Management
 405 S Rogers Ln
 Raleigh, NC 27610
 (919)398-3221
 Office@TrianglePondManagement.com
 www.TrianglePondManagement.com
Maintenance Service Report

Customer Name:		Date:	
Chandler Woods MOA		8/17/2023	
Address:			
214 Abbot Pl			
Aquatic Technician:			
Justin Tripp			
Time of Arrival:	Time of Departure:	Drive Time:	
10:54 AM	1:46 PM	21 min	
Type of Device(s) Maintained:			
BMP 1, BMP 2, BMP 3

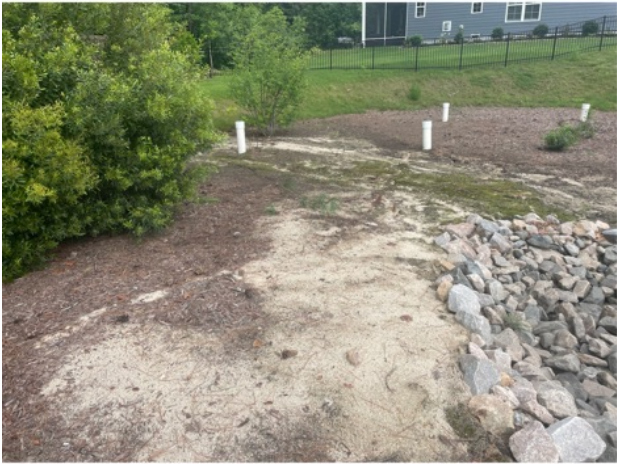
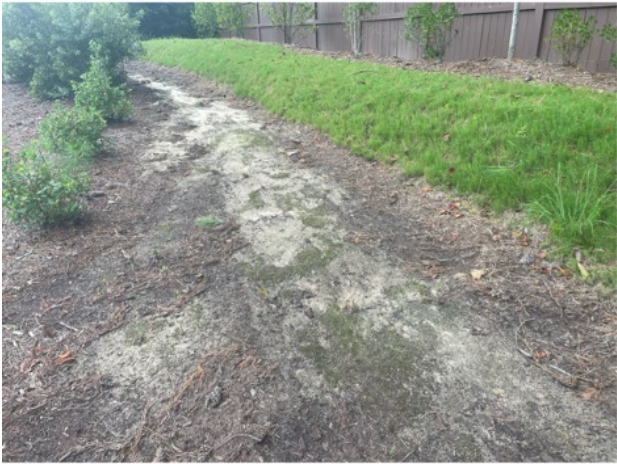
Photo 17:	Photo 18:

Repairs?	Comment:
Are repairs required? Yes	Bare areas at BMP3

Bare areas at BMP3	Bare areas at BMP3
Photo 19:	Photo 20:
