Triangle Pond Management
 405 S Rogers Ln
 Raleigh, NC 27610
 (919)398-3221
 Office@TrianglePondManagement.com
 www.TrianglePondManagement.com
Maintenance Service Report

Customer Name:		Date:	
Chandler Woods MOA		10/16/2023	
Address:			
214 Abbot Pl			
Aquatic Technician:			
Justin Tripp			
Time of Arrival:		Time of Departure:	
10:10 AM		11:53 AM	
Drive Time:			
		56 min	
Type of Device(s) Maintained:			
BMP 1, BMP 2, BMP 3

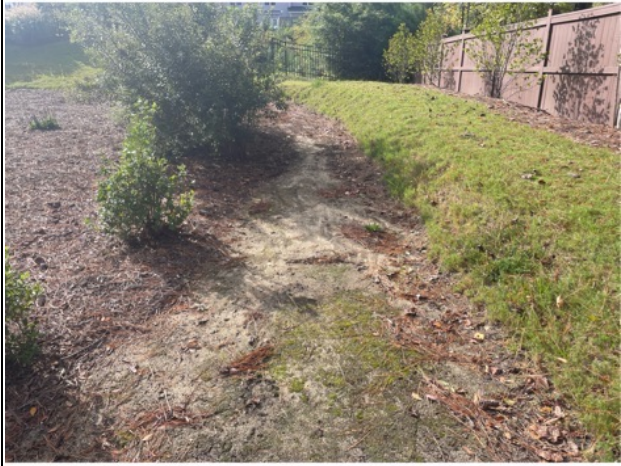
Additional Notes:
 The perimeter of each device was walked and all trash was removed.
 Minor filamentous algae was controlled.
 Debris and leaves were cleared from the riprap areas.
 Removed minor accumulated sediment from the BMP3 inlet pipe.
 Observed bare areas throughout BMP3. Recommend repairing.

<p>Bare areas at BMP3</p>	<p>Bare areas at BMP3</p>
Photo 19:	Photo 20:

Repairs?	Comment:
Are repairs required? Yes	Bare areas at BMP3

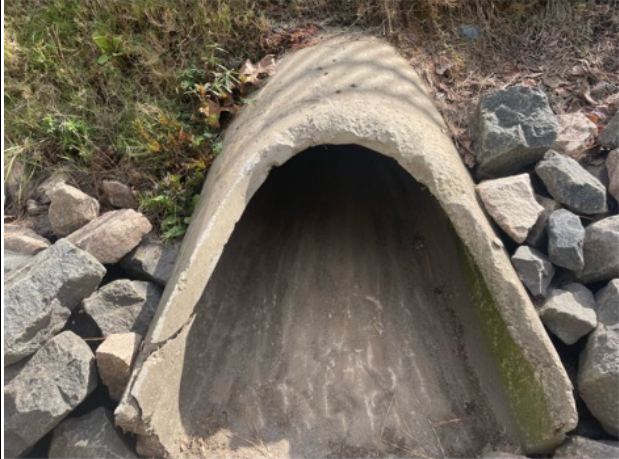
<p>Before removal of accumulated sediment at BMP3 inlet</p>	<p>After removal of accumulated sediment at BMP3 inlet</p>
