Triangle Pond Management
 405 S Rogers Ln
 Raleigh, NC 27610
 (919)398-3221
 Office@TrianglePondManagement.com
 www.TrianglePondManagement.com
Maintenance Service Report

Customer Name:		Date:	
Chandler Woods MOA		5/29/2024	
Address:			
214 Abbot Pl			
Aquatic Technician:			
Anthony Monefusco			
Time of Arrival:	Time of Departure:	Drive Time:	
8:10 AM	8:19 AM	20 minutes	
Type of Device(s) Maintained:			
BMP 1, BMP 2, BMP 3

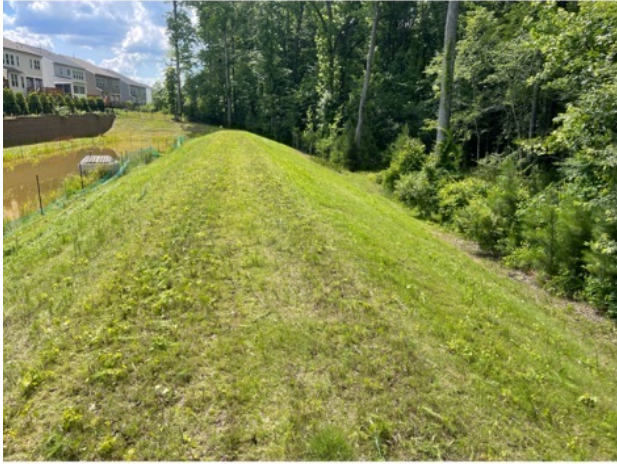
Photo 9:	Photo 10:

BMP2 view	BMP2 view
Photo 11:	Photo 12:

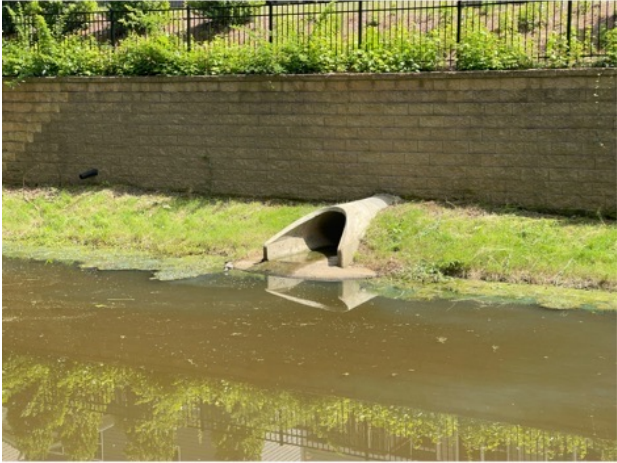
BMP2 inlet	BMP2 riser

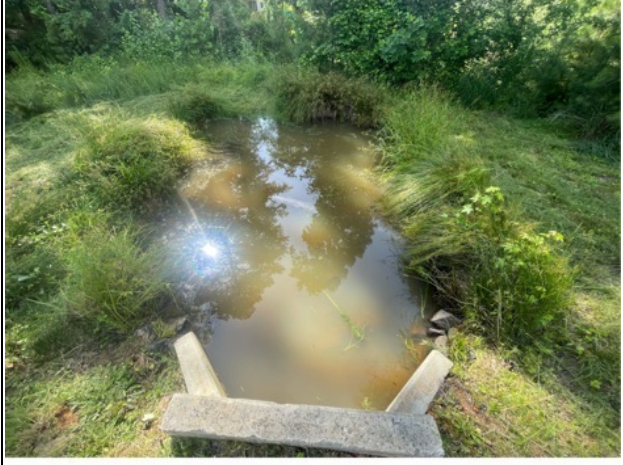
<p>A photograph showing a concrete BMP1 riser with a metal grate cover, situated in a grassy field. A small stream flows into the riser from the left. The surrounding area is green and grassy.</p>	
BMP1 inside riser
