**Triangle Pond Management**  
 405 S Rogers Ln  
 Raleigh, NC 27610  
 (919)398-3221  
 Office@TrianglePondManagement.com  
 www.TrianglePondManagement.com  
**Maintenance Service Report**

<b>Customer Name:</b>		<b>Date:</b>	
Chandler Woods MOA		2/23/2026	
<b>Address:</b>			
214 Abbot Pl			
<b>Aquatic Technician:</b>			
Jordan Woosley			
<b>Time of Arrival:</b>		<b>Time of Departure:</b>	
10:10 AM		1:38 PM	
<b>Drive Time:</b>			
11 min			
<b>Type of Device(s) Maintained:</b>			
BMP 1, BMP 2, BMP 3

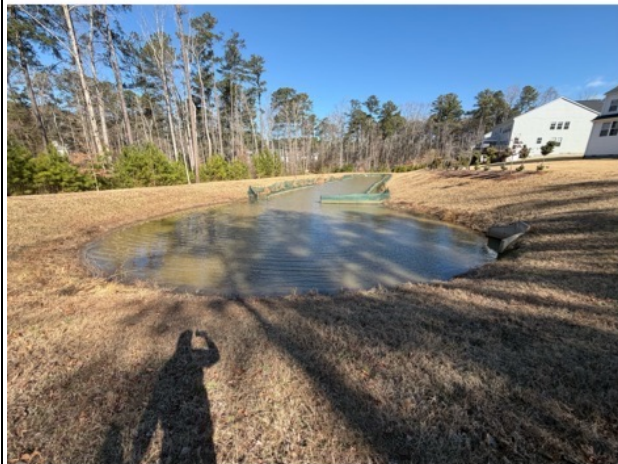
**Photo 1:**

BMP 1 overview

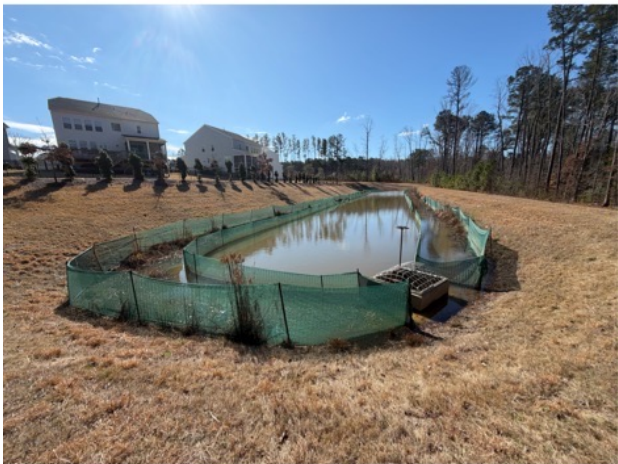
**Photo 2:**

BMP 1 overview

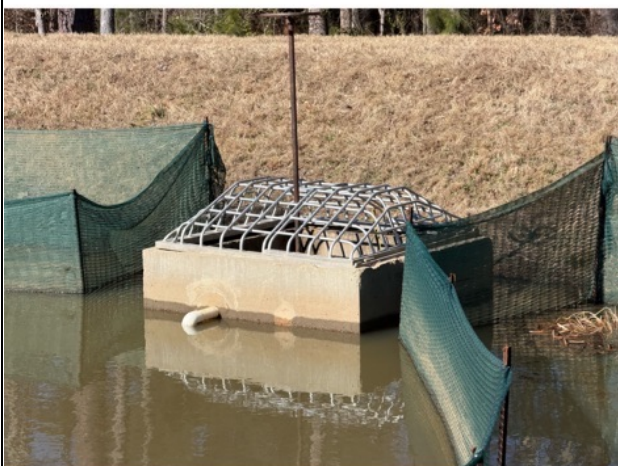
**Photo 3:**

The riser hatches at BMP 1/2 were locked shut preventing access to the riser interior which would be necessary to exercise the stuck drain valves.

BMP 1 riser

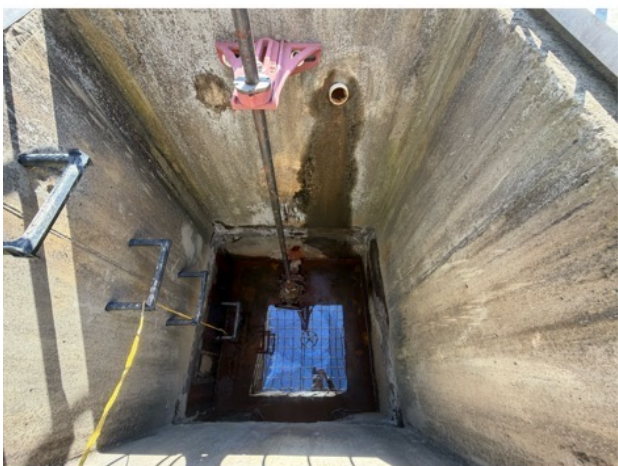
**Photo 4:**

BMP 1 riser interior

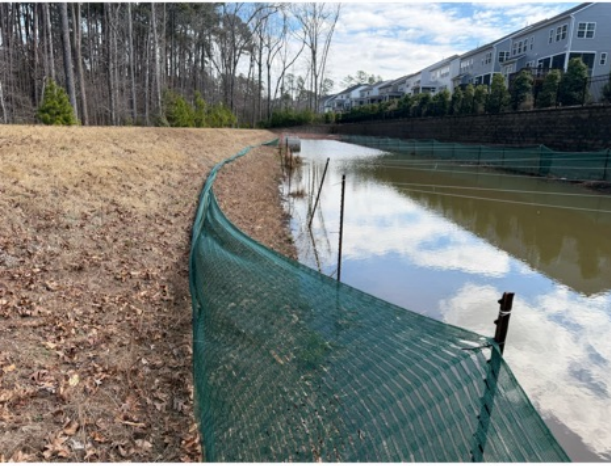
The wildlife exclusion fencing has come apart from the stakes around BMP 2, may require repairs.

<p>BMP 2 wildlife exclusion fencing coming apart from stakes</p>	<p>BMP 2 backside of dam</p>
Photo 19:	Photo 20:

Please contact our office with any additional questions, concerns, or to schedule repairs.

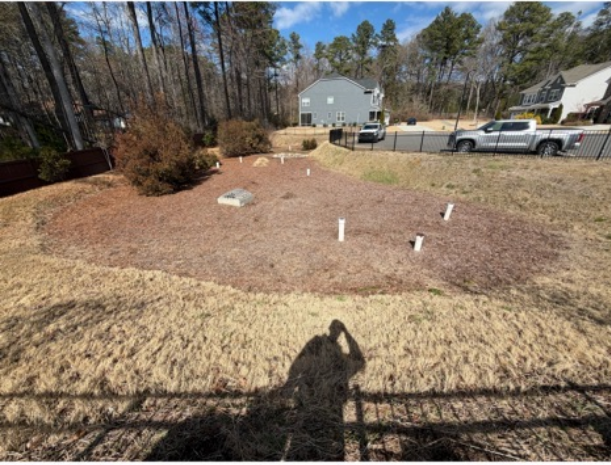
<p>BMP 3 overview</p>	<p>BMP 3 overview</p>

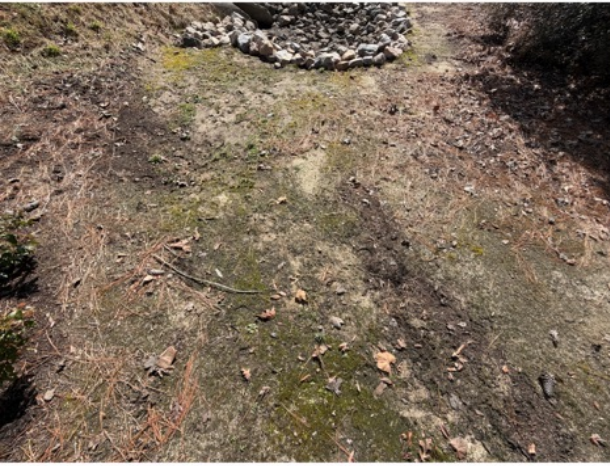
Mulch was raked and redistributed along portions of the BMP3 basin, however, water flow has washed out large areas of mulch.

<p>BMP 3 outlet</p>	<p>BMP 3 area lacking mulch</p>
Photo 27:	Photo 28:

It may be necessary to add supplemental mulch to cover the exposed areas.

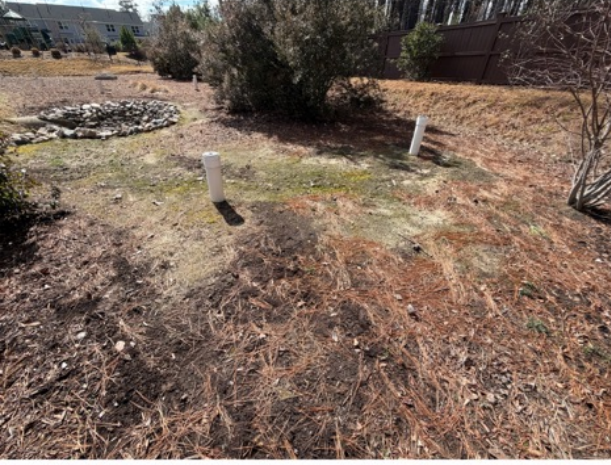
<p>BMP 3 area lacking mulch</p>
