**Triangle Pond Management**  
 405 S Rogers Ln  
 Raleigh, NC 27610  
 (919)398-3221  
 Office@TrianglePondManagement.com  
 www.TrianglePondManagement.com  
**Maintenance Service Report**

<b>Customer Name:</b>		<b>Date:</b>	
Chandler Woods MOA		4/21/2026	
<b>Address:</b>			
214 Abbot Pl			
<b>Aquatic Technician:</b>			
Jordan Woosley			
<b>Time of Arrival:</b>		<b>Time of Departure:</b>	
7:34 AM		10:02 AM	
		<b>Drive Time:</b>	
		56 min	
<b>Type of Device(s) Maintained:</b>			
BMP 1, BMP 2, BMP 3

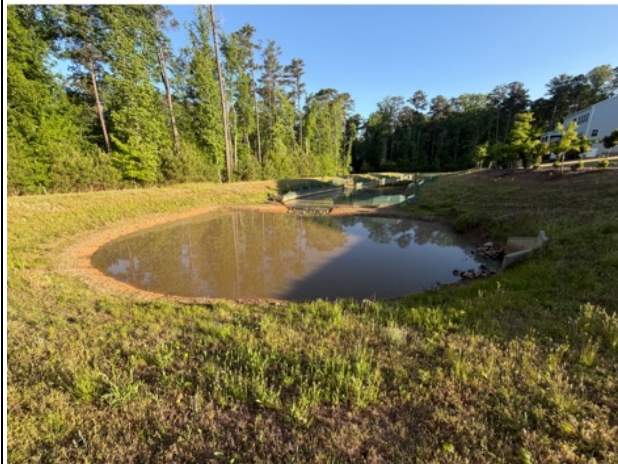
**Photo 1:** **Photo 2:**

BMP 1 overview

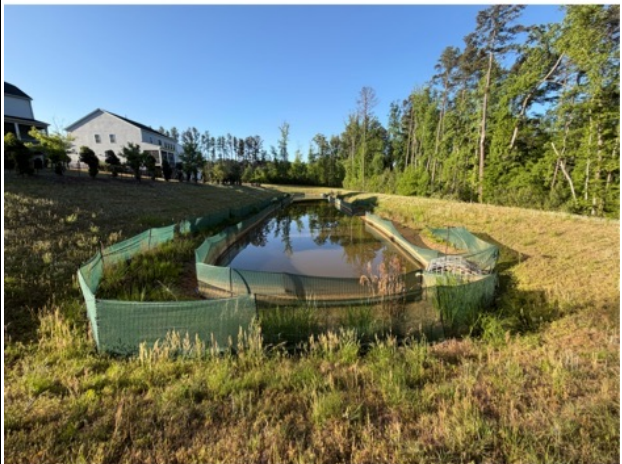
BMP 1 overview

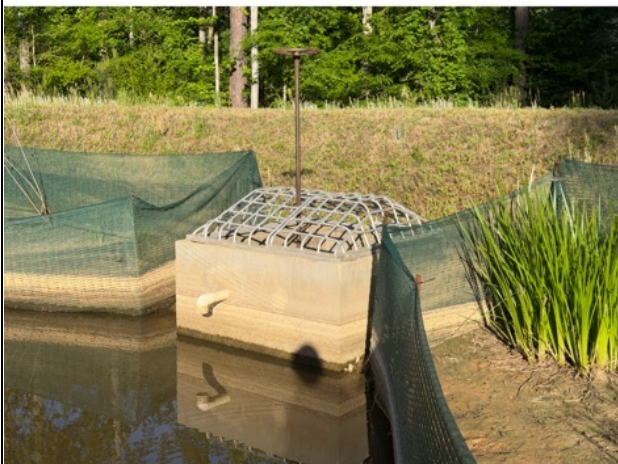
**Photo 3:** **Photo 4:**

BMP 1 riser

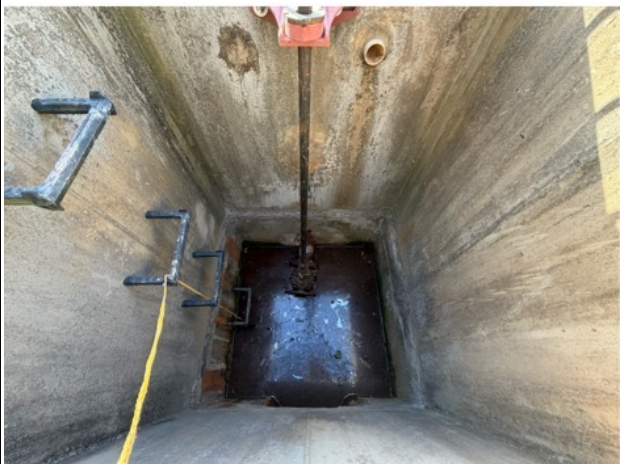
BMP 1 riser interior

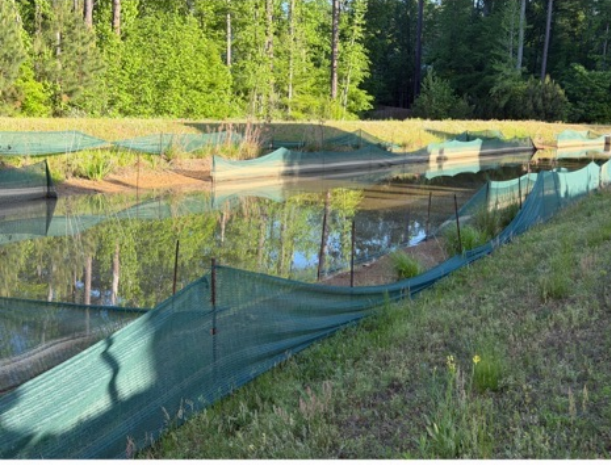
- ✓ It may be necessary to add supplemental mulch to cover the exposed areas.
- ✓ The wildlife exclusion fencing has come apart from the stakes around BMP 1/2. - May require repairs.

<p>BMP 1 wildlife exclusion fencing damage</p>	<p>BMP 1 backside of dam</p>

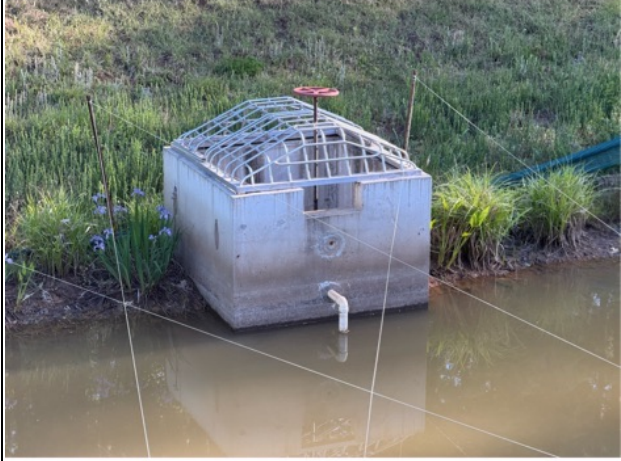
- ✓ Some minor seepage in the BMP 2 riser was observed this visit. - We will continue to monitor.
- ✓ All other components were functioning properly.

<p>BMP 2 riser</p>	<p>BMP 2 riser interior note: minor seepage near bottom of structure</p>

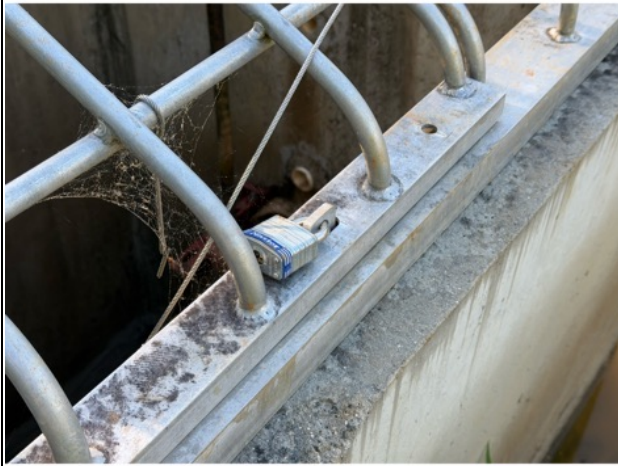
**Photo 17:**

- ✓ The riser hatches at BMP 1/2 were locked shut preventing access to the riser interior which would be necessary to exercise the stuck drain valves.
- ✓ Water levels were low, likely due to drought, devices appeared to be functioning properly.

BMP 2 lock on riser

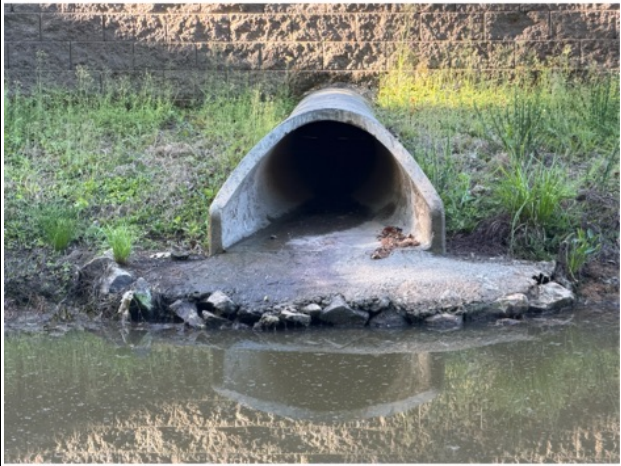
**Photo 18:**

BMP 2 inlet

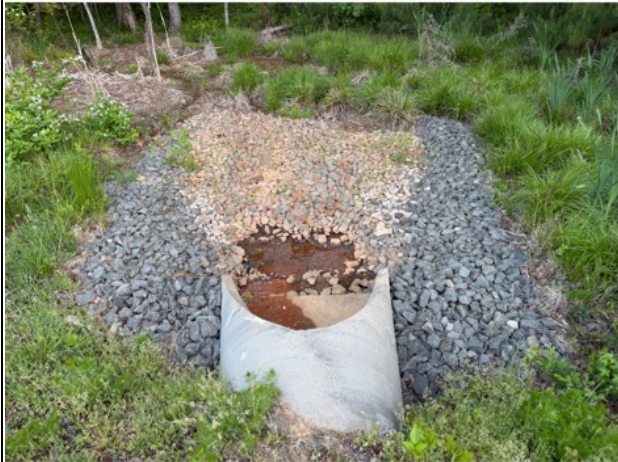
**Photo 19:**

BMP 2 outlet

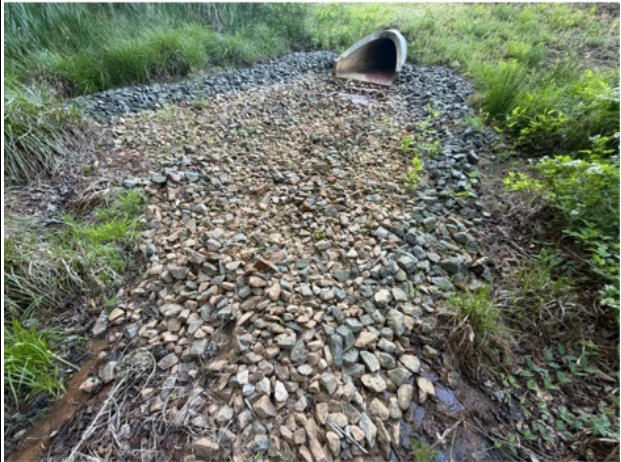
**Photo 20:**

BMP 2 outlet

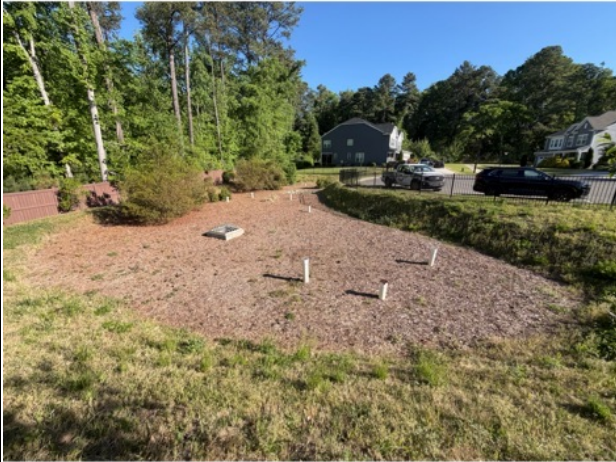
**Photo 25:**

BMP 2 overview

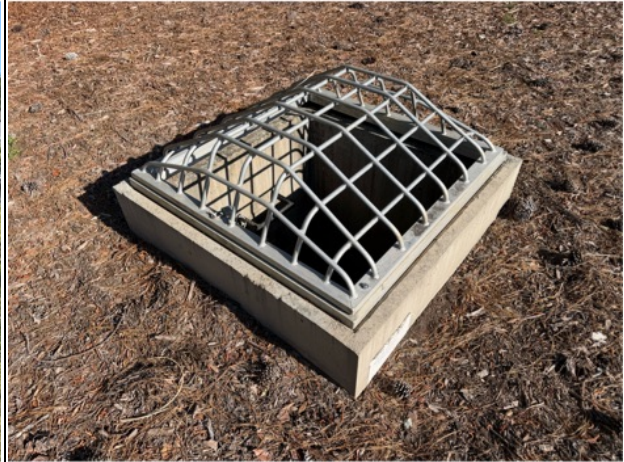
**Photo 26:**

BMP 2 riser

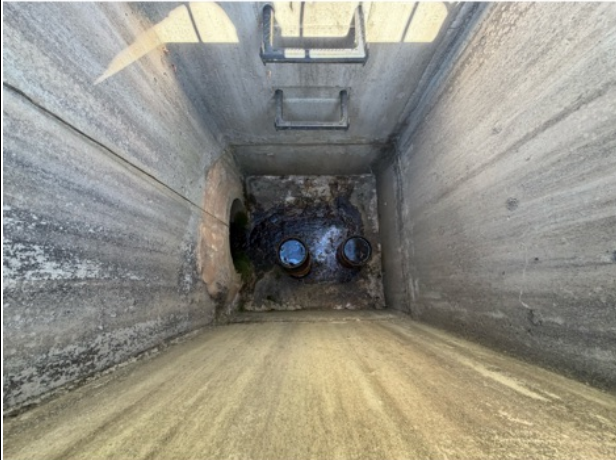
**Photo 27:**

BMP 2 riser interior

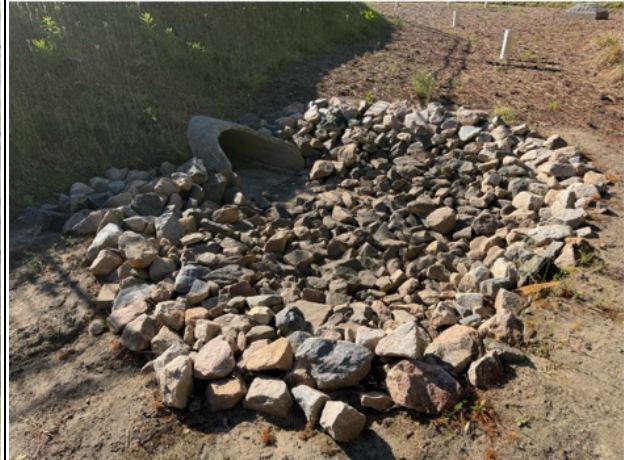
**Photo 28:**

BMP 2 inlet
