Triangle Pond Management
 405 S Rogers Ln
 Raleigh, NC 27610
 (919)398-3221
 Office@TrianglePondManagement.com
 www.TrianglePondManagement.com
Maintenance Service Report

Customer Name:		Date:	
Chandler Woods MOA		8/26/2024	
Address:			
214 Abbot Pl			
Aquatic Technician:			
Christian Allen			
Time of Arrival:		Time of Departure:	
6:58 AM		9:25 AM	
Drive Time:			
1 hr 9 min			
Type of Device(s) Maintained:			
BMP 1, BMP 2, BMP 3

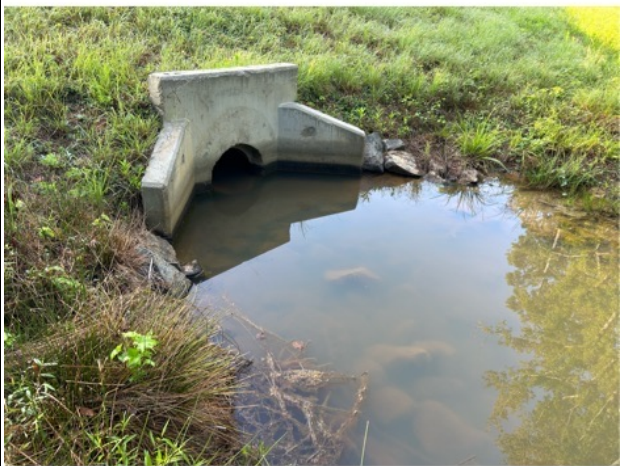
BMP1 Outlet

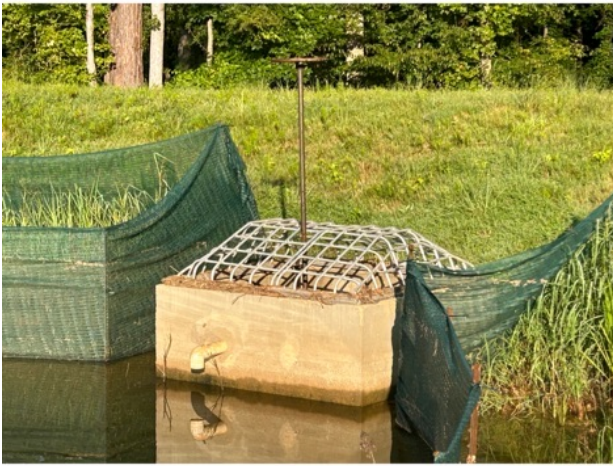
Photo 5:

Each device was walked and all trash was removed.
 Unwanted/invasive vegetation throughout each device was controlled with an approved herbicide.
 The water level in BMP1 is slightly low, possible leak within riser.
 There is a bare area along the top of the dam of BMP2, recommend repairs.
 The outlet easement for BMP3 Is overgrown, mowing services recommended. Accumulated sediment in the outlet of BMP3 was removed.
 All other components were functioning properly.

BMP1 Riser exterior

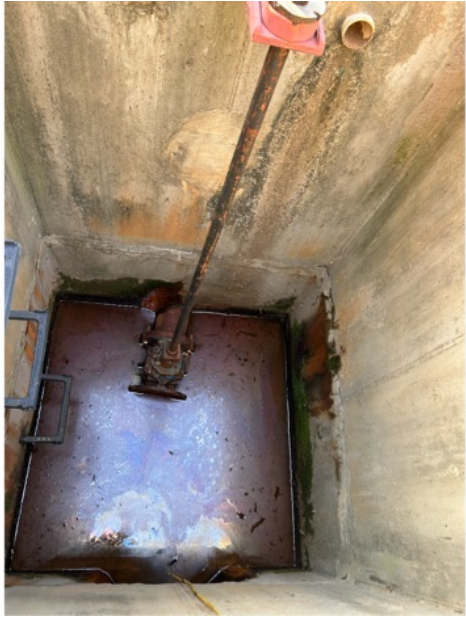
Photo 6:

BMP1 Riser interior

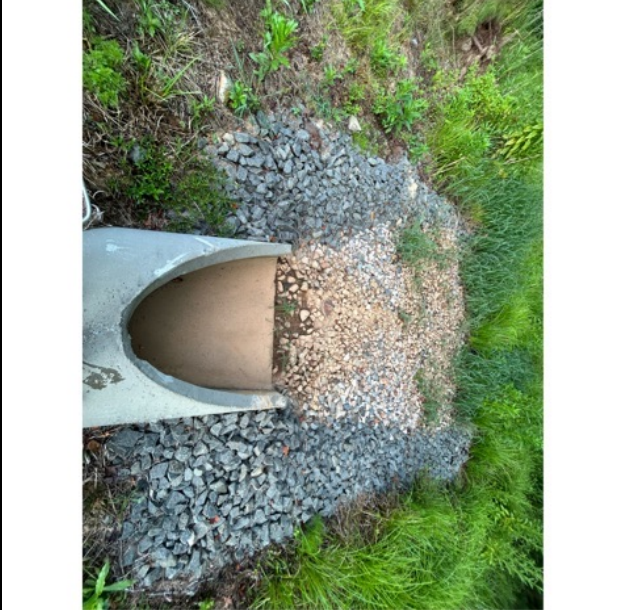
<p>BMP2 Riser interior</p>	<p>BMP2 Outlet</p>

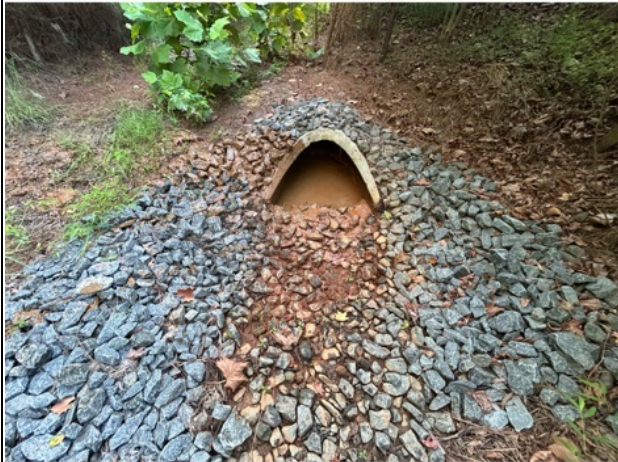
Photo 19:

BMP3 Outlet

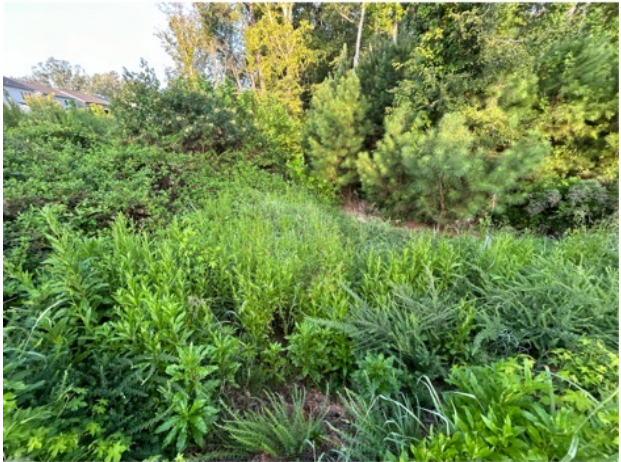
Photo 20:

BMP3 Outlet easement overgrowth

Please contact our office with any additional questions, concerns, or to schedule repairs.
