**Triangle Pond Management**  
 405 S Rogers Ln  
 Raleigh, NC 27610  
 (919)398-3221  
 Office@TrianglePondManagement.com  
 www.TrianglePondManagement.com  
**Maintenance Service Report**

| Chandler Woods MOA | | 5/23/2023 | |
| BMP 1, BMP 2, BMP 3 | | | |

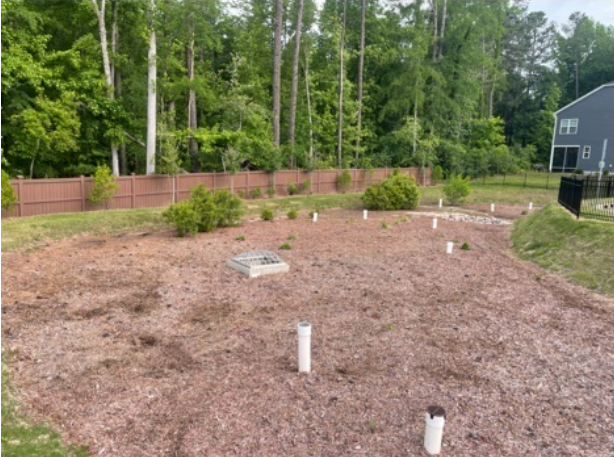
| Photo 1: | Photo 2: |

| Photo 1: | Photo 2: |
|---|--|
| BMP3 view | BMP3 view |

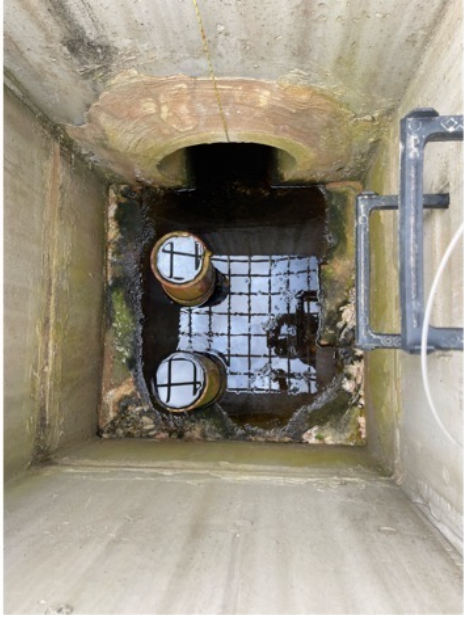
| Photo 5: | Photo 6: |

| Photo 5: | Photo 6: |
|---|--|
| BMP3 inside riser | BMP2 view |

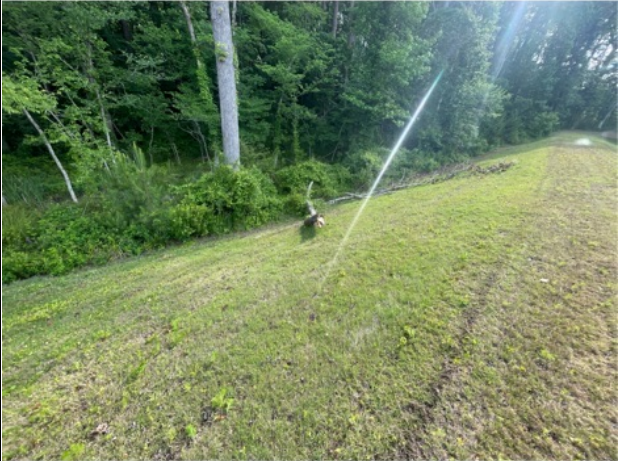
| Photo 5: | Photo 6: |
|---|--|
| Photo 7: | Photo 8: |

| Photo 5: | Photo 6: |
|---|--|
| BMP2 backsideview | BMP2 view |

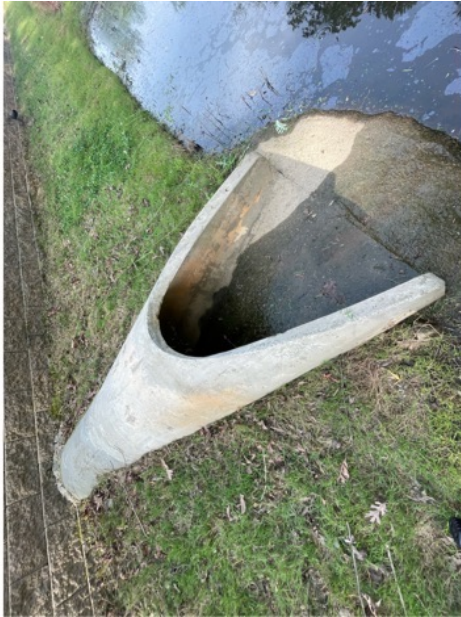
**Photo 9:**

BMP2 inlet

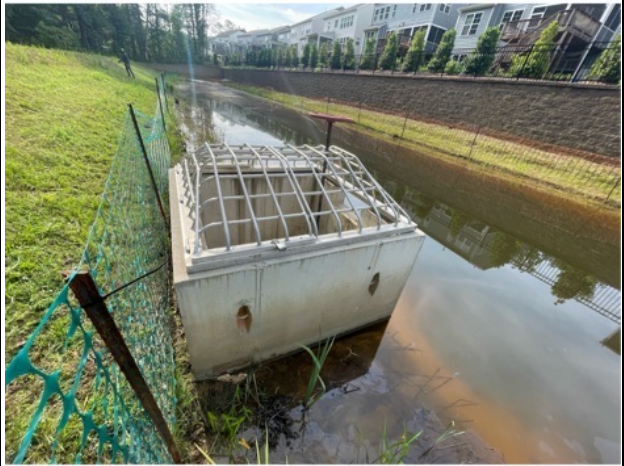
**Photo 10:**

BMP2 riser

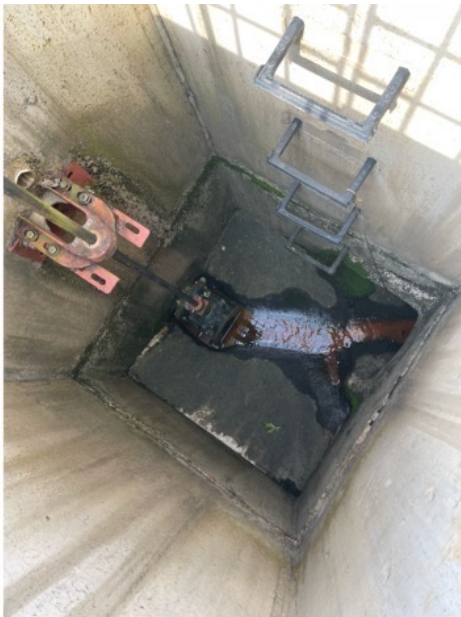
**Photo 11:**

BMP2 inside riser

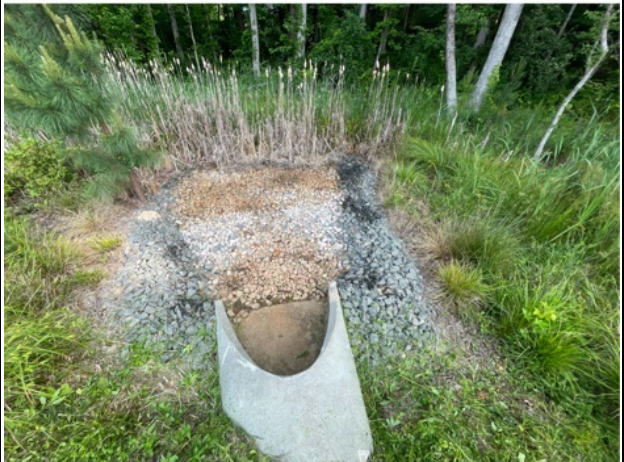
**Photo 12:**

BMP2 outlet

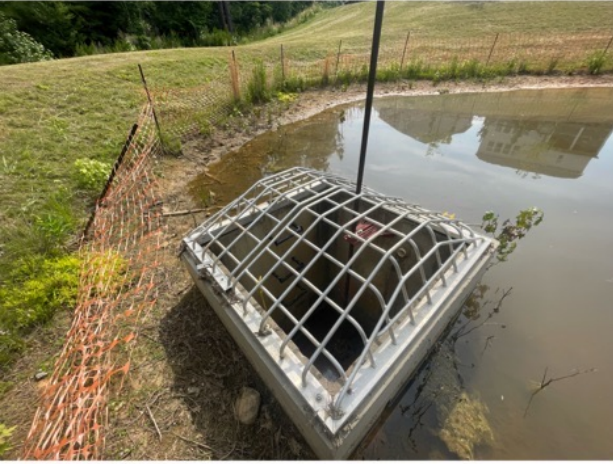
| Photo 17: | Photo 18: |

| Photo 17: | Photo 18: |
|---|--|
| BMP1 riser | BMP1 inside riser |
