Triangle Pond Management
 405 S Rogers Ln
 Raleigh, NC 27610
 (919)398-3221
 Office@TrianglePondManagement.com
 www.TrianglePondManagement.com
Maintenance Service Report

Customer Name:		Date:	
Chandler Woods MOA		11/29/2022	
Address:			
214 Abbot Pl			
Aquatic Technician:			
Anthony Montefusco			
Time of Arrival:		Time of Departure:	
1:03 PM		3:00 PM	
Drive Time:			
20 minutes			
Type of Device(s) Maintained:			
BMP 1, BMP 2, BMP 3

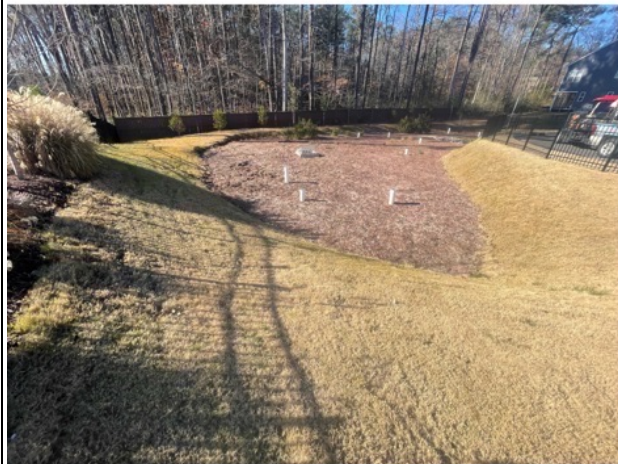
Photo 1: **Photo 2:**

BMP3 view

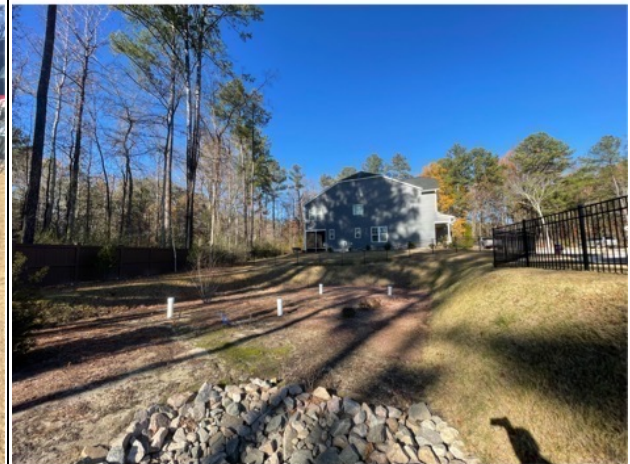
BMP3 view

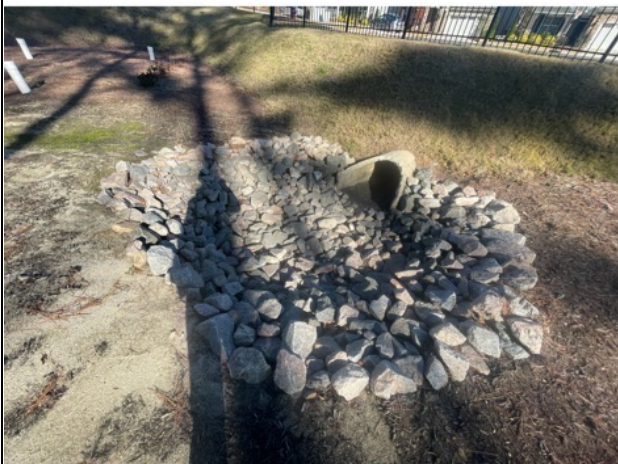
Photo 3: **Photo 4:**

BMP3 inlet

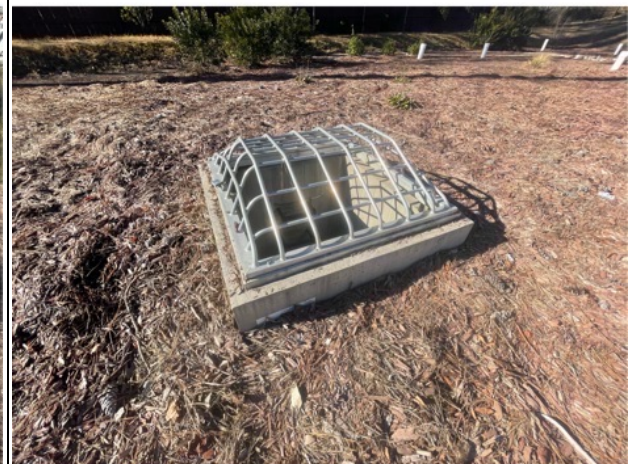
BMP3 riser

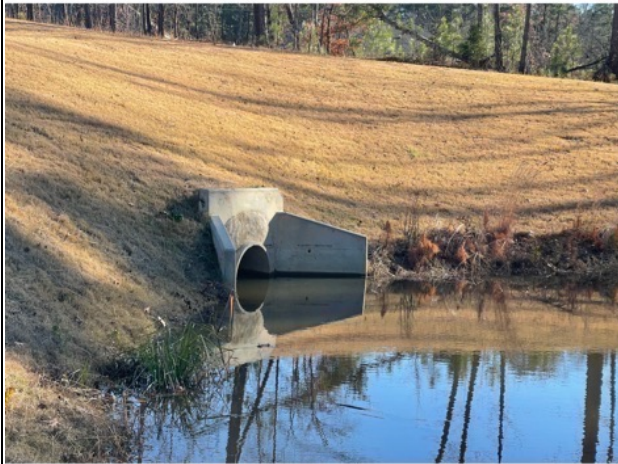
Photo 17:

BMP1 view

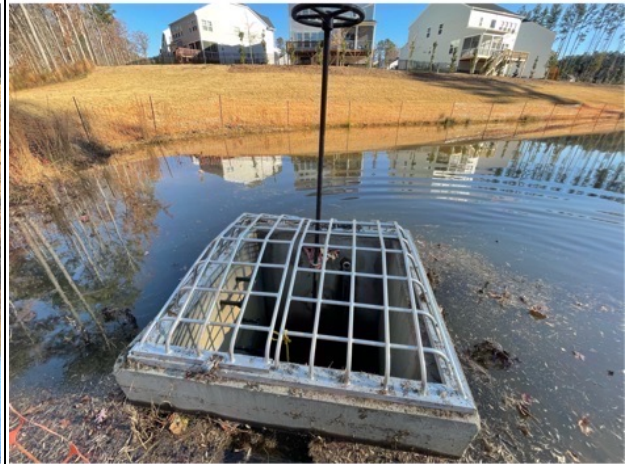
Photo 18:

BMP1 riser

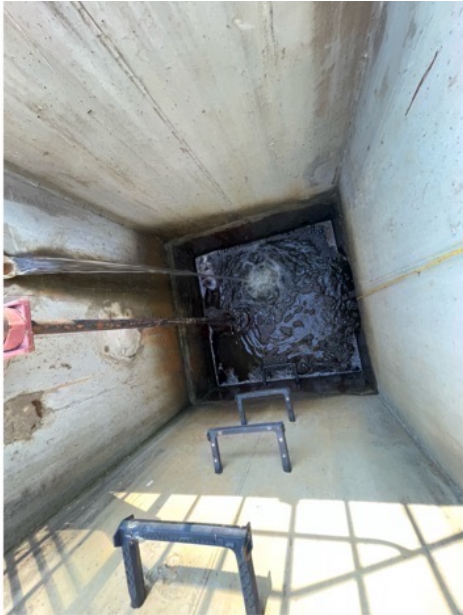
Photo 19:

BMP1 inside riser

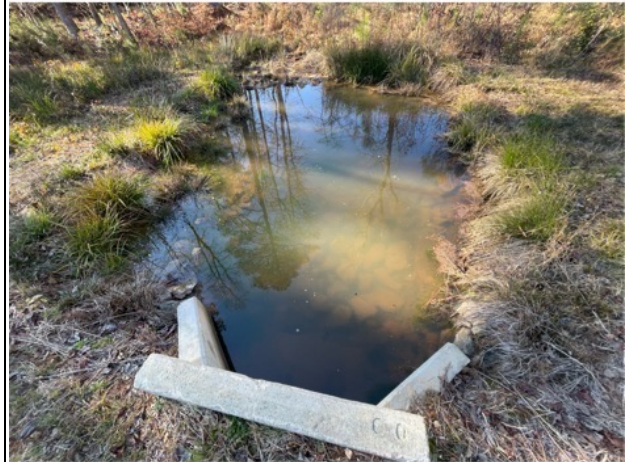
Photo 20:

BMP1 outflow
