Triangle Pond Management
 405 S Rogers Ln
 Raleigh, NC 27610
 (919)398-3221
 Office@TrianglePondManagement.com
 www.TrianglePondManagement.com
Maintenance Service Report

Customer Name:		Date:	
Chandler Woods MOA		8/25/2025	
Address:			
214 Abbot Pl			
Aquatic Technician:			
Jordan Woosley			
Time of Arrival:	Time of Departure:	Drive Time:	
1:28 PM	4:29 PM	1 hr 6 min	
Type of Device(s) Maintained:			
BMP 1, BMP 2, BMP 3

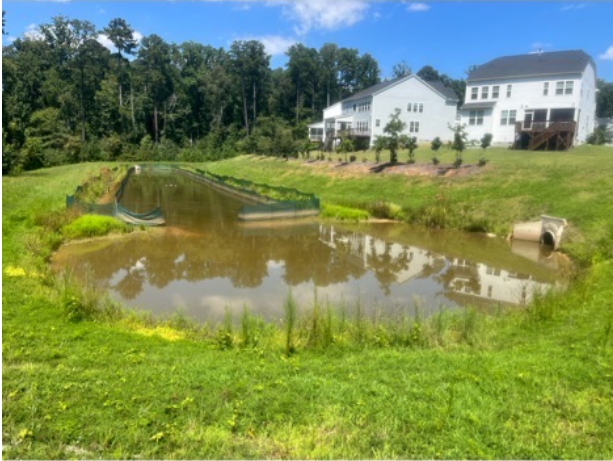
Photo 1:	Photo 2:

BMP1 overview	BMP1 overview
Photo 3:	Photo 4:

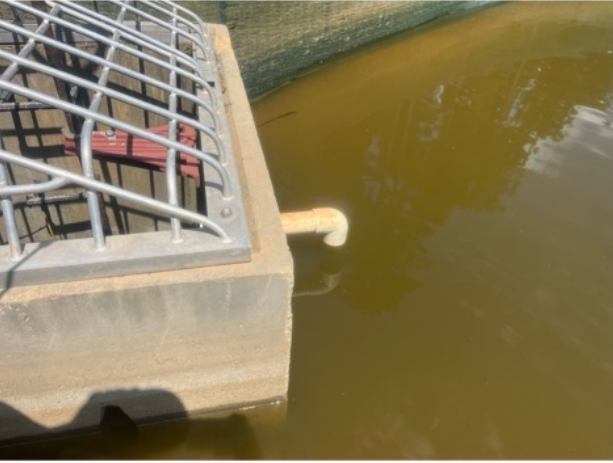
BMP1 riser orifice	BMP1 riser interior
