**Triangle Pond Management**  
 405 S Rogers Ln  
 Raleigh, NC 27610  
 (919)398-3221  
 Office@TrianglePondManagement.com  
 www.TrianglePondManagement.com  
**Maintenance Service Report**

| Chandler Woods MOA | | 2/24/2023 | |
| BMP 1, BMP 2, BMP 3 | | | |

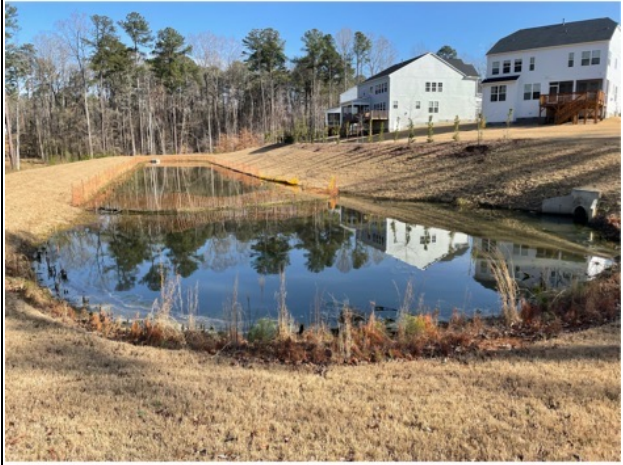
| Photo 13: | Photo 14: |
|---|--|
| Photo 15: | Photo 16: |

| Photo 13: | Photo 14: |
|---|--|
| BMP3 | BMP3 inlet |

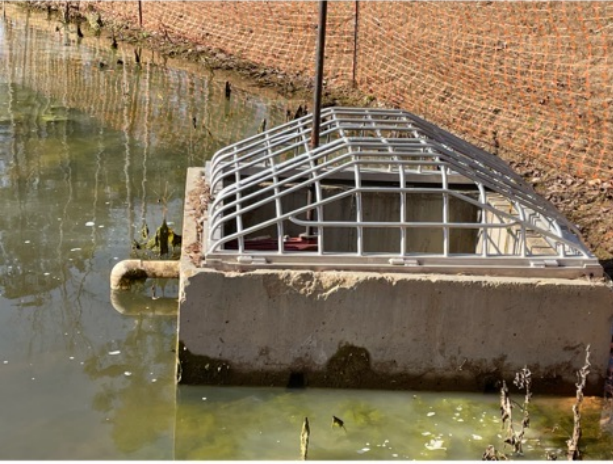
| Photo 17: | Photo 18: |

| Photo 17: | Photo 18: |
|---|--|
| BMP3 riser | BMP3 inside riser |

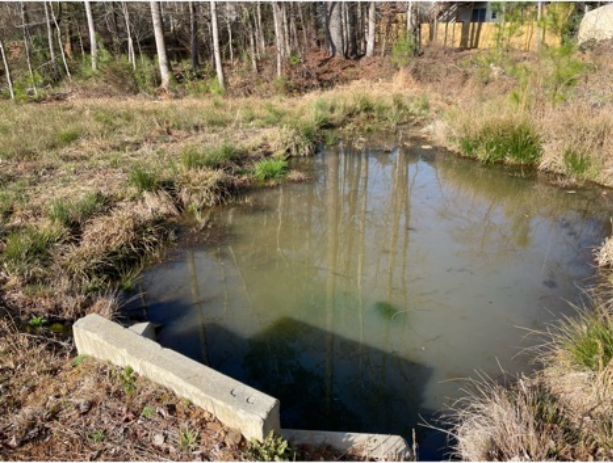
| Photo 17: | Photo 18: |
|---|--|
| Photo 19: | Photo 20: |

| Photo 17: | Photo 18: |
|---|--|
| BMP3 outlet | |
