**Triangle Pond Management**  
 405 S Rogers Ln  
 Raleigh, NC 27610  
 (919)398-3221  
 Office@TrianglePondManagement.com  
 www.TrianglePondManagement.com  
**Maintenance Service Report**

| Chandler Woods MOA | | 7/17/2026 | |
| 214 Abbot Pl | | | |

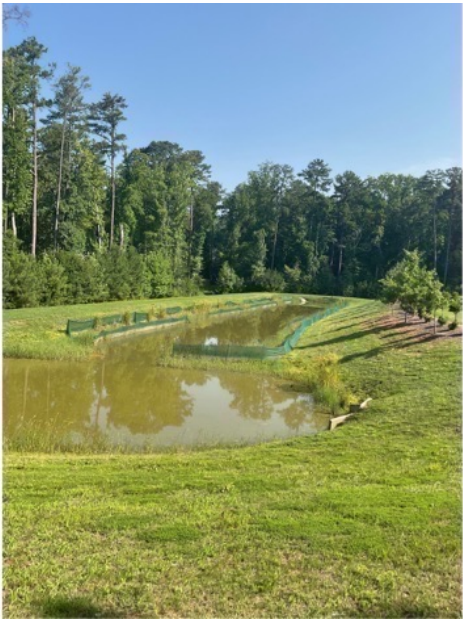
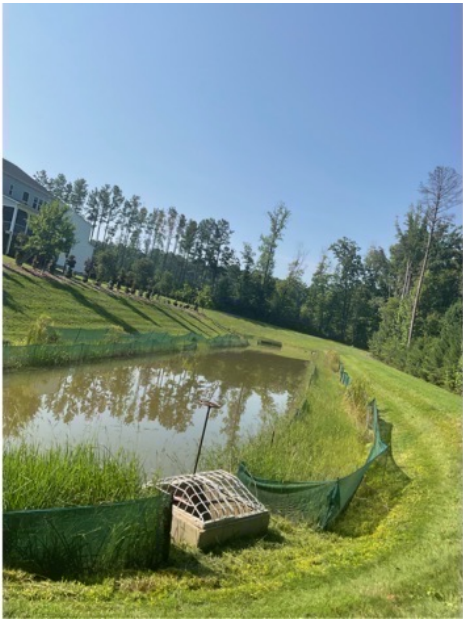
| Photo 1: | Photo 2: |
|---|---|
| WP1 overview | WP1 overview |

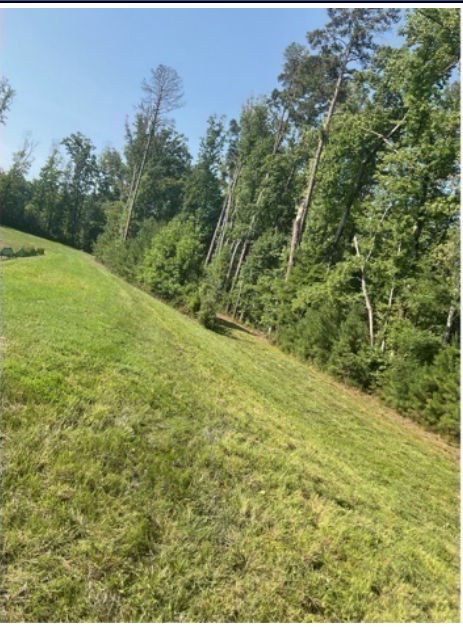
| Photo 1: | Photo 2: |
|---|---|
| WP1 back of dam | WP1 inlet |

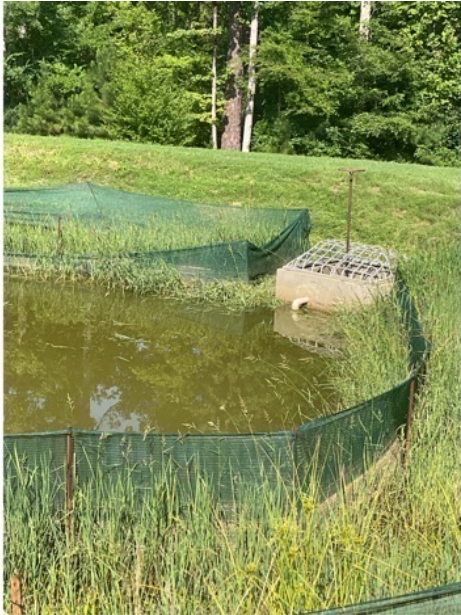
**Photo 5:**

WP1 riser

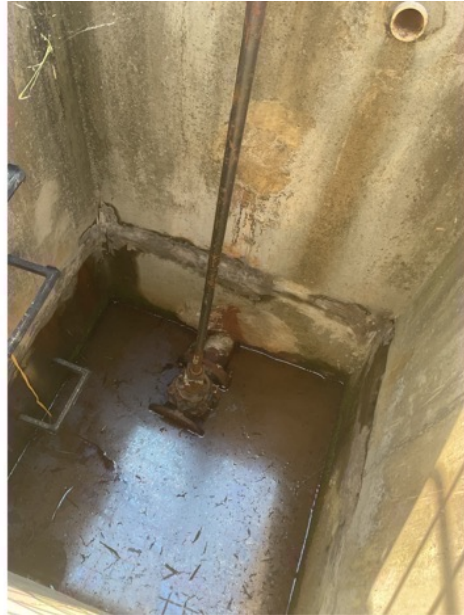
**Photo 6:**

WP1 inside riser

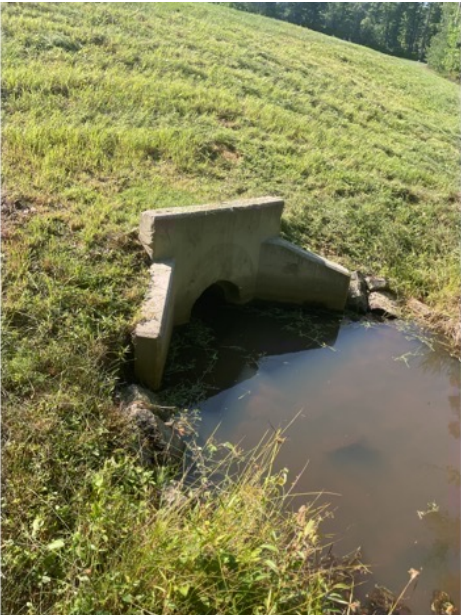
**Photo 7:**

WP1 outlet

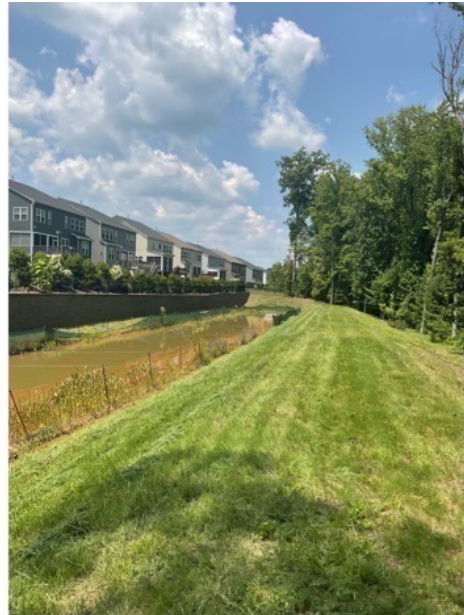
**Photo 8:**

WP2 overview

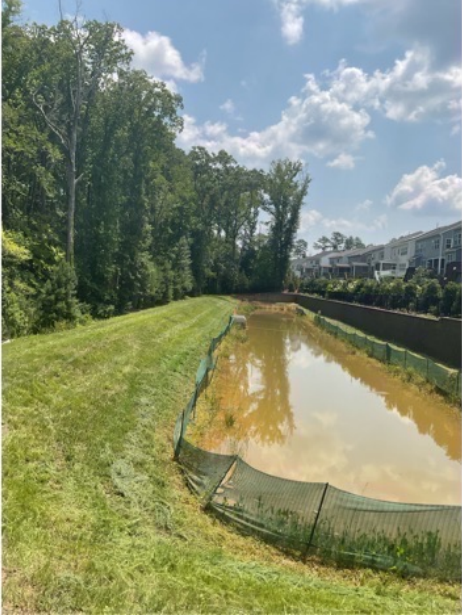
| Photo 9: | Photo 10: |
|---|---|
| WP2 overview | WP2 riser |

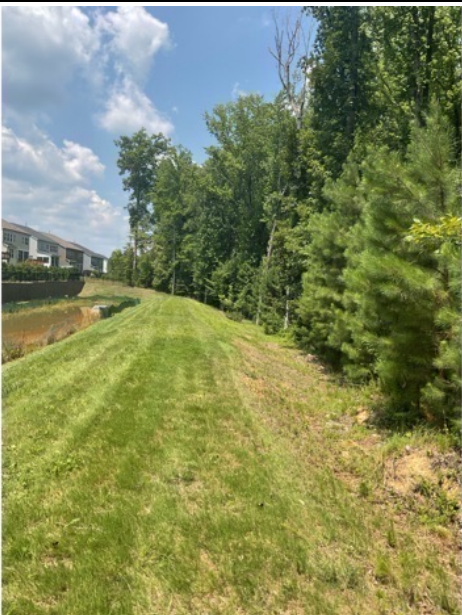
| Photo 9: | Photo 10: |
|---|---|
| WP2 back of dam | WP2 inside riser |

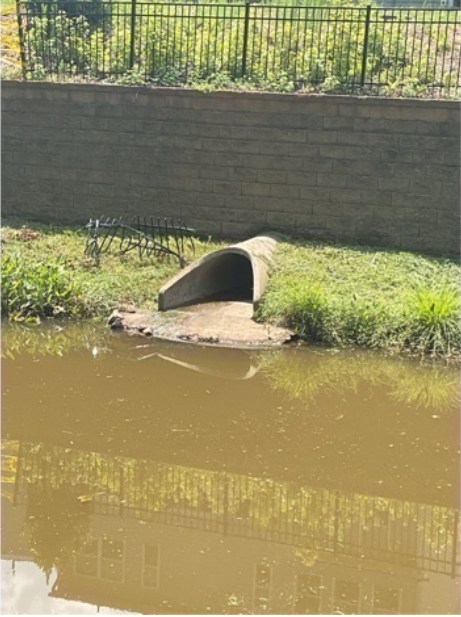
| Photo 13: | Photo 14: |
|---|---|
| WP2 inlet | WP2 outlet |

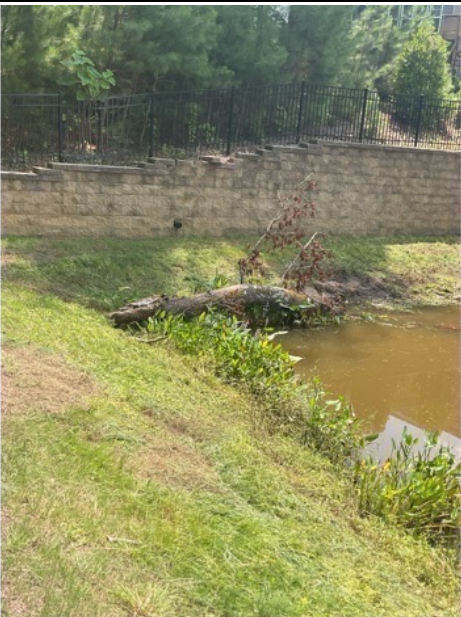
| Additional Notes: |
|---|
| <p>Mowing and trimming services were completed.</p> <p>Walked perimeter and removed unwanted woody vegetation.</p> <p>Walked perimeter and picked up trash.</p> <p>Cleared leaves and debris out of riprap areas.</p> <p>Water level is normal.</p> <p>All devices draining properly.</p> <p>Treated unwanted vegetation with approved herbicide.</p> <p>WP2 observed a fallen tree limb and a fence piece broken caused by the fallen tree limb/ recommend removal.</p> |

| Photo 13: | Photo 14: |
|---|---|
| WP2 fallen tree limb | BR3 overview |

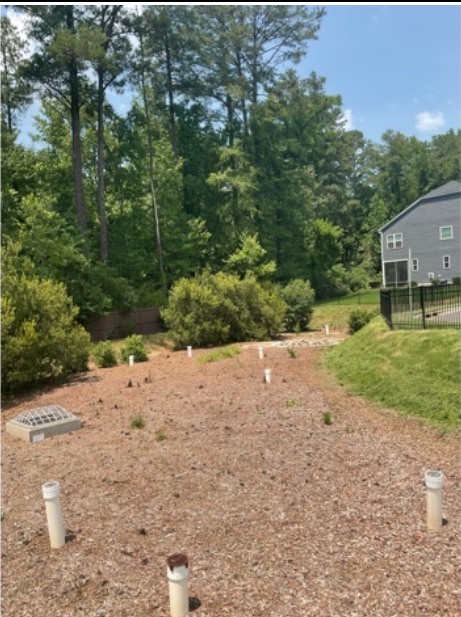
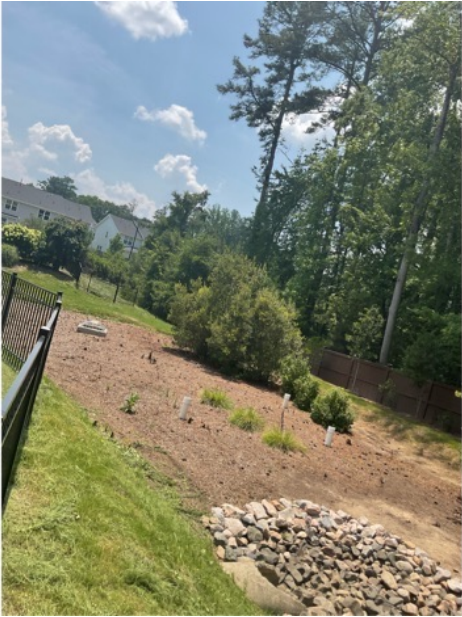
| Photo 17: | Photo 18: |
|---|---|
| BR3 overview | BR3 back of dam |

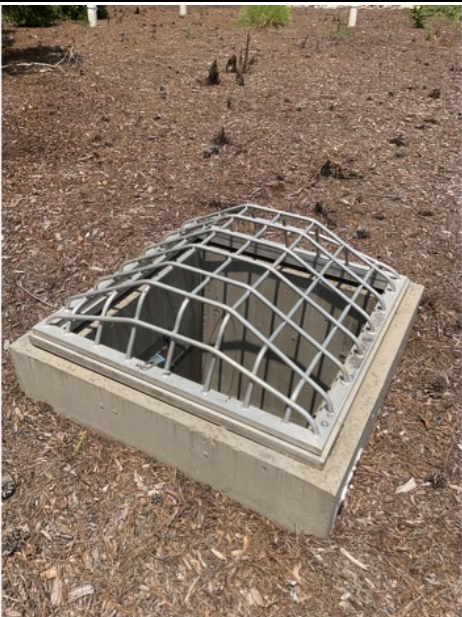
| Photo 17: | Photo 18: |
|---|---|
| BR3 riser | BR3 inside riser |

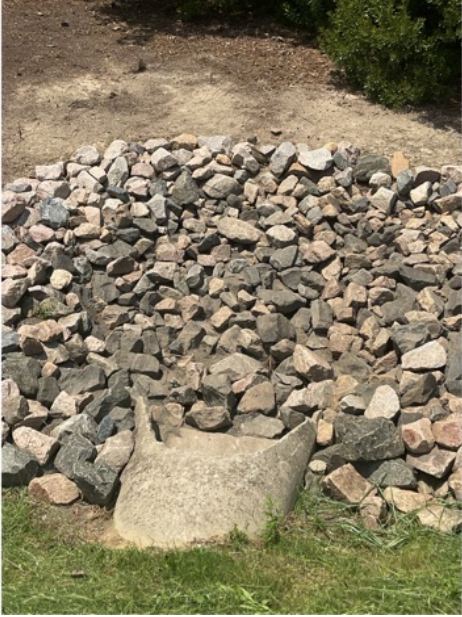
| Photo 21: | Photo 22: |
|---|---|
| BR3 inlet | BR3 outlet |
