Triangle Pond Management
 405 S Rogers Ln
 Raleigh, NC 27610
 (919)398-3221
 Office@TrianglePondManagement.com
 www.TrianglePondManagement.com
Maintenance Service Report

Customer Name:		Date:	
Chandler Woods MOA		3/31/2023	
Address:			
214 Abbot Pl			
Aquatic Technician:			
Nick Norton			
Time of Arrival:	Time of Departure:	Drive Time:	
8:48 AM	1:10 PM	50 min	
Type of Device(s) Maintained:			
BMP 1, BMP 2, BMP 3

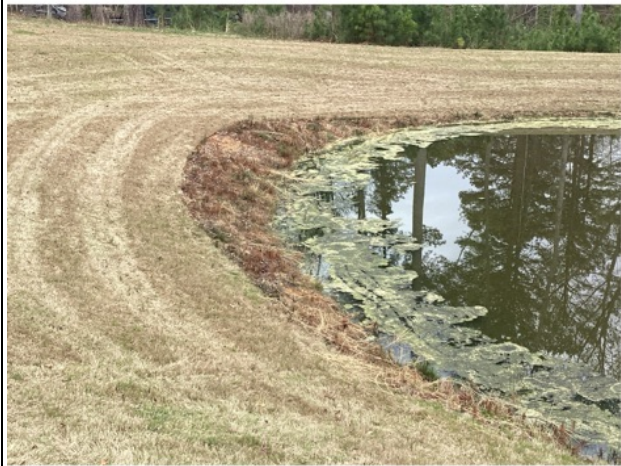
BMP1 lacking beneficial plants

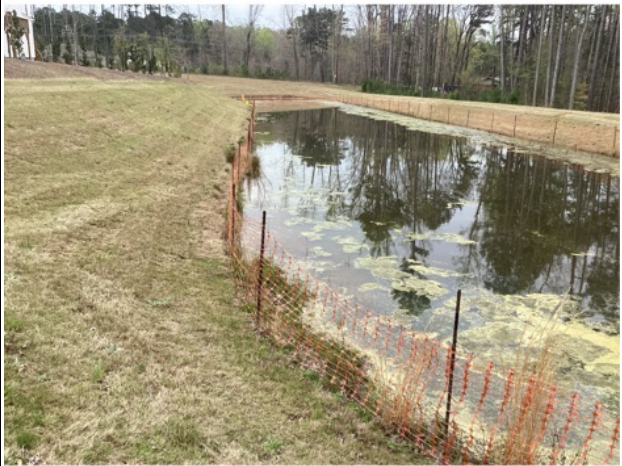
BMP1 overall

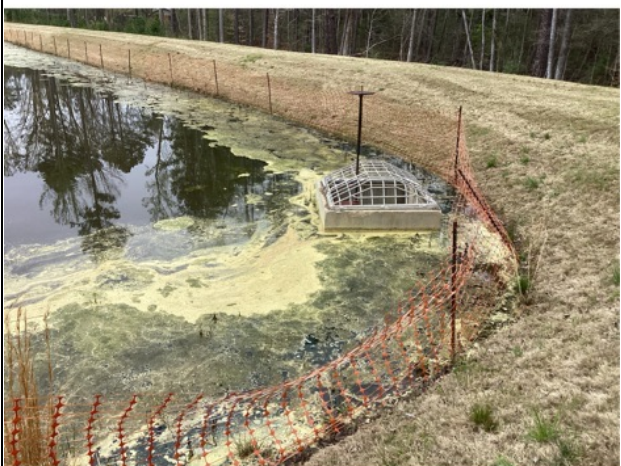
BMP1 riser

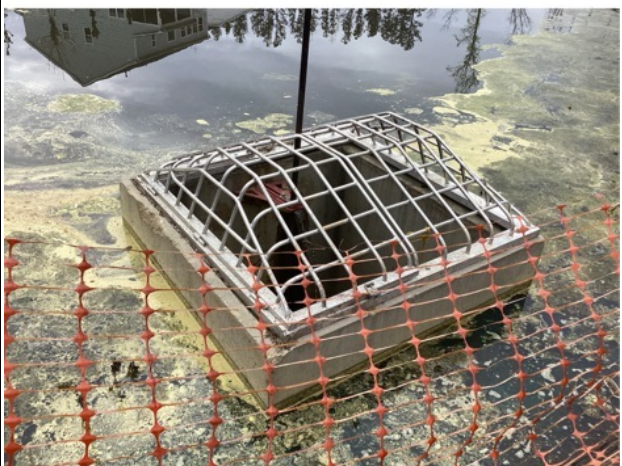
BMP1 riser

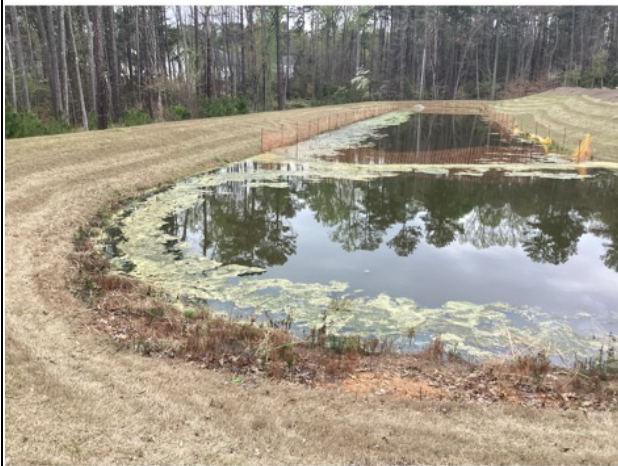
Photo 9:

BMP1 overall

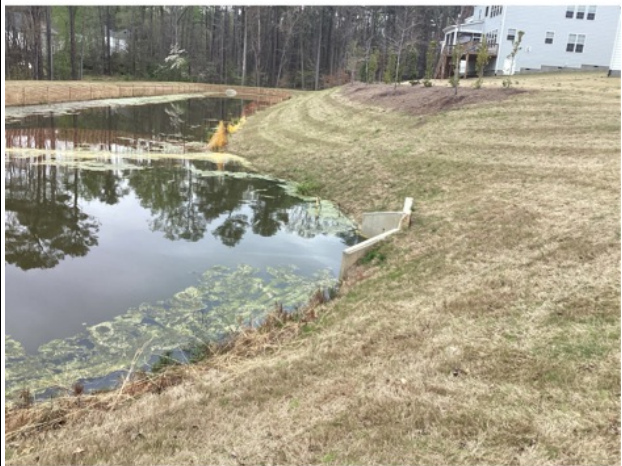
Photo 10:

BMP1 overall

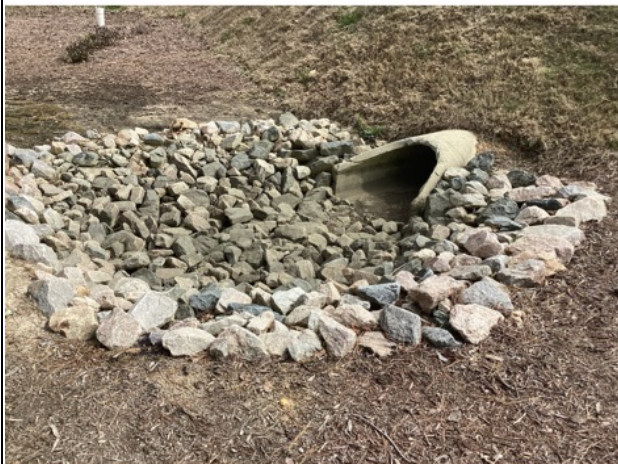
Photo 11:

BMP3 inlet

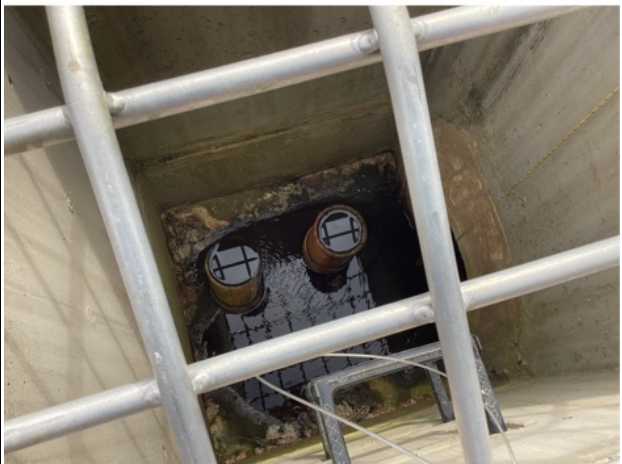
Photo 12:

BMP3 inside riser

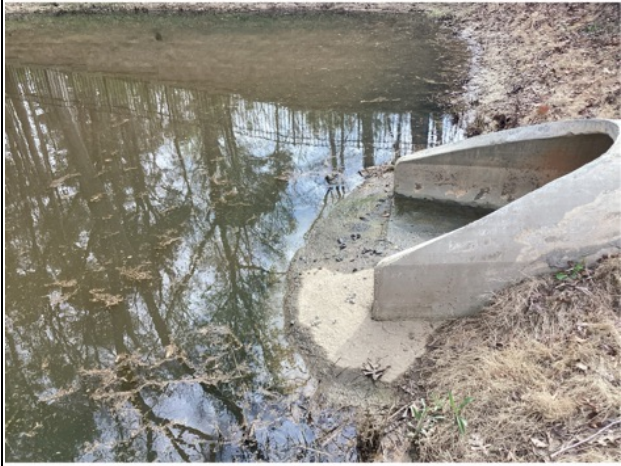
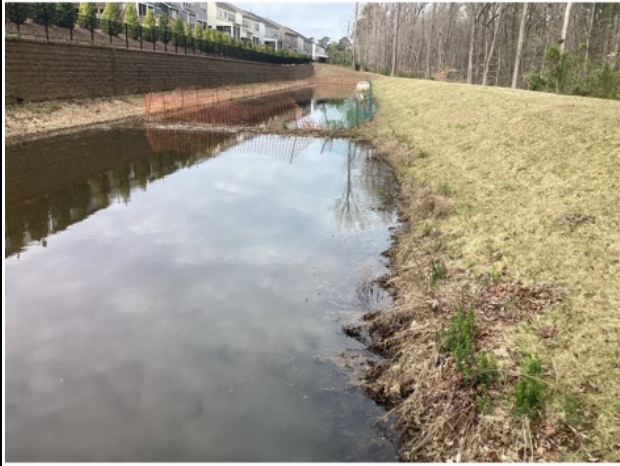
Photo 17:	Photo 18:

BMP2 inlet	BMP2 overall
Photo 19:	Photo 20:

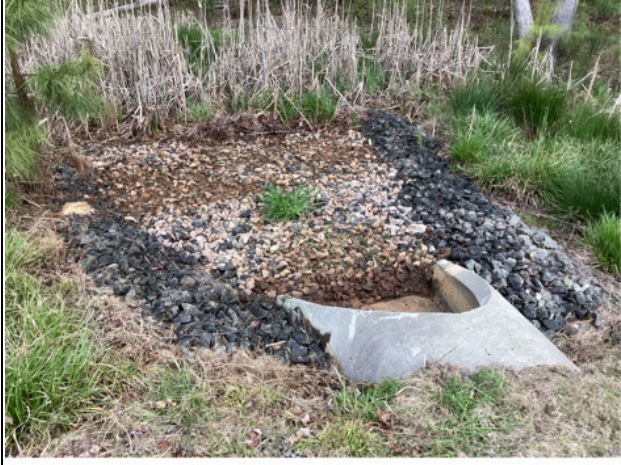
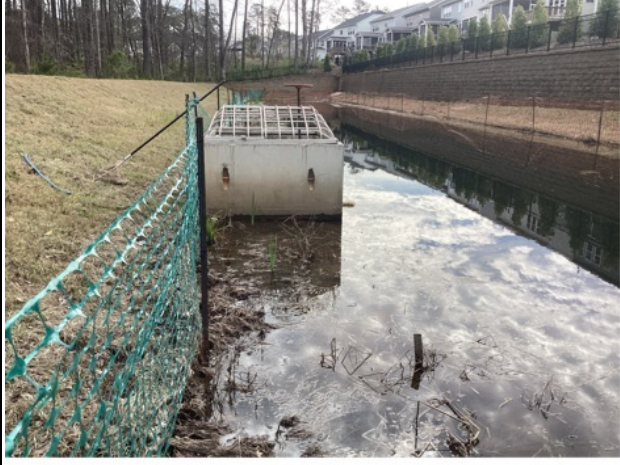
BMP2 outflow	BMP2 riser

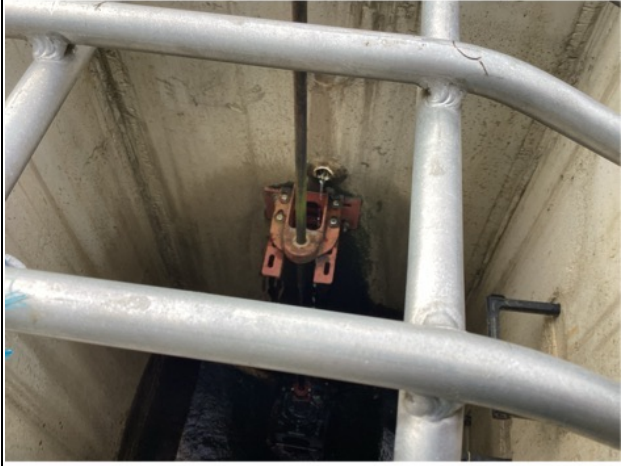
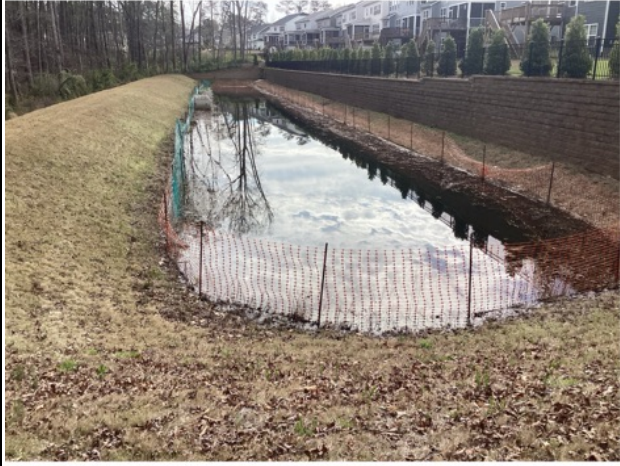
Photo 21:	Photo 22:

BMP2 inside riser	BMP2 overall
Photo 23:	Photo 24:
