Triangle Pond Management
 405 S Rogers Ln
 Raleigh, NC 27610
 (919)398-3221
 Office@TrianglePondManagement.com
 www.TrianglePondManagement.com
Maintenance Service Report

| Chandler Woods MOA | | 6/20/2024 | |
| BMP 1, BMP 2, BMP 3 | | | |

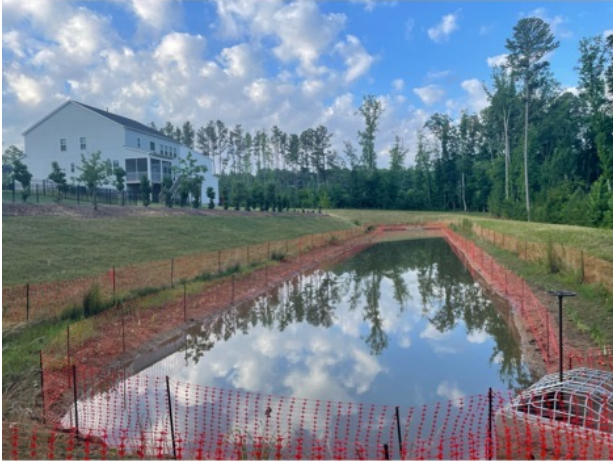
| Photo 1: | Photo 2: |

| Photo 1: | Photo 2: |
|---|--|
| BMP 1 | BMP 1 |

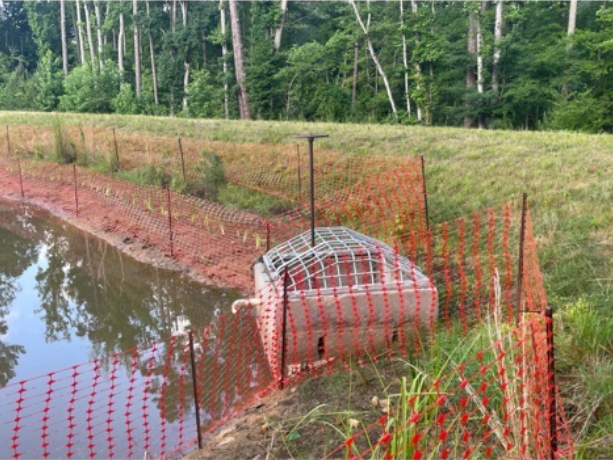
| Photo 1: | Photo 2: |
|---|--|
| Photo 3: | Photo 4: |

| Additional Notes: |
|--|
| <p>The devices were walked and all trash was removed.</p> <p>Unwanted/Invasive vegetation throughout the devices were controlled.</p> <p>Invasive hardwood saplings were cut and removed.</p> <p>The water level at BMP 1 and BMP 2 was significantly low. This could possibly be due to leaks within the risers.</p> <p>Please contact our office with any questions, concerns, or to schedule repairs.</p> |

| Photo 1: | Photo 2: |
|---|--|
| BMP 1 riser | BMP 1 inside riser |

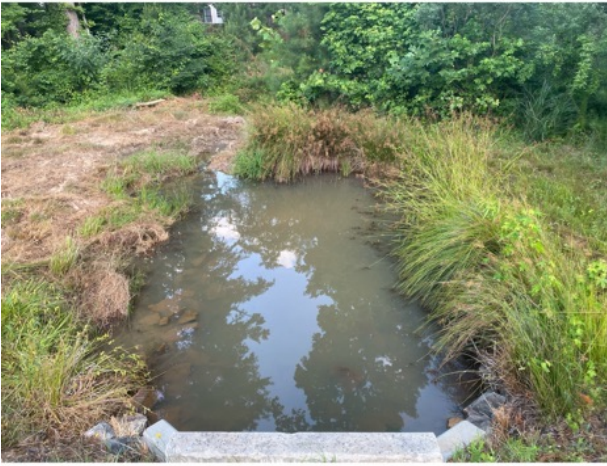
| Photo 5: | Photo 6: |

| Photo 5: | Photo 6: |
|---|--|
| BMP 1 inlet | BMP 1 outlet |

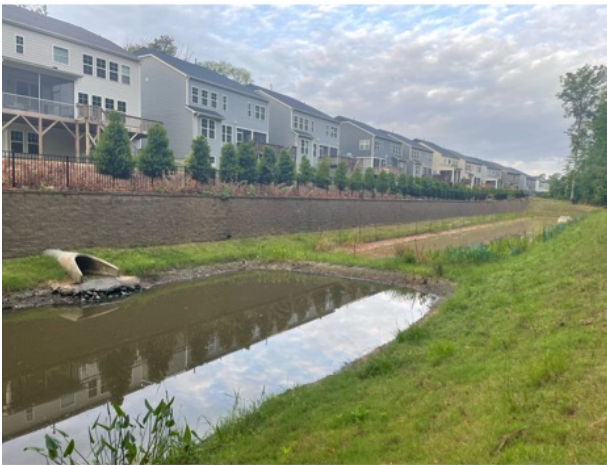
| Photo 5: | Photo 6: |
|---|--|
| Photo 7: | Photo 8: |

| Photo 5: | Photo 6: |
|---|--|
| BMP 2 | BMP 2 |
