Triangle Pond Management
 405 S Rogers Ln
 Raleigh, NC 27610
 (919)398-3221
 Office@TrianglePondManagement.com
 www.TrianglePondManagement.com
Maintenance Service Report

| Chandler Woods MOA | | 2/28/2025 | |
| BMP 1, BMP 2, BMP 3 | | | |

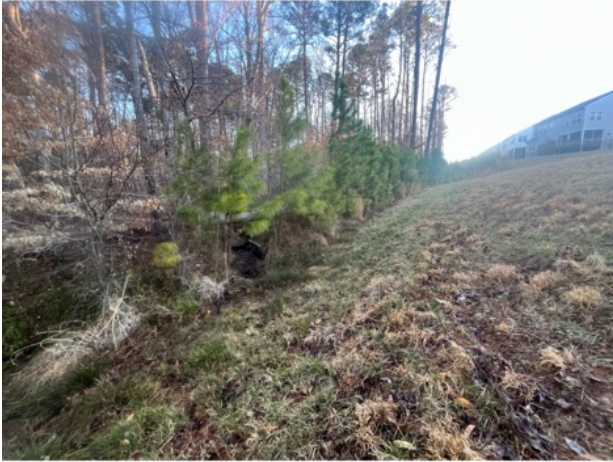
| Photo 5: | Photo 6: |

| Photo 5: | Photo 6: |
|---|--|
| BMP1 trees along the toe of the dam | BMP1 inlet |

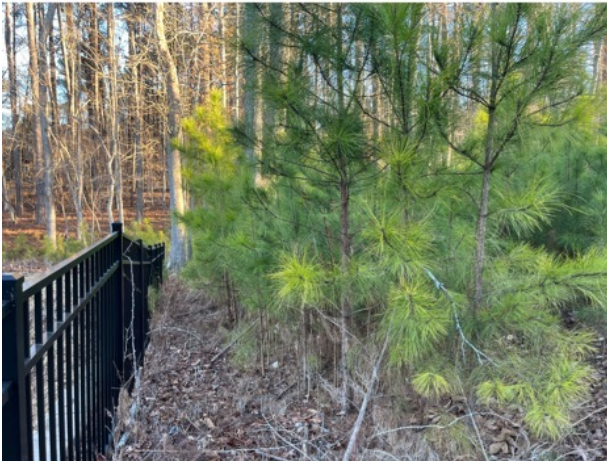
| Photo 5: | Photo 6: |
|---|--|
| Photo 7: | Photo 8: |

| Photo 5: | Photo 6: |
|---|--|
| BMP2 overall | BMP2 unwanted trees along the fenceline |

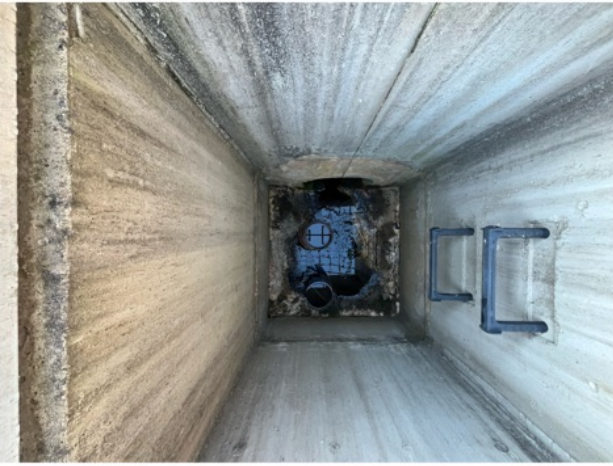
| Photo 17: | Photo 18: |

| Photo 17: | Photo 18: |
|---|--|
| BMP3 riser interior | BMP3 inlet |

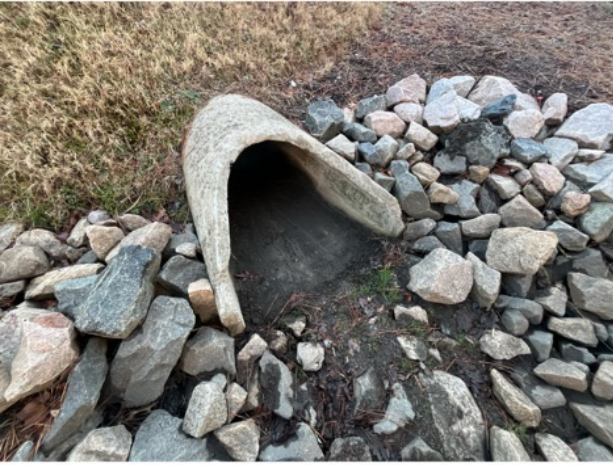
| Photo 17: | Photo 18: |
|---|--|
| Photo 19: | Photo 20: |

| Photo 17: | Photo 18: |
|---|--|
| BMP3 sediment removed from inlet | BMP3 recommend mulch replenishment |

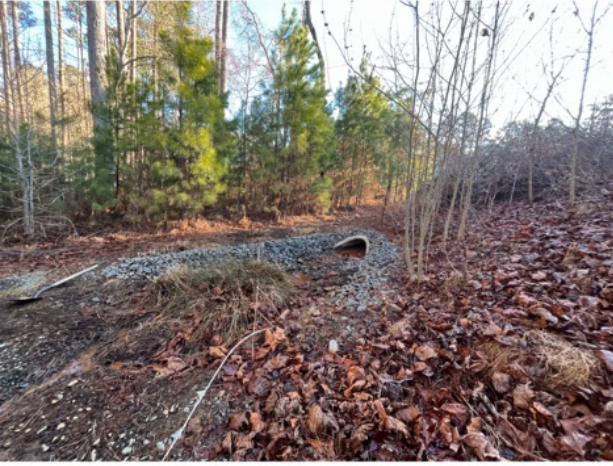
| Photo 21: | Photo 22: |

| Photo 21: | Photo 22: |
|---|--|
| <p>BMP3 outlet. Recommend cutting back trees from area</p> | <p>BMP3 recommend pruning overgrown shrubs within the SCM</p> |
