Triangle Pond Management
 405 S Rogers Ln
 Raleigh, NC 27610
 (919)398-3221
 Office@TrianglePondManagement.com
 www.TrianglePondManagement.com
Maintenance Service Report

Customer Name:		Date:	
Chandler Woods MOA		3/28/2025	
Address:			
214 Abbot Pl			
Aquatic Technician:			
Colin Roberts			
Time of Arrival:	Time of Departure:	Drive Time:	
10:01 AM	1:27 PM	26 mins	
Type of Device(s) Maintained:			
BMP 1, BMP 2, BMP 3

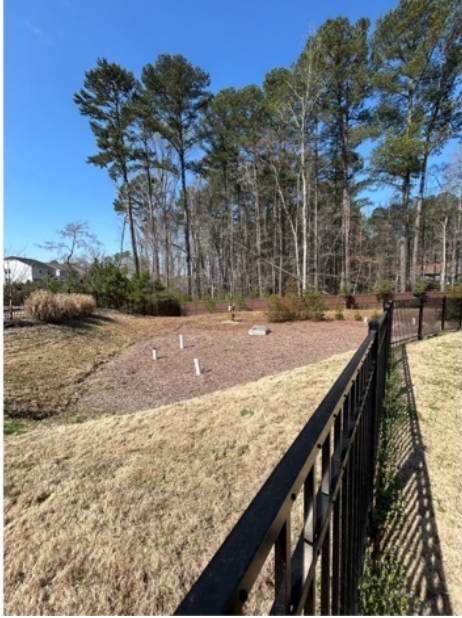
Photo 1:	Photo 2:

BMP 3 overview	BMP 3 overview
Photo 3:	Photo 4:

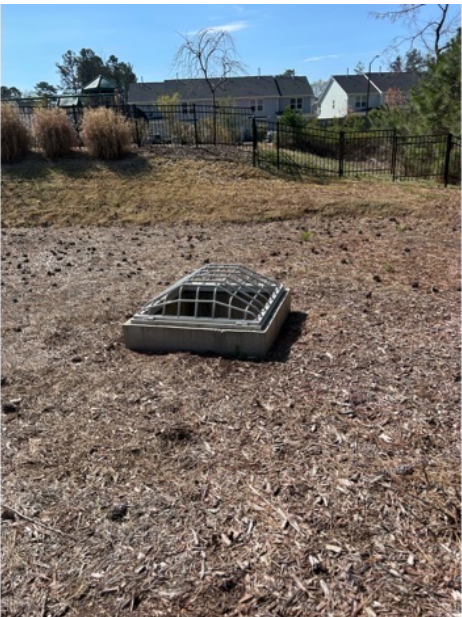
BMP 3 riser	BMP 3 inside riser

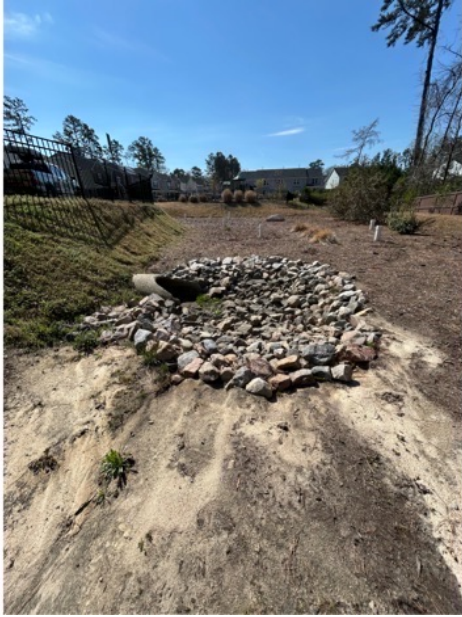
Photo 5:	Photo 6:

BMP 3 inlet	BMP 2 overview
Photo 7:	Photo 8:

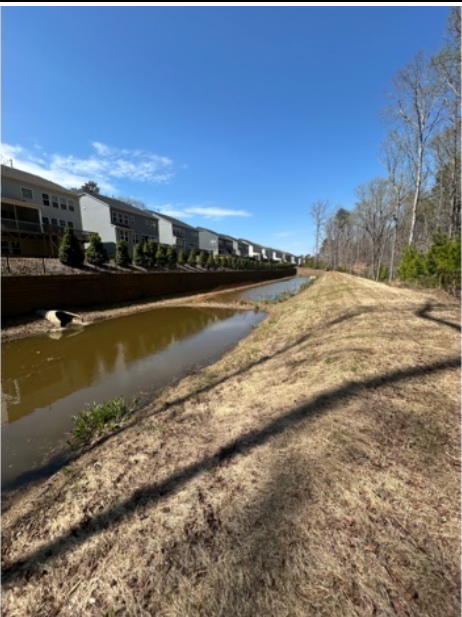
BMP 2 overview	BMP 2 riser

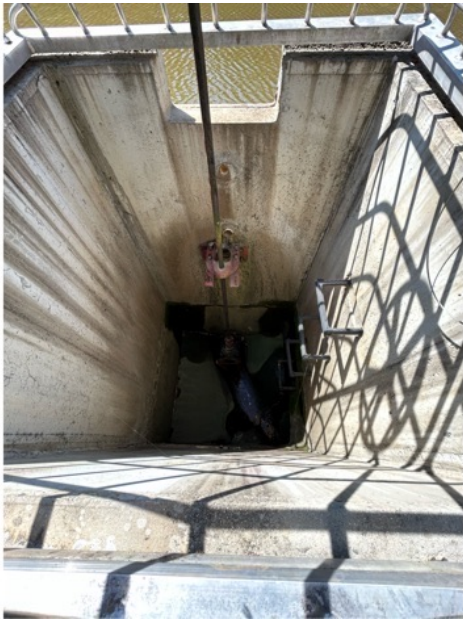
Photo 9:

BMP 2 inside riser

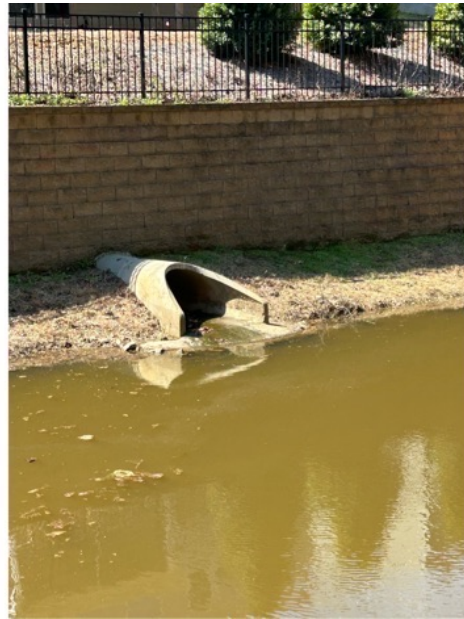
Photo 10:

BMP 2 inlet

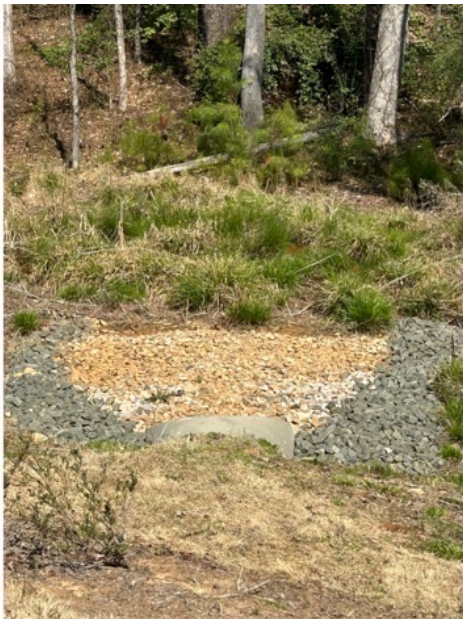
Photo 11:

BMP 2 outlet

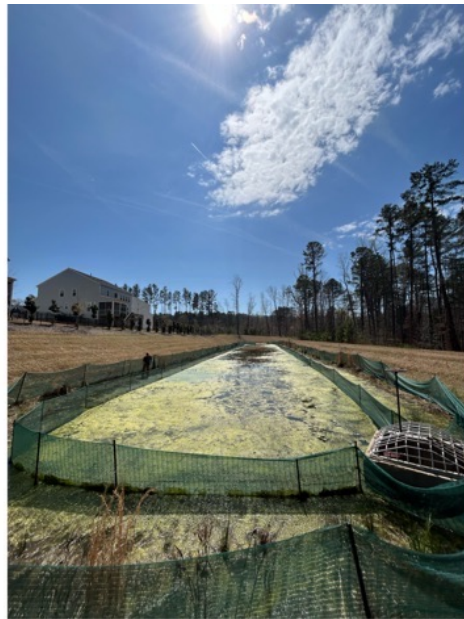
Photo 12:

BMP 1 overview
