**Triangle Pond Management**  
 405 S Rogers Ln  
 Raleigh, NC 27610  
 (919)398-3221  
 Office@TrianglePondManagement.com  
 www.TrianglePondManagement.com  
**Maintenance Service Report**

<b>Customer Name:</b>		<b>Date:</b>	
Chandler Woods MOA		3/25/2026	
<b>Address:</b>			
214 Abbot Pl			
<b>Aquatic Technician:</b>			
Jonathan Johnson			
<b>Time of Arrival:</b>		<b>Time of Departure:</b>	
1:10 PM		4:10 PM	
<b>Drive Time:</b>			
13 min			
<b>Type of Device(s) Maintained:</b>			
BMP 1, BMP 2, BMP 3

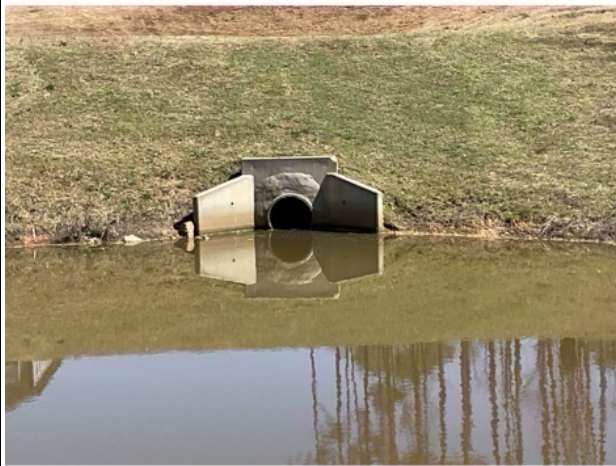
**Photo 5:**

BMP1 inlet

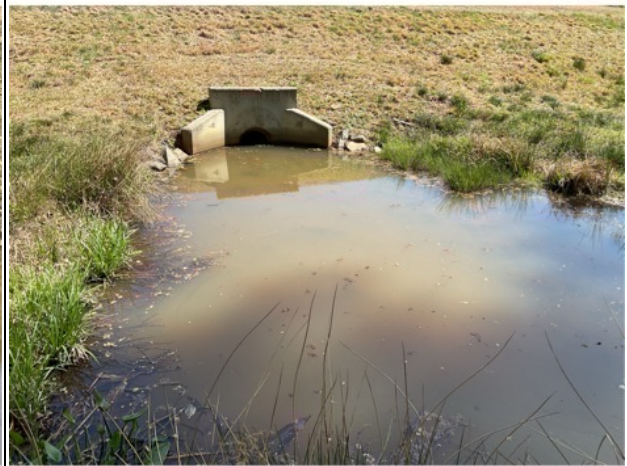
**Photo 6:**

BMP1 outlet

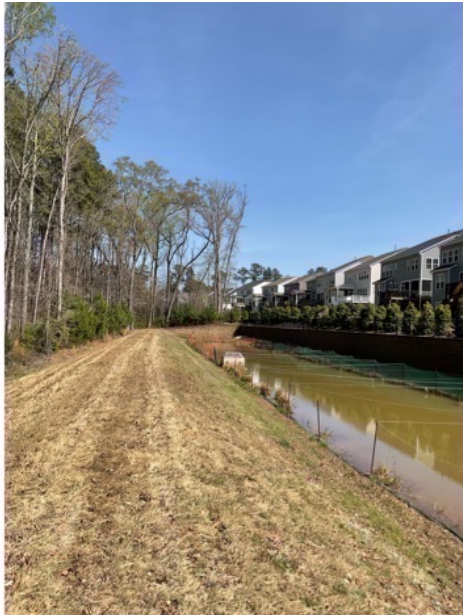
**Photo 7:**

BMP2 overview

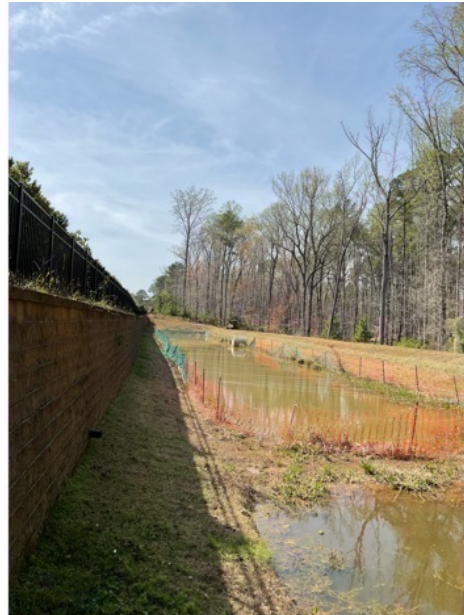
**Photo 8:**

BMP2 overview

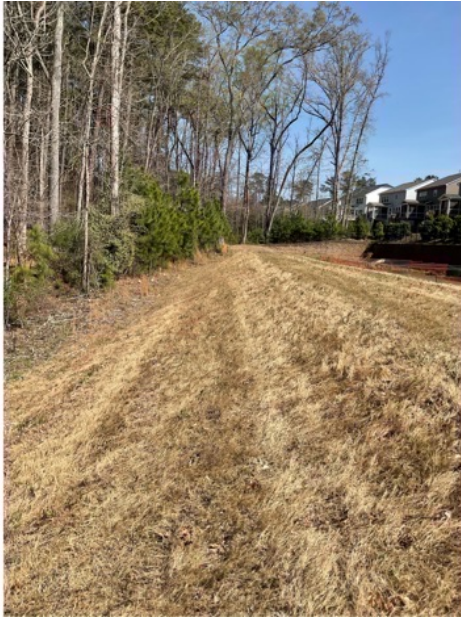
**Photo 9:**

BMP2 back of dam

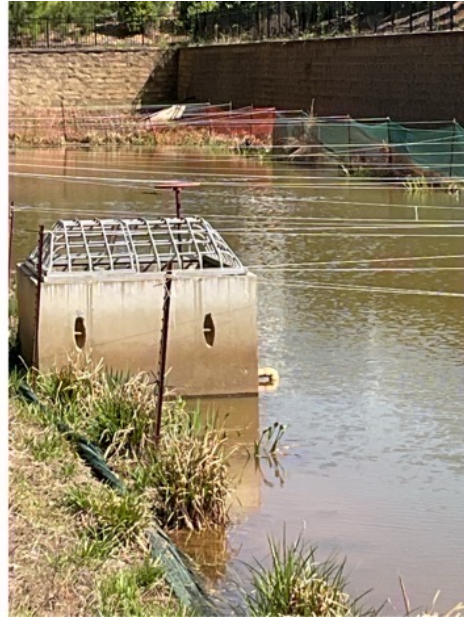
**Photo 10:**

BMP2 riser

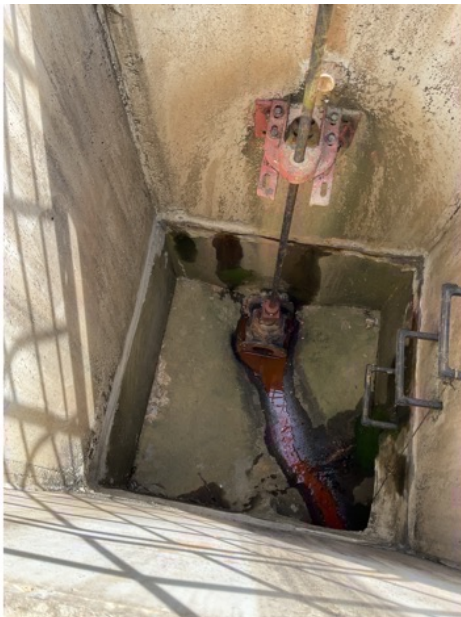
**Photo 11:**

BMP2 inside riser

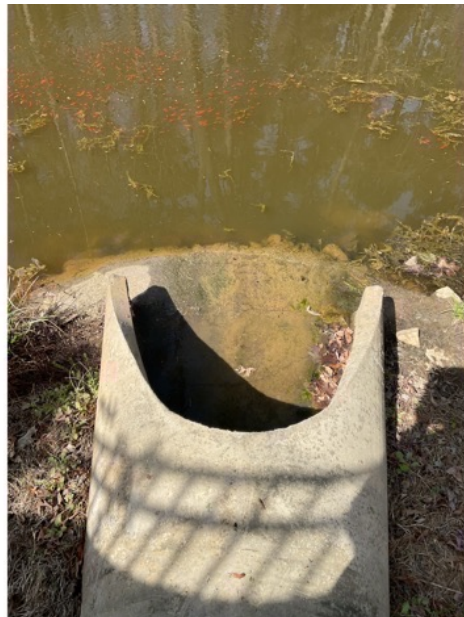
**Photo 12:**

BMP2 inlet

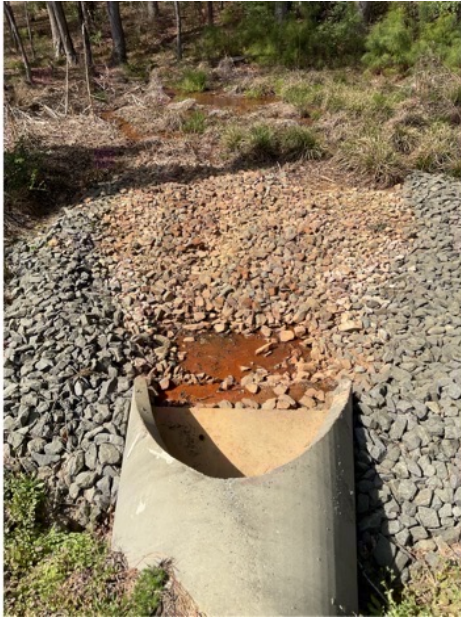
**Photo 13:**

BMP2 outlet

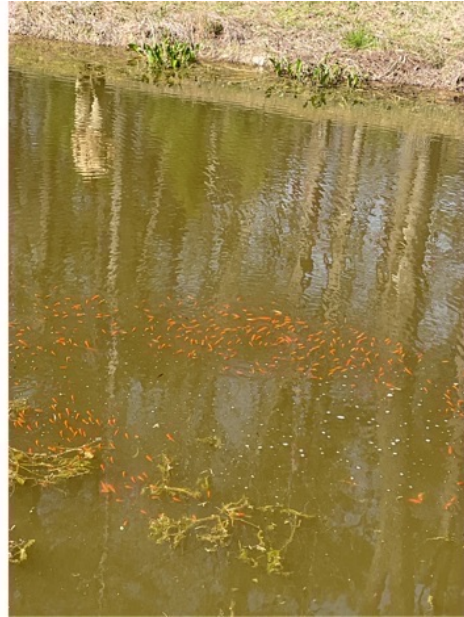
**Photo 14:**

Walked perimeter and picked up trash.  
Cleared rip rap of leaves and debris.  
Walked the perimeter and removed woody vegetation.  
Water level is normal.  
All devices are draining properly.  
Mowing and trimming services were performed.  
Observed large amount of goldfish inhabiting entire length of Shoreline in BMP2, repairs recommended.

BMP2 goldfish

Please contact our office with any additional questions, concerns, or to schedule repairs.

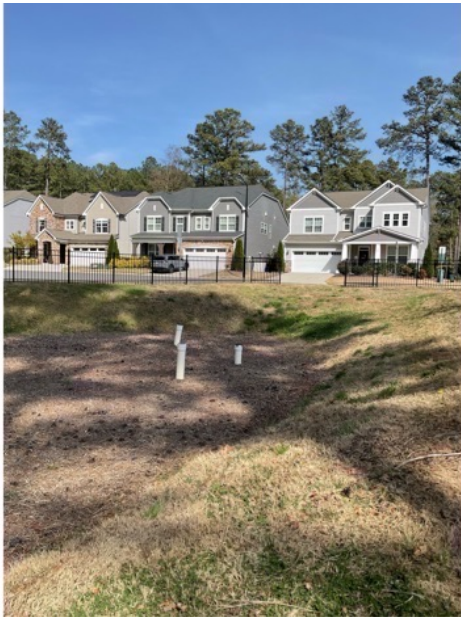
**Photo 15:**

BMP3 overview

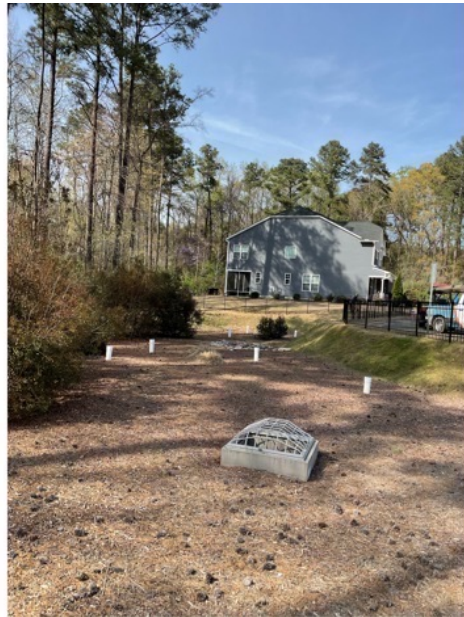
**Photo 16:**

BMP3 overview

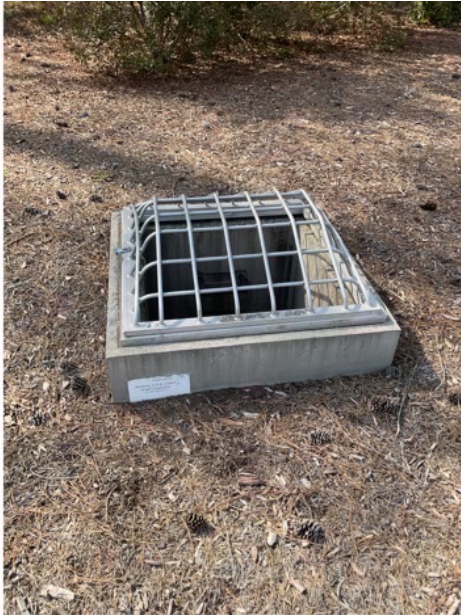
**Photo 17:**

BMP3 riser

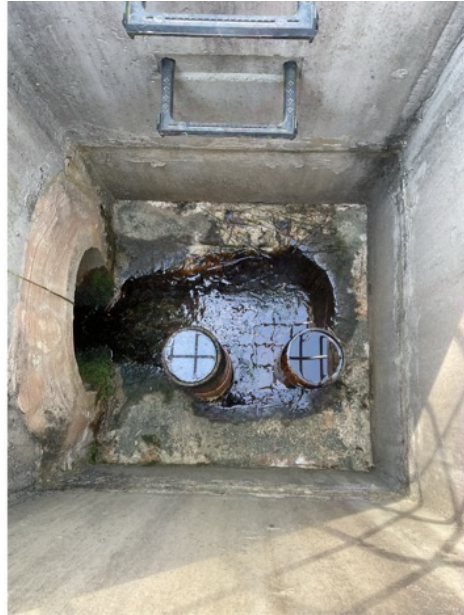
**Photo 18:**

BMP3 inside riser

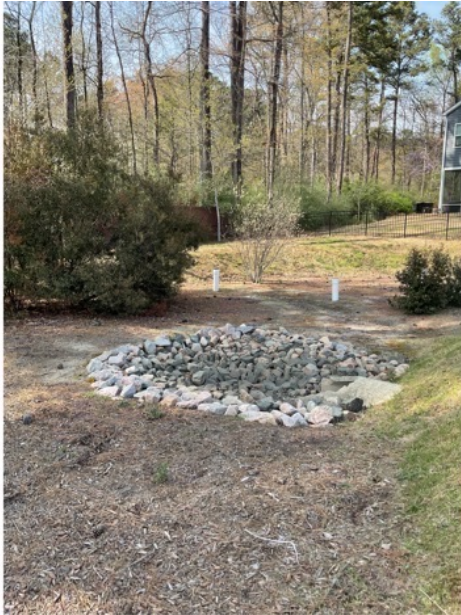
**Photo 19:**

BMP3 inlet

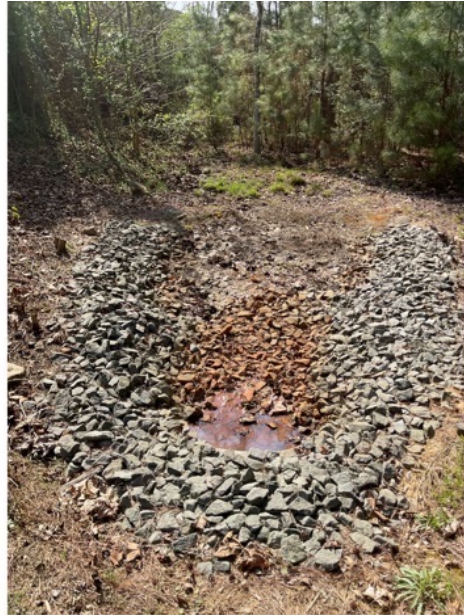
**Photo 20:**

BMP3 outlet
