**Triangle Pond Management**  
 405 S Rogers Ln  
 Raleigh, NC 27610  
 (919)398-3221  
 Office@TrianglePondManagement.com  
 www.TrianglePondManagement.com  
**Maintenance Service Report**

<b>Customer Name:</b>		<b>Date:</b>	
Chandler Woods MOA		1/27/2025	
<b>Address:</b>			
214 Abbot Pl			
<b>Aquatic Technician:</b>			
Matthew Jefferies			
<b>Time of Arrival:</b>	<b>Time of Departure:</b>	<b>Drive Time:</b>	
8:16 AM	10:25 AM	45 min	
<b>Type of Device(s) Maintained:</b>			
BMP 1, BMP 2, BMP 3

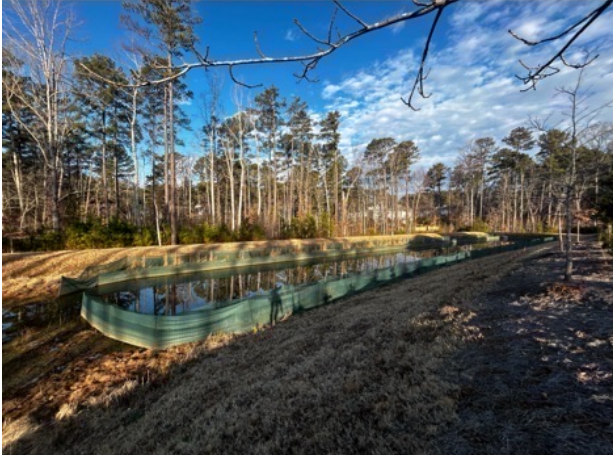
Photo 1:	Photo 2:

BMP 1 overall	Bmp1 overall
Photo 3:	Photo 4:

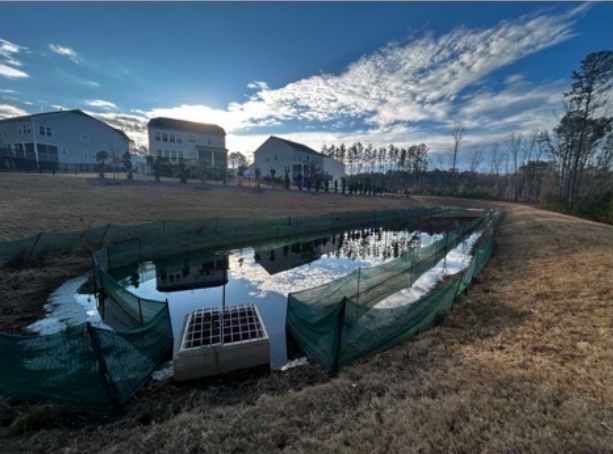
BMP1 overall	BMP1 inlet

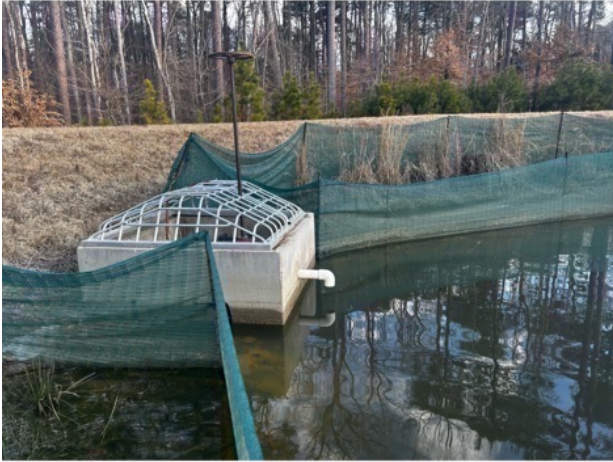
Photo 5:	Photo 6:

BMP1 riser	BMP1 outlet
Photo 7:	Photo 8:

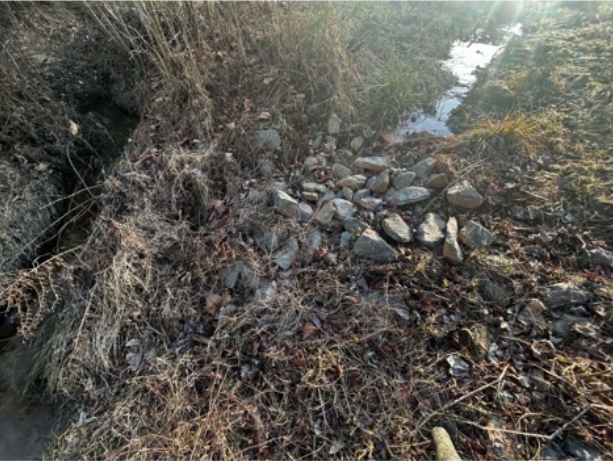
Bmp1 outlet blockage	BMP 2 overlook
