Triangle Pond Management
 405 S Rogers Ln
 Raleigh, NC 27610
 (919)398-3221
 Office@TrianglePondManagement.com
 www.TrianglePondManagement.com
Maintenance Service Report

Customer Name:		Date:	
Chandler Woods MOA		4/22/2024	
Address:			
214 Abbot Pl			
Aquatic Technician:			
Justin Tripp			
Time of Arrival:	Time of Departure:	Drive Time:	
12:58 PM	2:44 PM	16 min	
Type of Device(s) Maintained:			
BMP 1, BMP 2, BMP 3

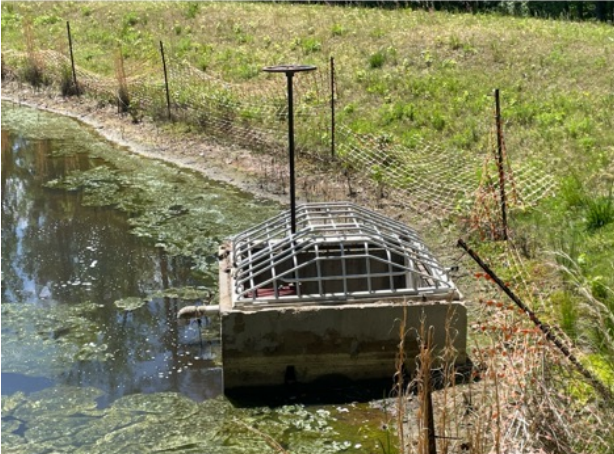
BMP 1 inlet	BMP 1 riser

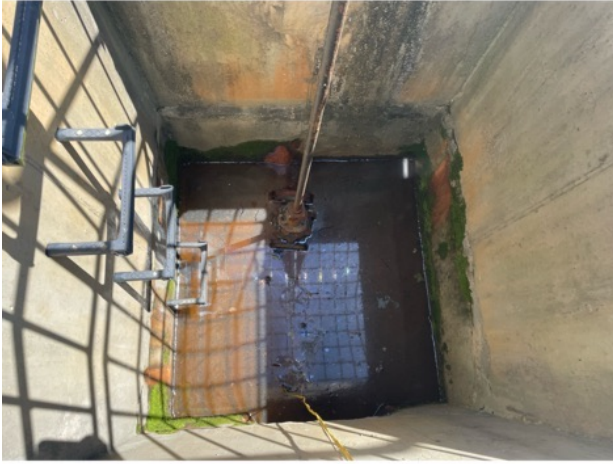
BMP 1 inside riser	BMP 1 outlet
Photo 7:	Photo 8:

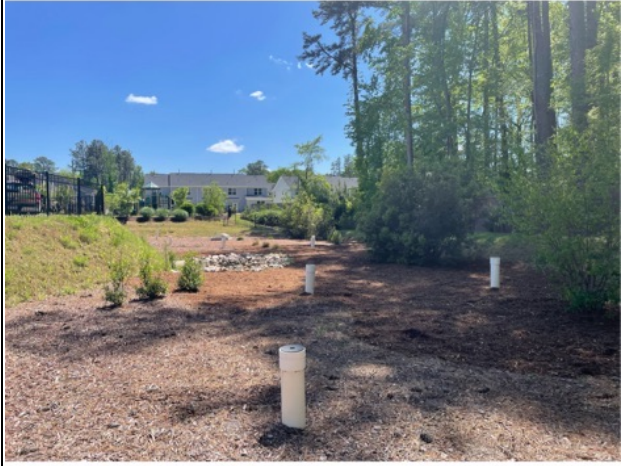
BMP 3	BMP 3 riser
Photo 15:	Photo 16:

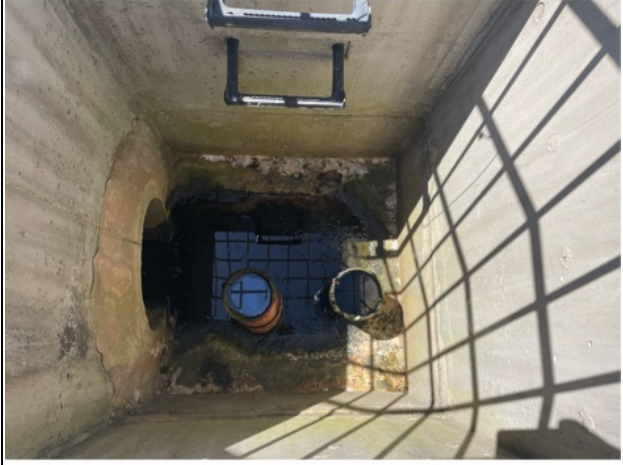
BMP 3 inside riser	BMP 3 inlet

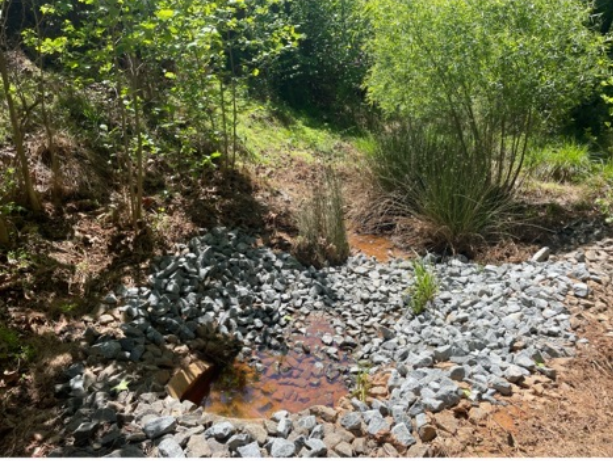
BMP 3 outlet	
Photo 19:	Photo 20:
