# Annual Inspection and Maintenance Reports for Stormwater Control Measures (SCMs)

**CHANDLER WOODS – CHAPEL HILL, NC**  
 Stormwater Control Measure (SCM) Location Map

Site Name:	Chandler Woods	Date:	04/19/2024
SCM Location:	Abbot Place	SCM ID Number: (if applicable, per approved plans)

### SCM #1 – WET DETENTION POND #1 (WEST)

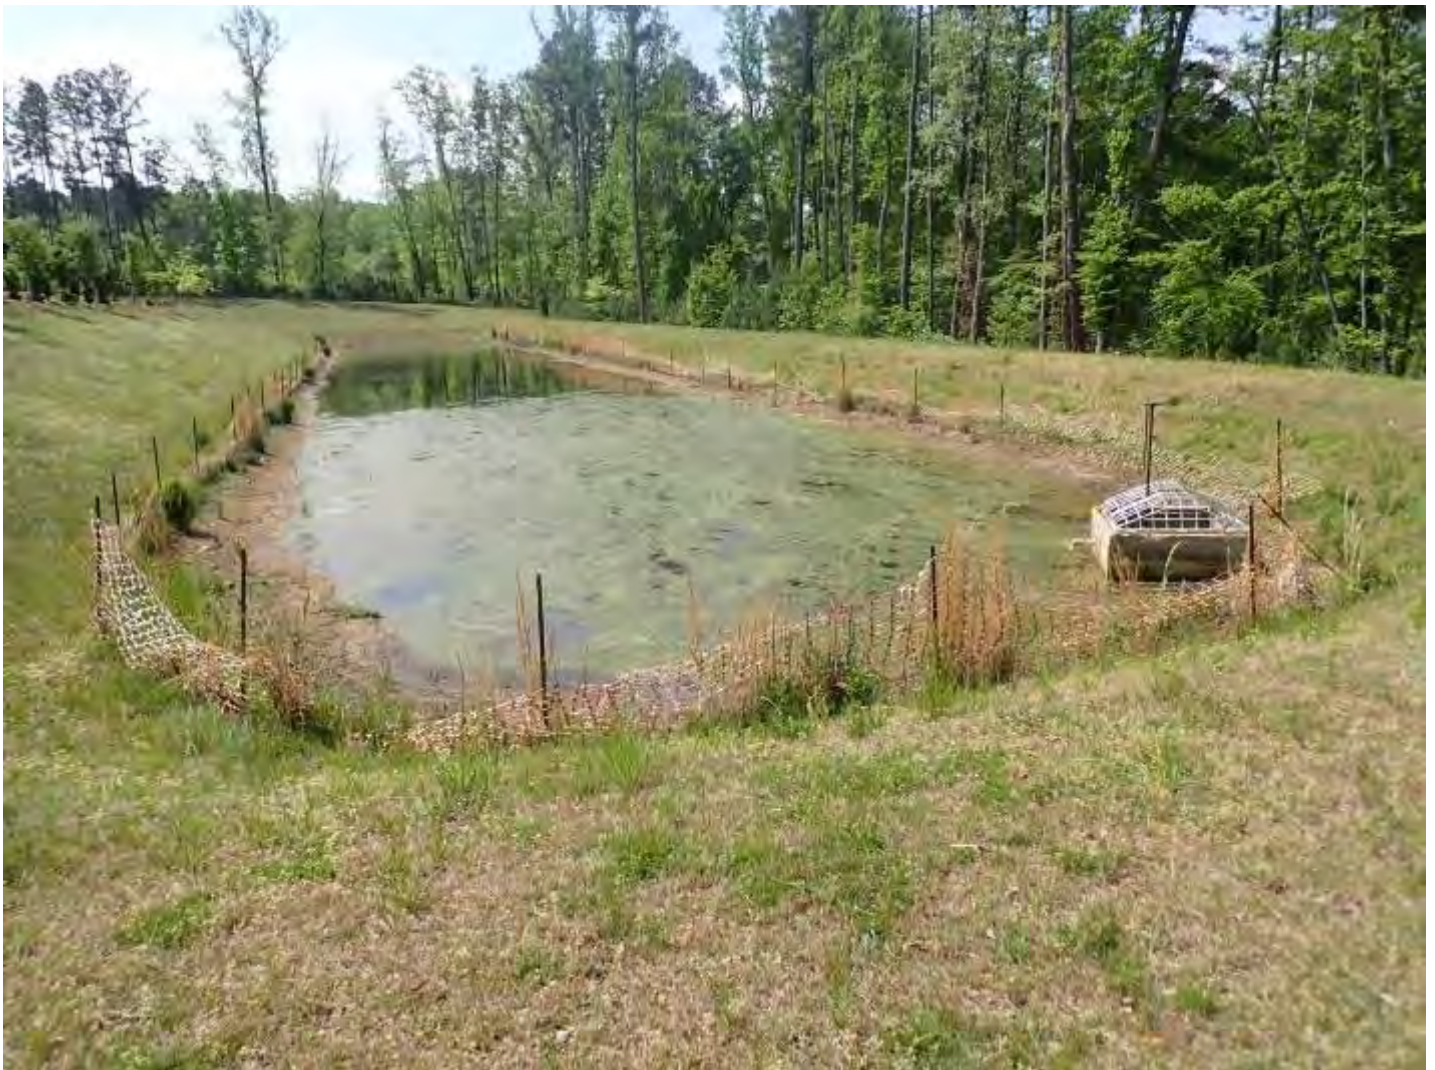
**A: VIEW OF WET DETENTION POND**

ASSESSMENT	CODE	COMMENTS
Sediment and Debris Accumulation	PASS	
Visible Pollution or High Turbidity	PASS	
Plants are Dead, Diseased or Dying	M	See photographic journal
Vegetation Height and Density	PASS	
Bare Soils or Erosive Gullies	PASS	
Invasive Vegetation (Estimate %)	PASS	
Algae or Aquatic Weed Cover (Estimate %)	PASS	Algae (30%) actively managed via routine maintenance
Other (describe)

*(ALGAE ADDRESSED VIA ROUTINE MAINTENANCE; CONTRACTOR ADVISED RECENTLY TREATED)*

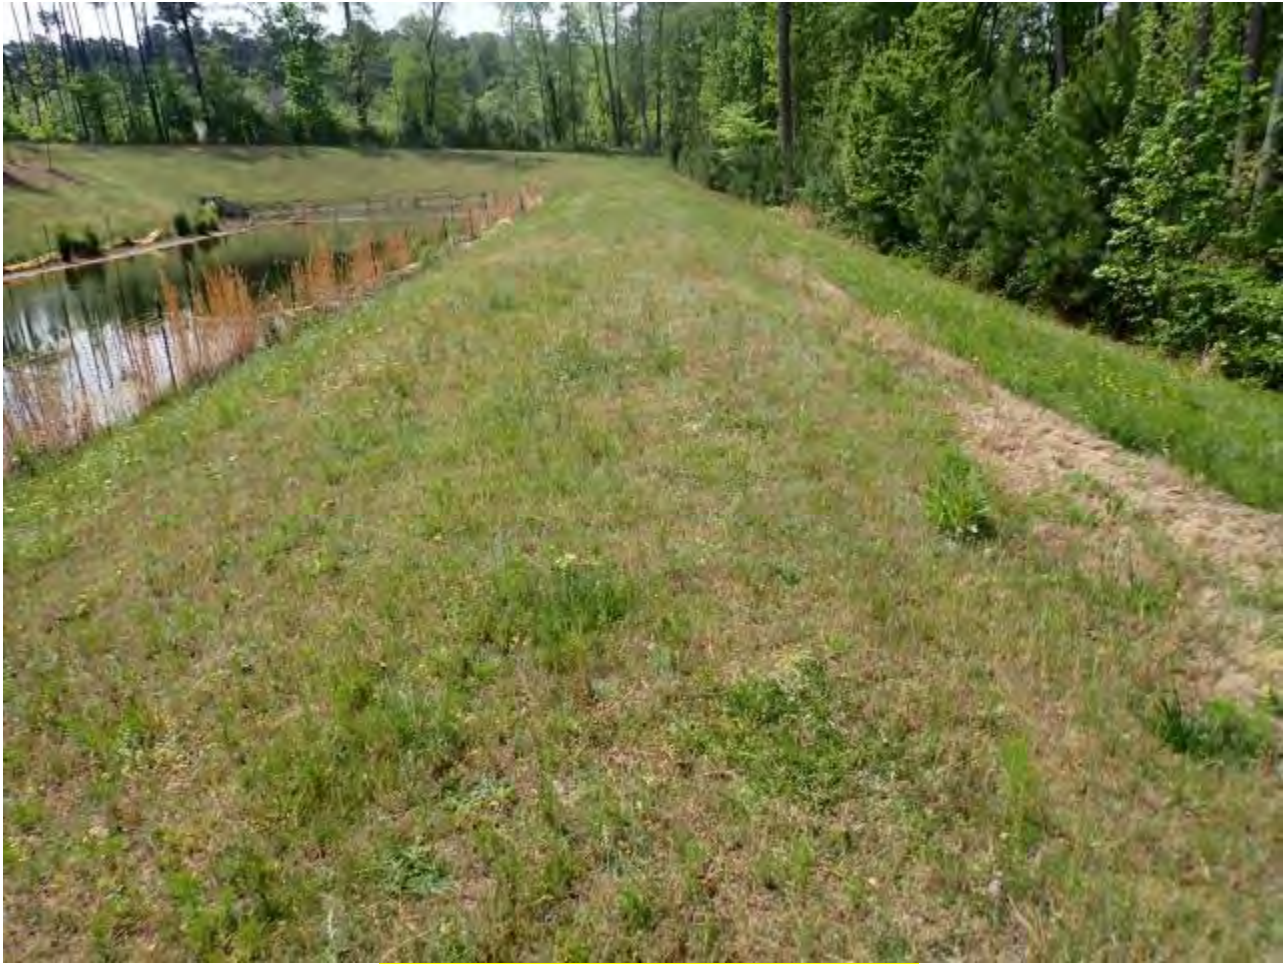
**C: VIEW OF DAM EMBANKMENT**

ASSESSMENT	CODE	COMMENTS
Erosion or Loss of Dam Material	PASS	
Shrubs or Trees Present	M	Remove woody's along toe of dam; see photographic journal
Animal Burrows	PASS	
Soft or Boggy Areas	PASS	
Other (Describe)	M	Bare/sparse areas at downslope; see photographic journal

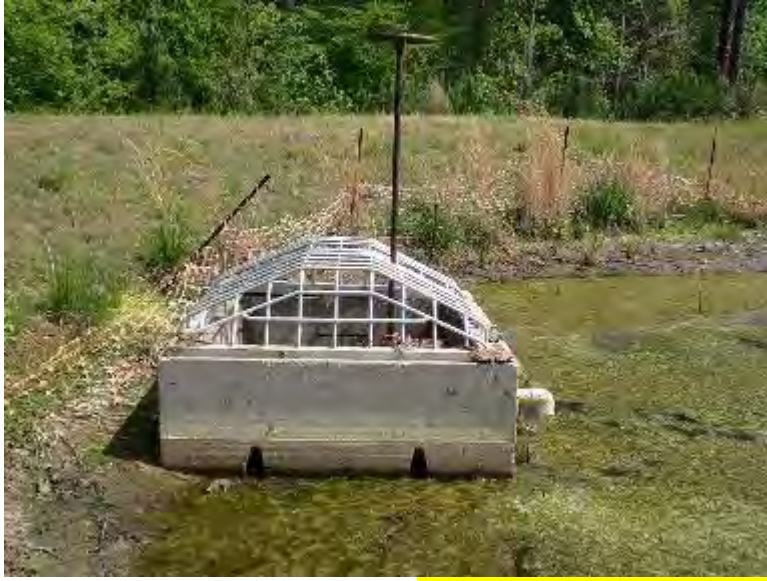
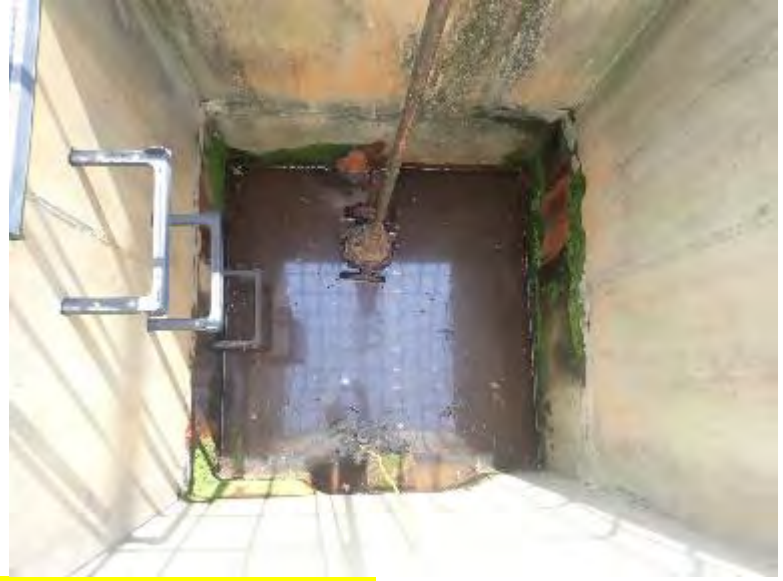
**E: VIEW OF RISER EXTERIOR AND INTERIOR**

ASSESSMENT	CODE	COMMENTS
Obstruction: Vegetation, Debris, Sediment, Other	PASS	
Structural Condition	PASS	
Velocity Dissipator Pad Condition	PASS	
Pipe Condition	PASS	
Orifice Condition	PASS	
Erosion or Undercutting	PASS	
High-flow Bypass	PASS	
Other (describe)	M	Seepage at riser outlet structure; see photographic journal

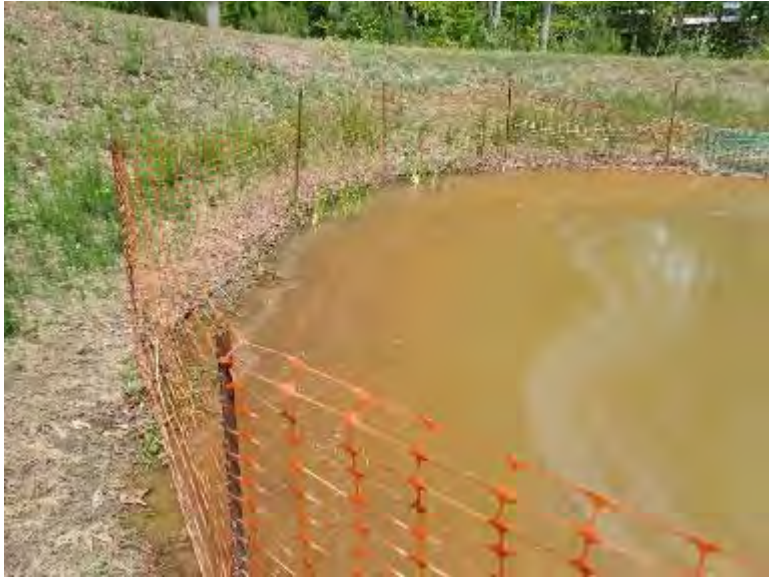
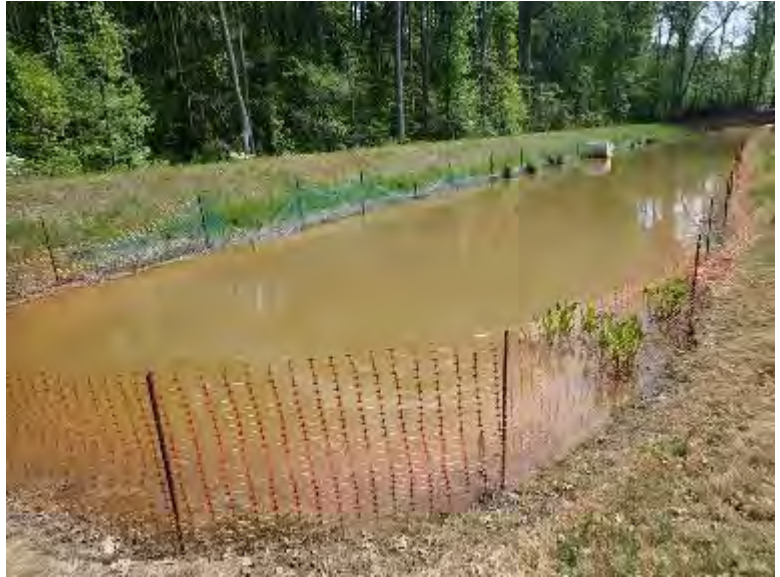
ASSESSMENT	CODE	COMMENTS
Sediment and Debris Accumulation	PASS	
Visible Pollution or High Turbidity	PASS	
Plants are Dead, Diseased or Dying	M	See photographic journal
Vegetation Height and Density	PASS	
Bare Soils or Erosive Gullies	PASS	
Invasive Vegetation (Estimate %)	PASS	
Algae or Aquatic Weed Cover (Estimate %)	PASS	
Other (describe)	M	Overgrowth at retaining walls; see photographic journal

**A: COMPARE PLANT ESTABLISHMENT AT LITTORAL SHELF WITH PLANTING PLAN;  
DETERMINE SHORTFALLS & PERFORM SUPPLEMENTAL PLANTING ACCORDINGLY**

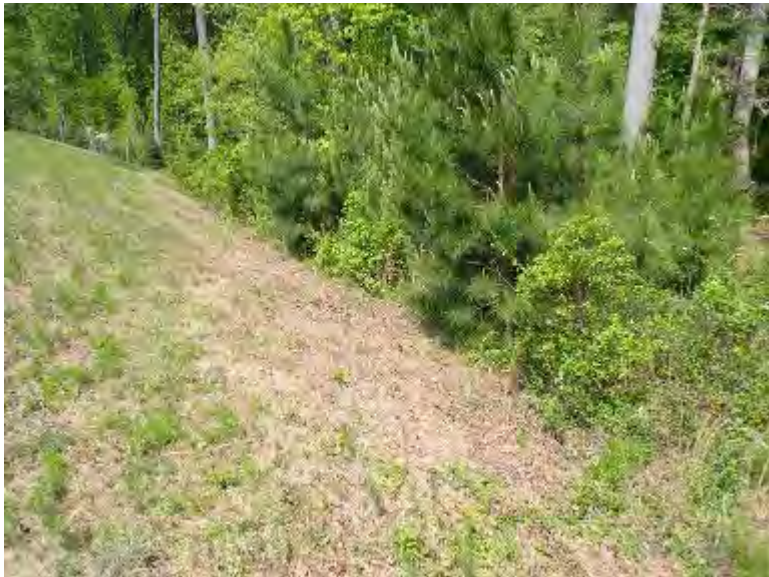
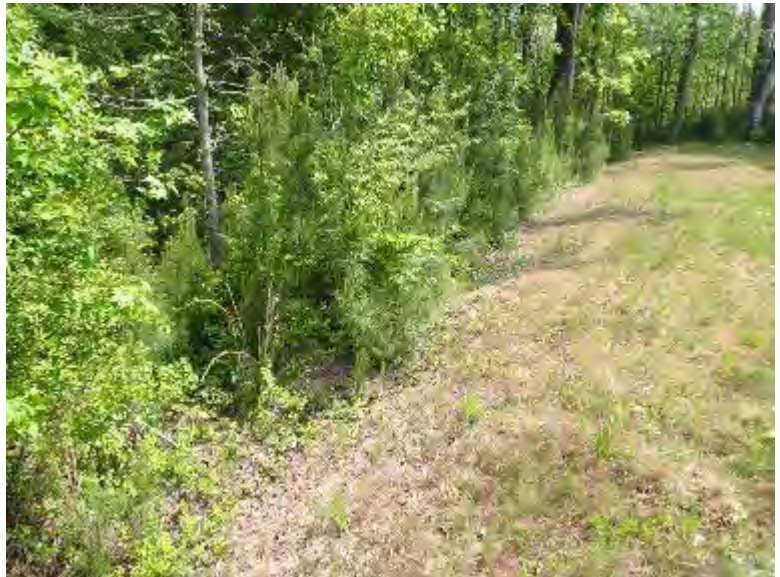
ASSESSMENT	CODE	COMMENTS
Erosion or Loss of Dam Material	PASS	
Shrubs or Trees Present	M	Remove woody's along toe of dam; see photographic journal
Animal Burrows	PASS	
Soft or Boggy Areas	PASS	
Other (Describe)	M	Maintenance required at landscaped portions; see photo journal

**B: CUT/REMOVE IMMATURE WOODY VEGETATION AT DAM TOE UPWARDS FROM THE  
MATURE TREE LINE; STRING-TRIM REMAINING HERBACEOUS GROWTH**

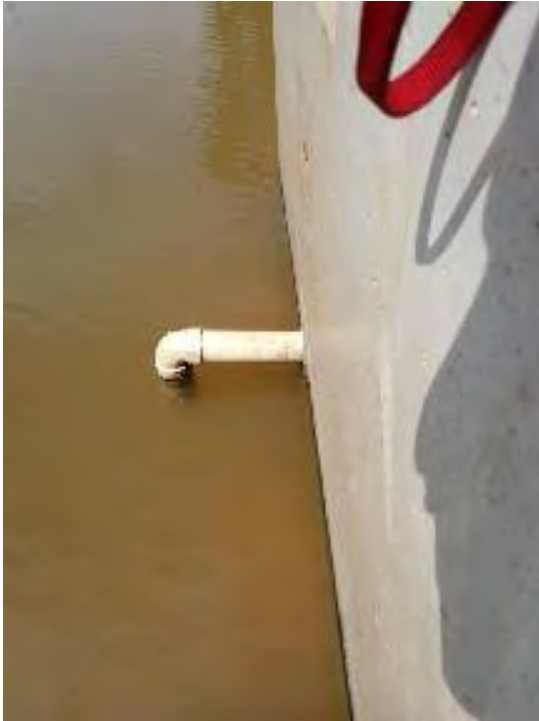
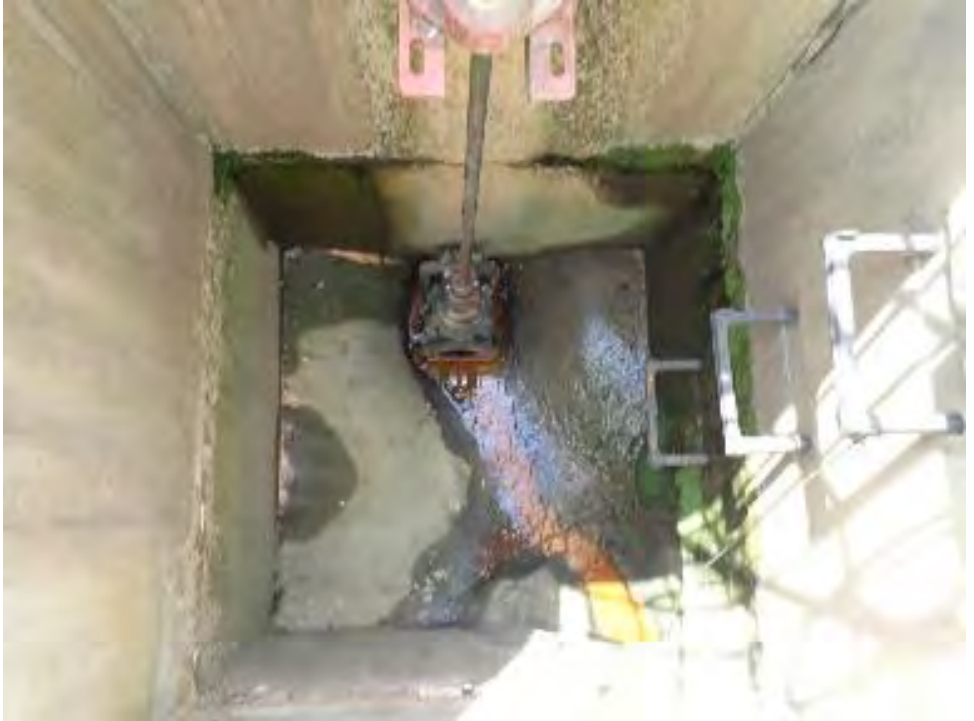
ASSESSMENT	CODE	COMMENTS
Obstruction: Vegetation, Debris, Sediment, Other	PASS	
Structural Condition	PASS	
Velocity Dissipator Pad Condition	PASS	
Pipe Condition	PASS	
Orifice Condition	PASS	
Erosion or Undercutting	PASS	
High-flow Bypass	PASS	
Other (describe)	M	Seepage at riser outlet structure; see photographic journal

**D: REMEDIATE LOW POOL LEVEL RESULTING FROM OUTLET STRUCTURE LEAKS: THOROUGHLY CLEAN ORGANICS FROM ALL SEEPAGE POINTS & SEAL W/ NON-SHRINK HYDRAULIC GROUT**

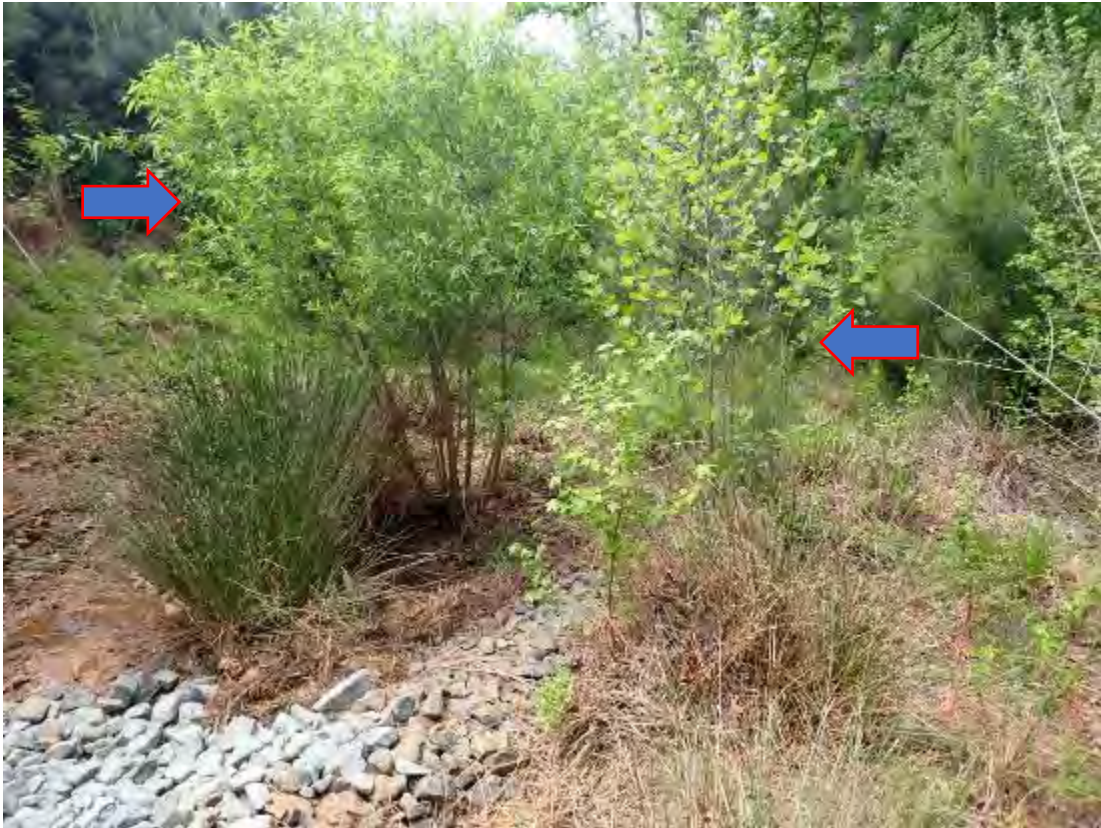
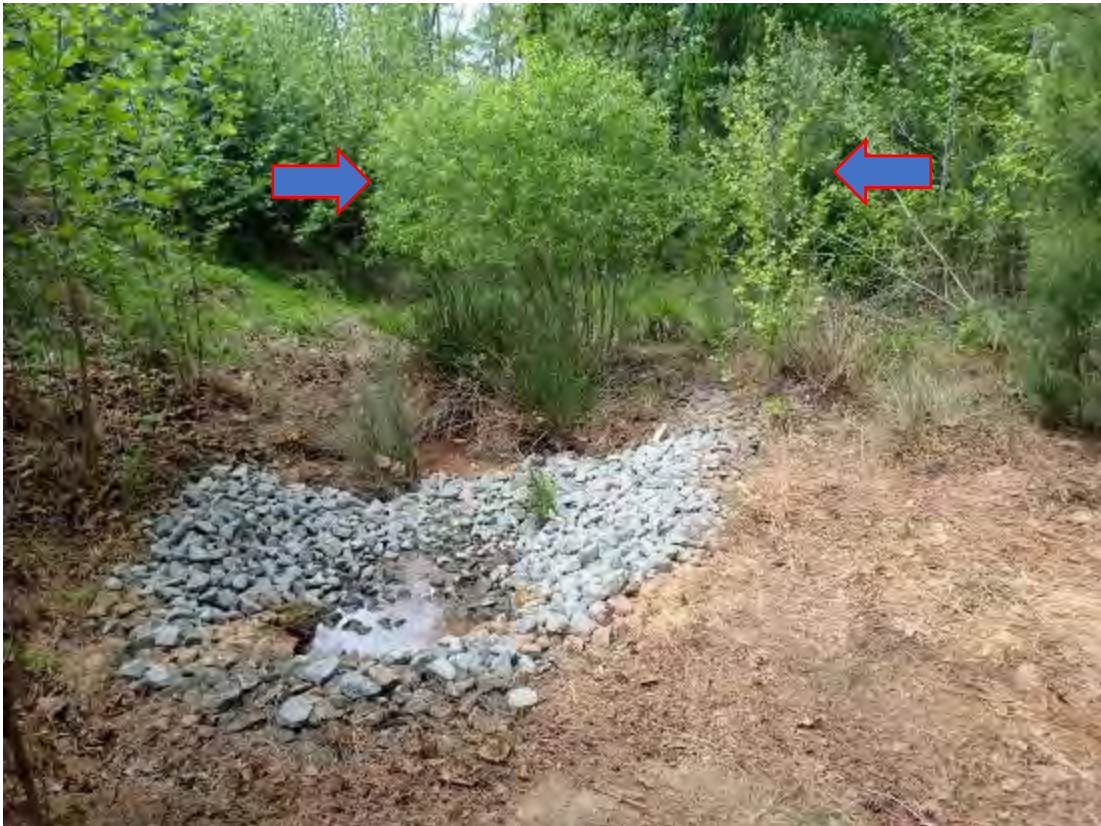
ASSESSMENT	CODE	COMMENTS
Obstruction: Vegetation, Debris, Sediment, Other	PASS	
Structural Condition	PASS	
Velocity Dissipator Pad Condition	M	Nuisance trees present; see photographic journal
Pipe Condition	PASS	
Erosion or Undercutting	PASS	
High-flow Bypass	PASS	Turf emergency spillway stable with established vegetation
Other (Describe)

**A: CUT/REMOVE TWO NUISANCE TREES FROM OUTLET DISCHARGE AREA;  
TREAT WILLOW TREE STUMPS WITH HERBICIDE TO PREVENT REGROWTH**

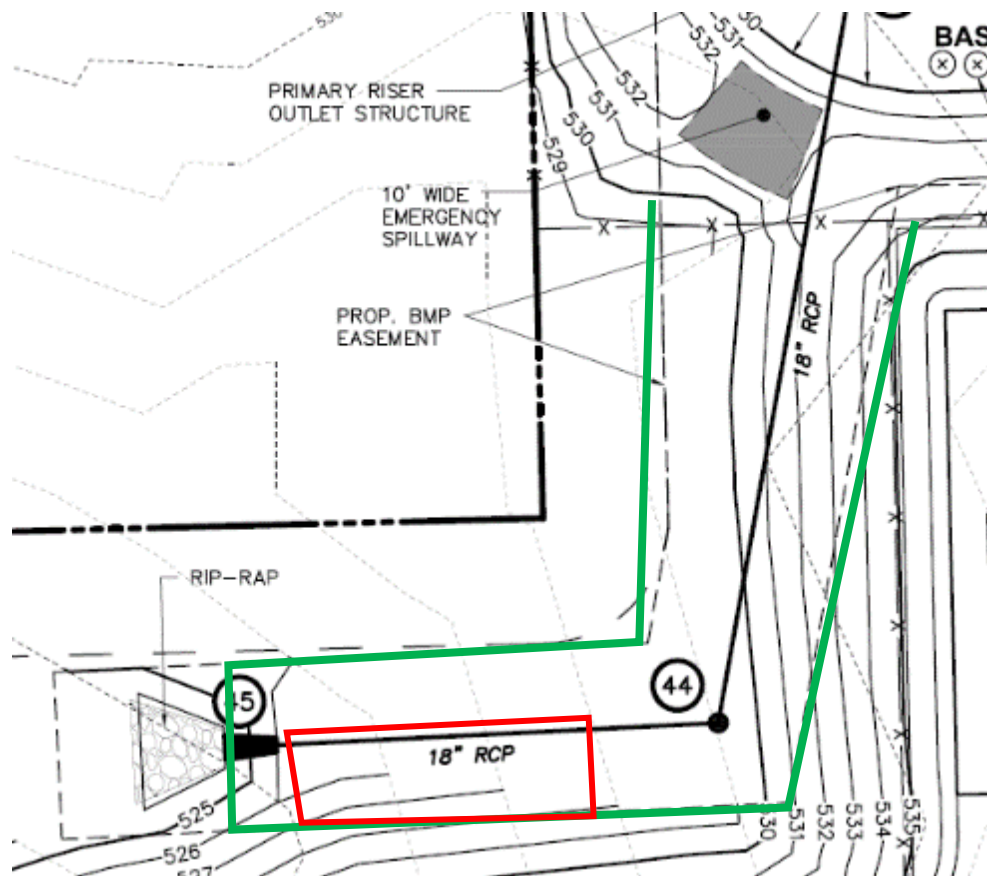
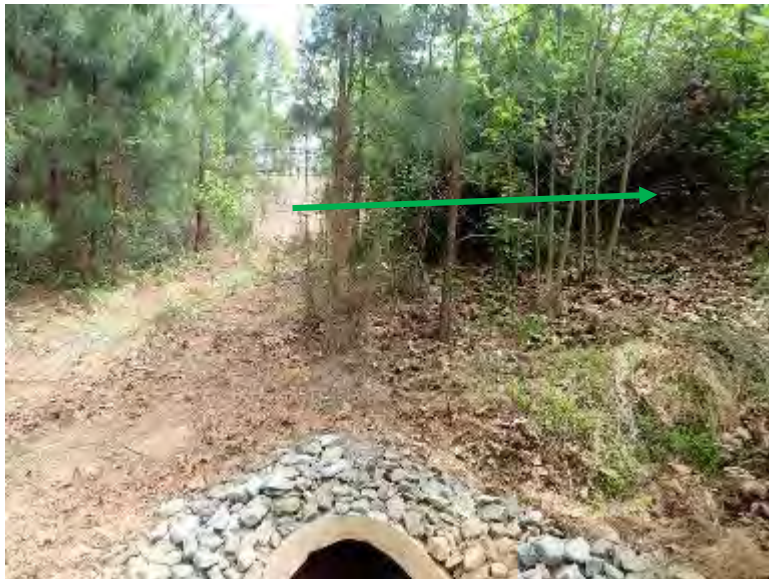
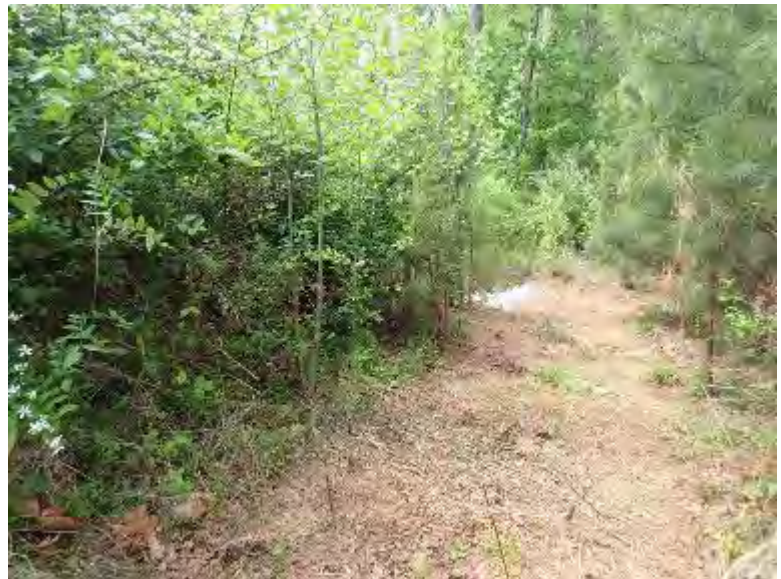
ASSESSMENT	CODE	COMMENTS
Trash or Debris	PASS	
Access	M	Portion of outlet easement overgrown; see Photo Journal
Vandalism	PASS	
Signage	N/A	
Other (Describe)		
Other (Describe)		
Other (Describe)

**B: CUT & REMOVE TREES & SHRUBS AT REMAINING PORTION OF OUTLET DISCHARGE EASEMENT CORRIDOR (AREA IN RED ABOVE (ENTIRE EASEMENT OUTLINED IN GREEN); MAINTAIN AS MOWED AT A MAXIMUM HEIGHT OF 18"**
