**Triangle Pond Management**  
 405 S Rogers Ln  
 Raleigh, NC 27610  
 (919)398-3221  
 Office@TrianglePondManagement.com  
 www.TrianglePondManagement.com  
**Maintenance Service Report**

<b>Customer Name:</b>		<b>Date:</b>	
Chandler Woods MOA		6/24/2026	
<b>Address:</b>			
214 Abbot Pl			
<b>Aquatic Technician:</b>			
Christian Folk			
<b>Time of Arrival:</b>		<b>Time of Departure:</b>	
10:30 AM		1:25 PM	
<b>Drive Time:</b>			
39min			
<b>Type of Device(s) Maintained:</b>			
WP 1, WP 2, BR 3

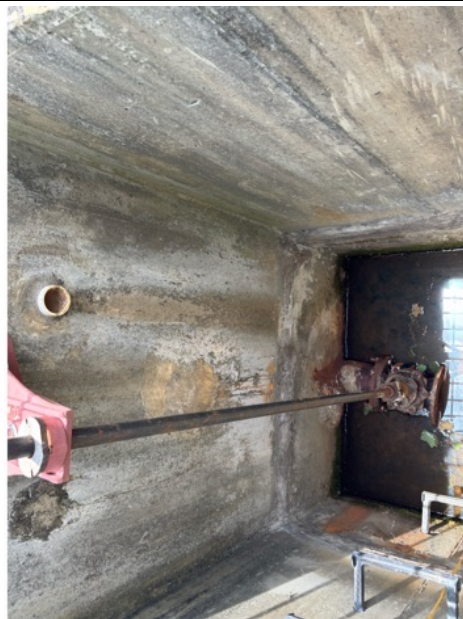
**Photo 4:**

The riser hatches at BMP 1/2 were locked shut preventing access to the riser interior which would be necessary to exercise the stuck drain valves.

Riser interior

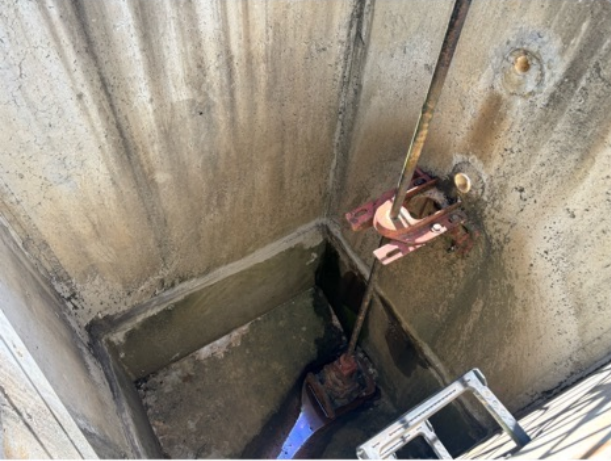
<p>Overview</p>	<p>Riser</p>
Photo 11:	Photo 12:

Some minor seepage in the BMP 2 riser was observed in prior visit. - We will continue to All other components were functioning properly.

<p>Riser interior</p>	<p>Inlet</p>

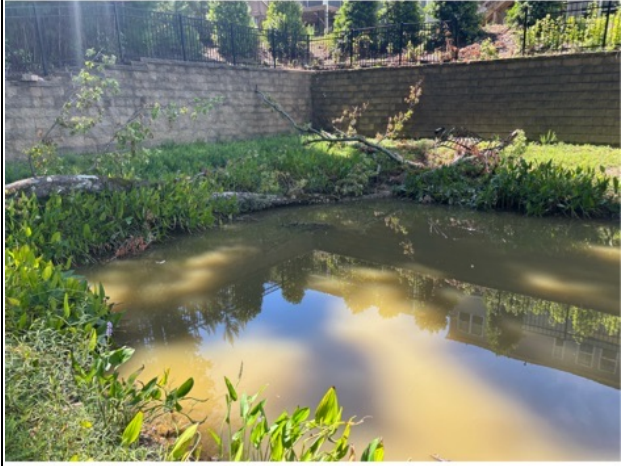
Photo 13:	Photo 14:

Water levels were low, likely due to drought, devices appeared to be functioning properly. Tree fallen in BMP2 laying across pond and has taken out fencing. - Recommend removal and repair.

Fallen tree	Backside of dam
Photo 15:	Photo 16:

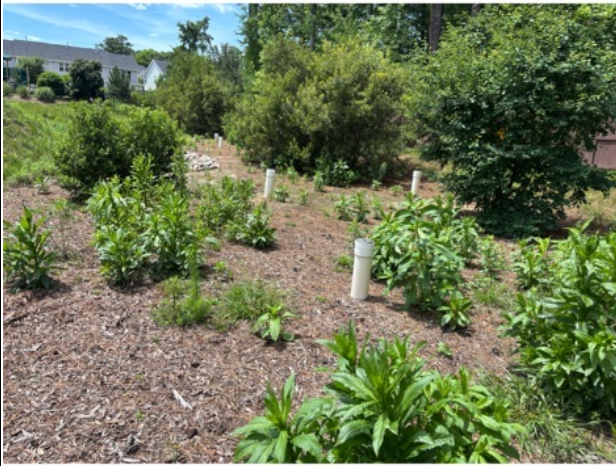
Photo 17:

Each device was walked, trash and debris was removed. Debris was cleared from the rip-rap areas as necessary. Unwanted vegetation in the basin of BMP 3 was controlled, as well as in the rip-rap areas. It may be necessary to add supplemental mulch to cover the exposed areas in BMP3. The wildlife exclusion fencing has come apart from the stakes around BMP 1/2. - May require repair.

Overview
