Triangle Pond Management
 405 S Rogers Ln
 Raleigh, NC 27610
 (919)398-3221
 Office@TrianglePondManagement.com
 www.TrianglePondManagement.com
Maintenance Service Report

Customer Name:		Date:	
Chandler Woods MOA		5/18/2026	
Address:			
214 Abbot Pl			
Aquatic Technician:			
Jonathan Johnson			
Time of Arrival:		Time of Departure:	
8:15 AM		1:53 PM	
Drive Time:			
1 hr			
Type of Device(s) Maintained:			
BMP 1, BMP 2, BMP 3

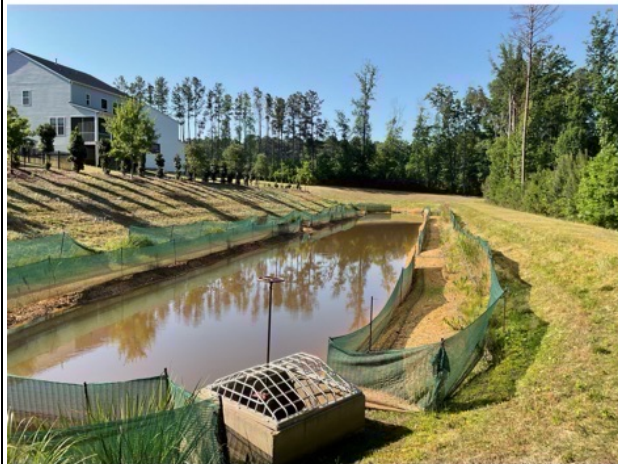
BMP1 overview

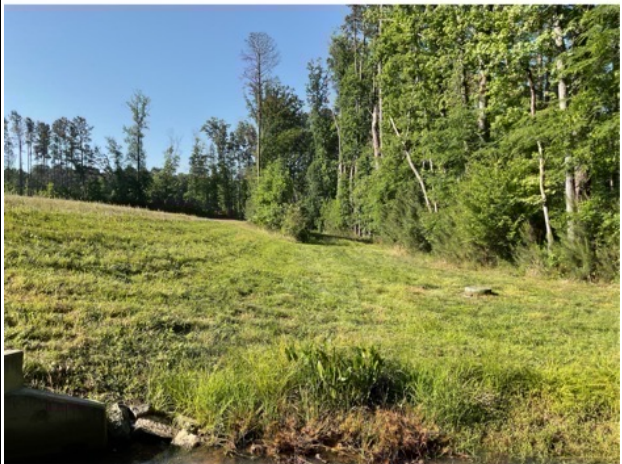
BMP1 back of dam

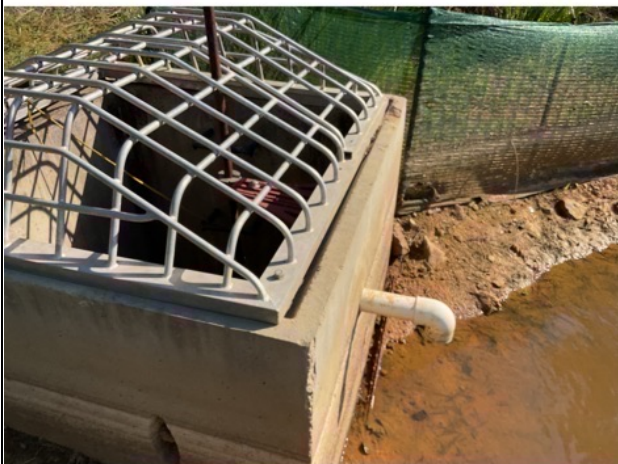
BMP1 riser

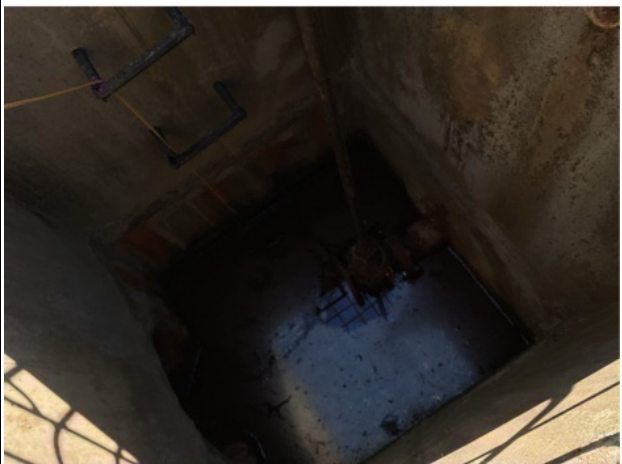
BMP1 inside riser

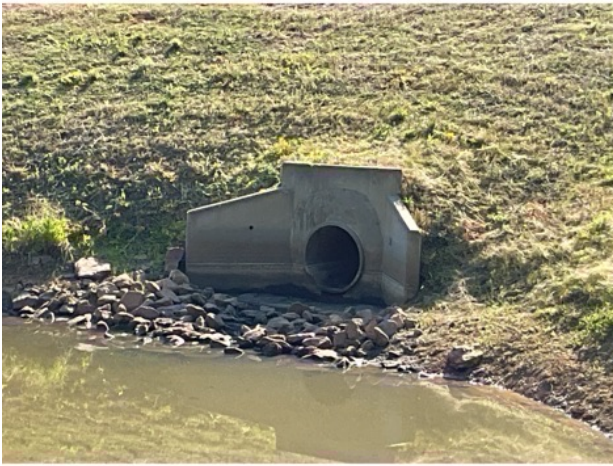
Photo 5:

BMP1 inlet

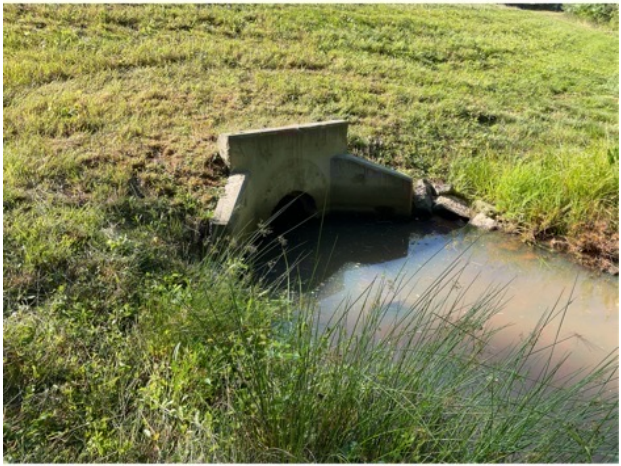
Photo 6:

BMP1 outlet

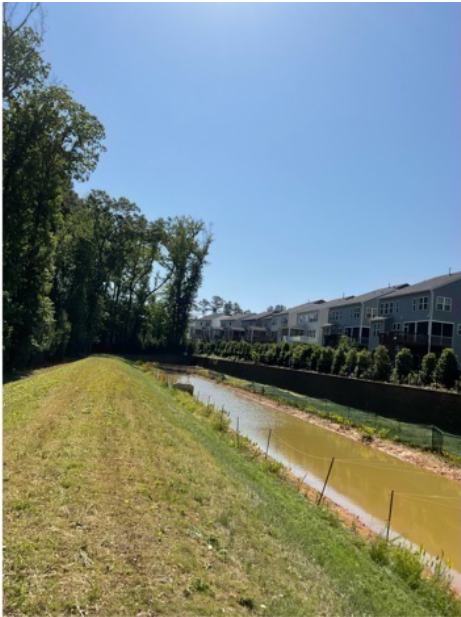
Photo 7:

BMP2 overview

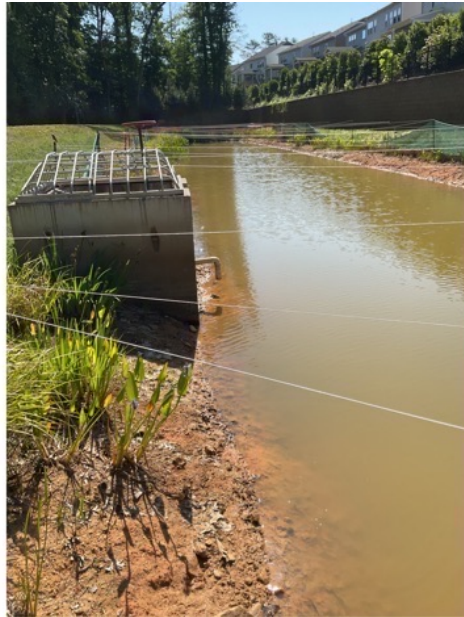
Photo 8:

BMP2 riser

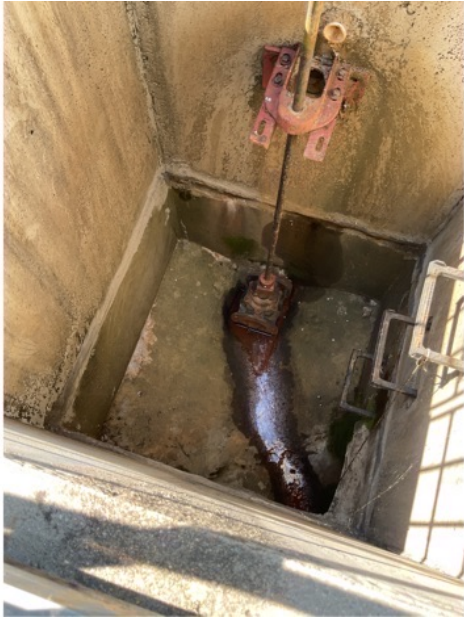
Photo 9:

BMP2 overview

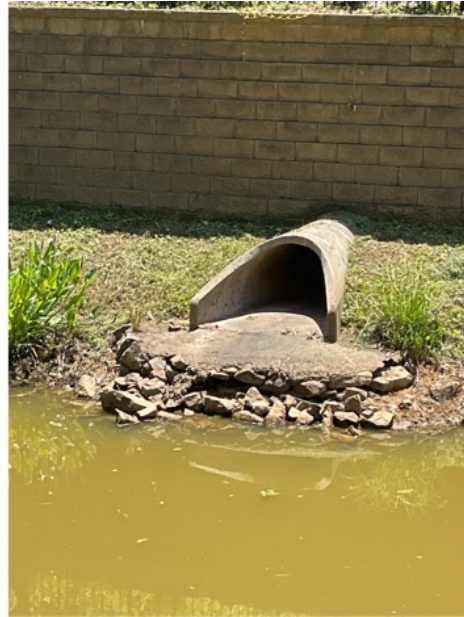
Photo 10:

BMP2 inlet

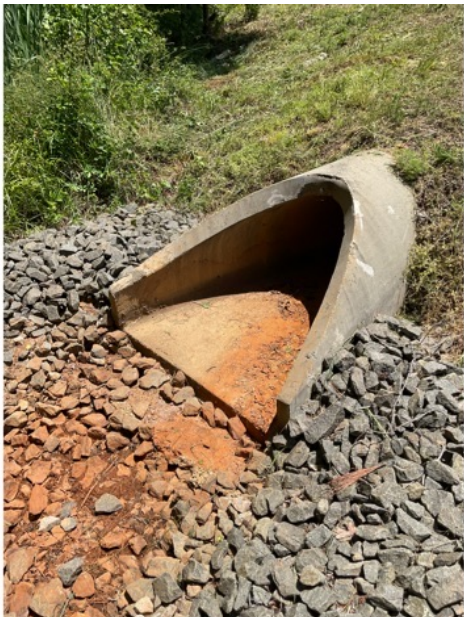
Photo 11:

BMP2 outlet

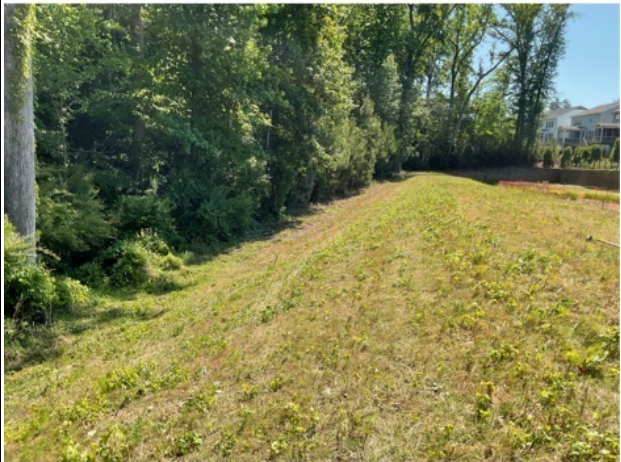
Photo 12:

BMP2 back of dam

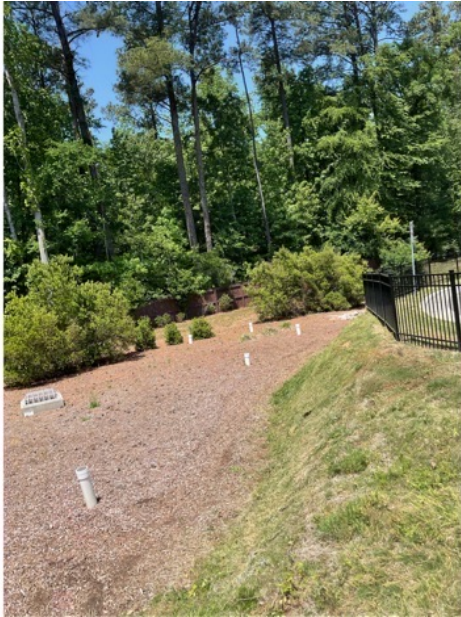
Photo 13:

BMP3 overview

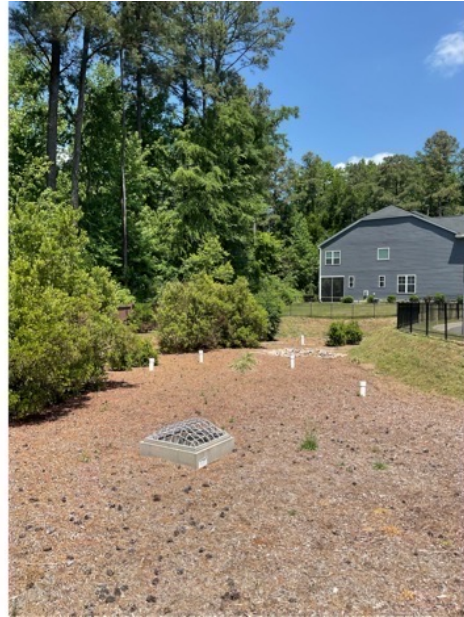
Photo 14:

BMP3 overview

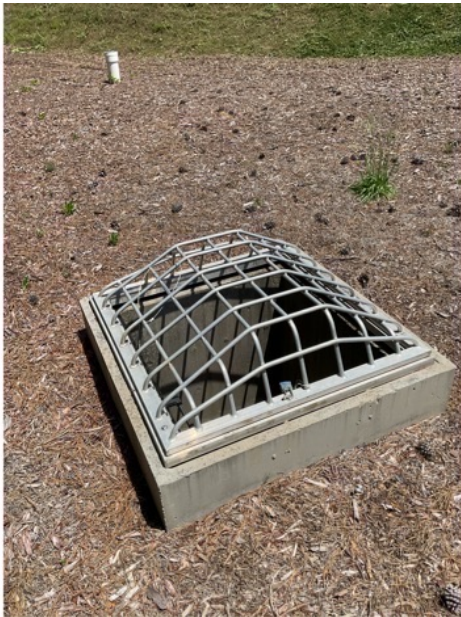
Photo 15:

BMP3 riser

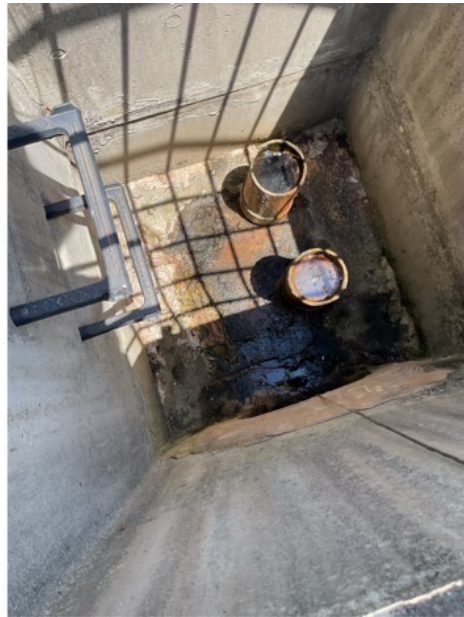
Photo 16:

BMP3 inside riser

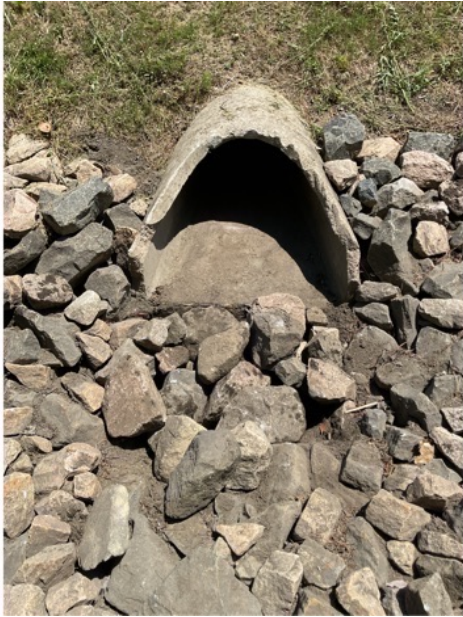
Photo 17:

BMP3 inlet

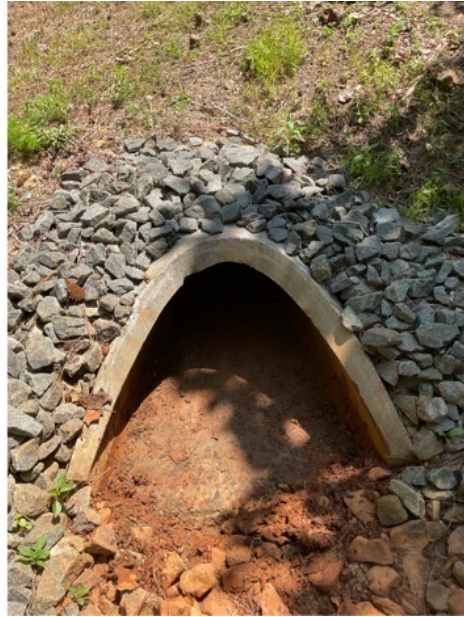
Photo 18:

BMP3 outlet

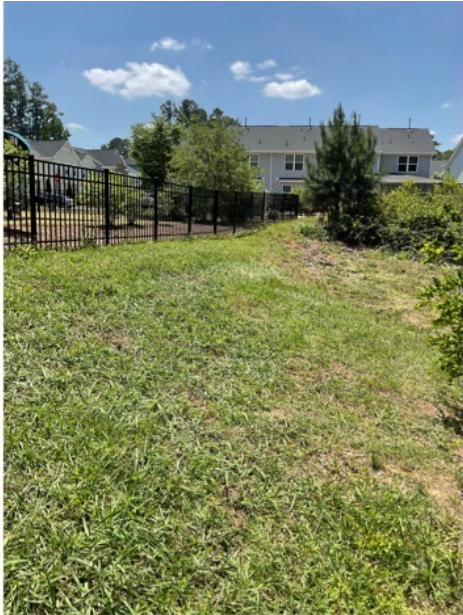
Photo 19:

BMP3 back of dam
