**Triangle Pond Management**  
 405 S Rogers Ln  
 Raleigh, NC 27610  
 (919)398-3221  
 Office@TrianglePondManagement.com  
 www.TrianglePondManagement.com  
**Maintenance Service Report**

| Chandler Woods MOA | | 9/15/2026 | |
| 214 Abbot Pl | | | |

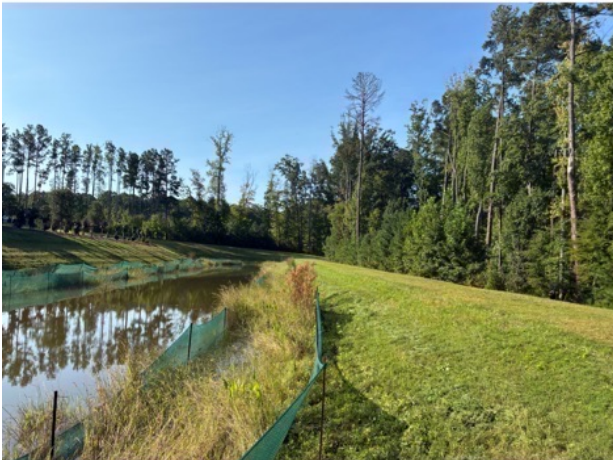
| Photo 1: | Photo 2: |

| Photo 1: | Photo 2: |
|---|---|
| BMP1 overview | BMP1 overview |

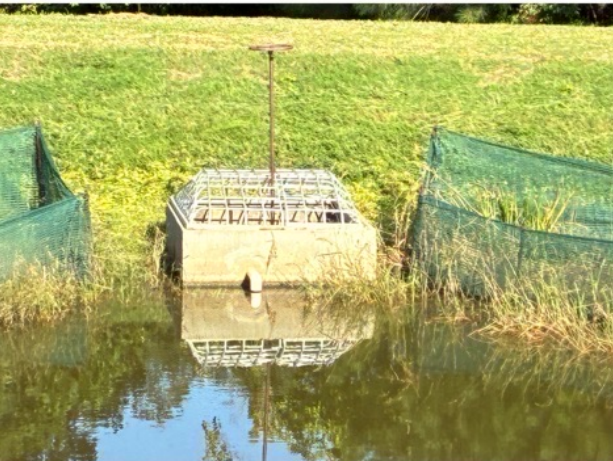
| Photo 1: | Photo 2: |
|---|---|
| Photo 3: | Photo 4: |

| Photo 1: | Photo 2: |
|---|---|
| BMP1 riser | BMP1 inside riser |

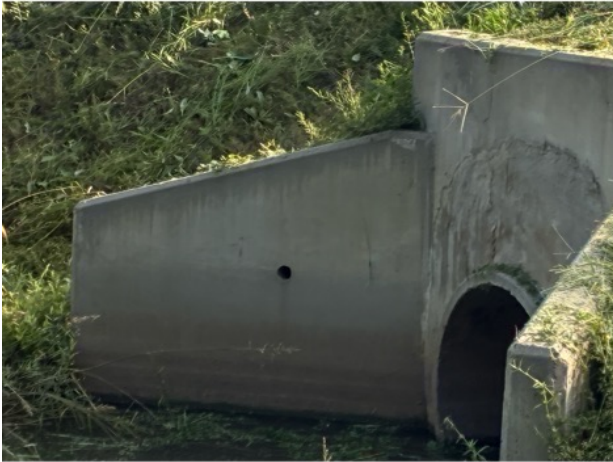
| Photo 5: | Photo 6: |

| Photo 5: | Photo 6: |
|---|---|
| BMP1 inlet | BMP1 outlet |

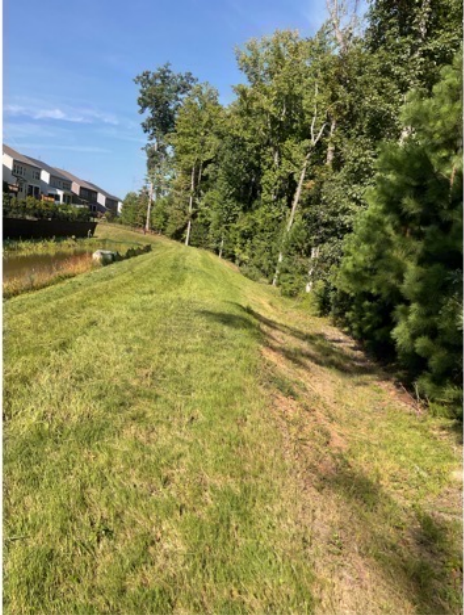
| Photo 5: | Photo 6: |
|---|---|
| Photo 7: | Photo 8: |

| Photo 5: | Photo 6: |
|---|---|
| BMP2 back of dam | BMP2 overview |

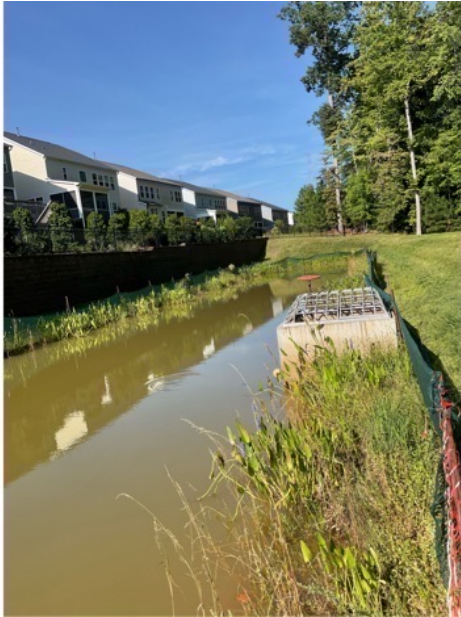
**Photo 9:**

BMP2 riser

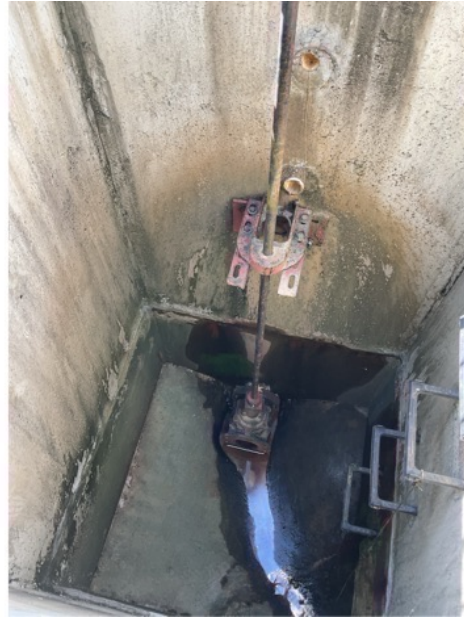
**Photo 10:**

BMP2 inside riser

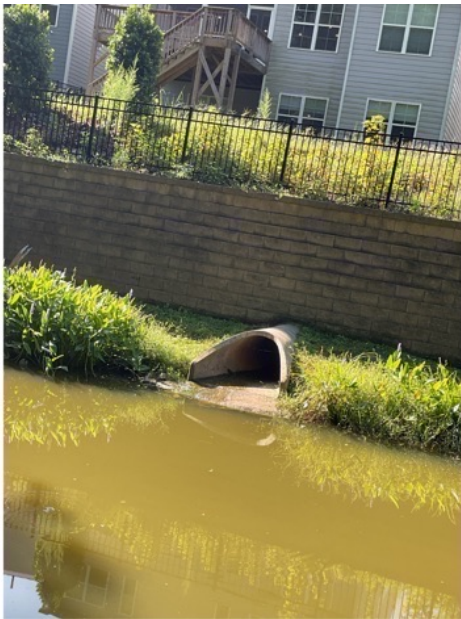
**Photo 11:**

BMP2 inlet

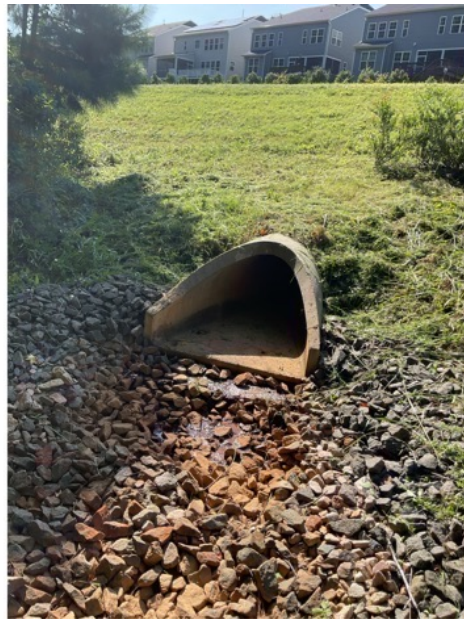
**Photo 12:**

BMP2 outlet

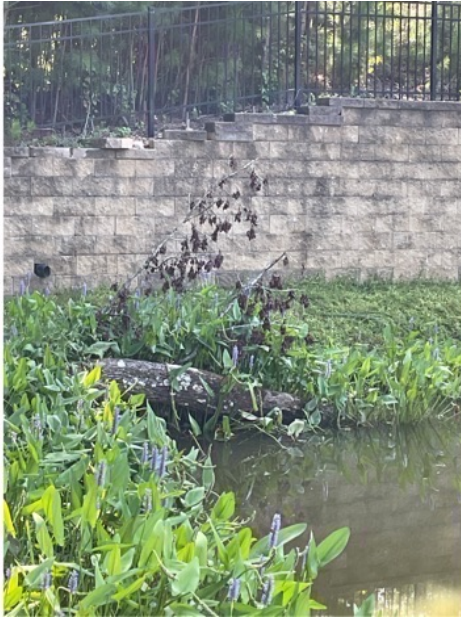
**Photo 13:**

| Additional Notes: |
|---|
| <p>Mowing and trimming services were completed.</p> <p>Walked perimeter and picked up trash.</p> <p>Walked perimeter and removed woodie vegetation.</p> <p>Water level was normal.</p> <p>All devices draining properly.</p> <p>Treated unwanted vegetation with approved herbicide.</p> <p>Large Log at the end of BMP2. - <u>Recommend removal.</u></p> <p>Please contact our office with any additional questions, concerns, or to schedule repairs.</p> |

BMP2 LOG

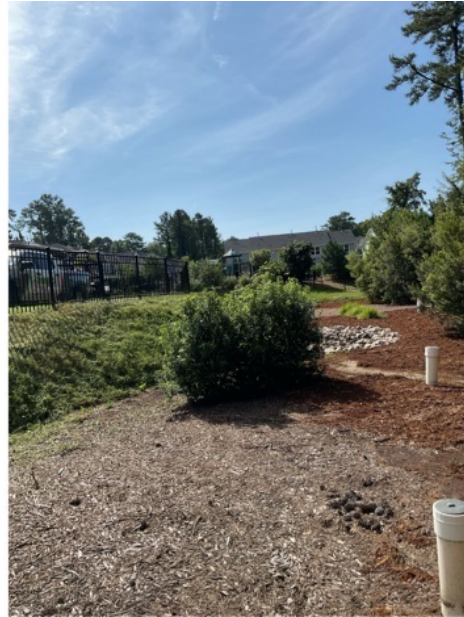
**Photo 14:**

BMP3 overview

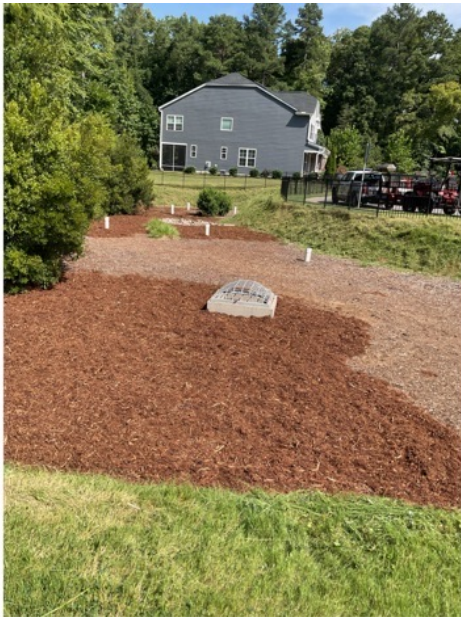
**Photo 15:**

BMP3 overview

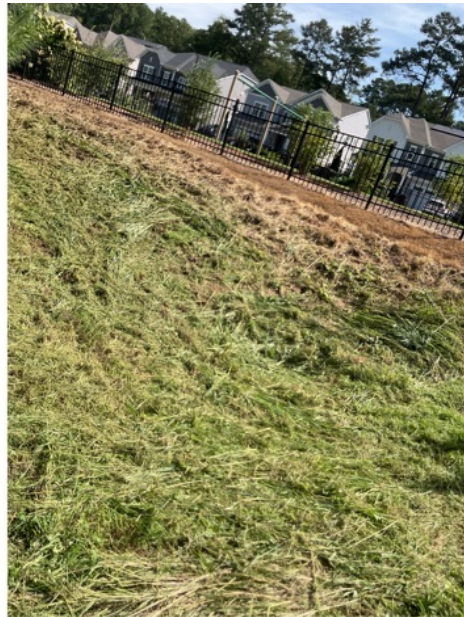
**Photo 16:**

BMP3 back of dam

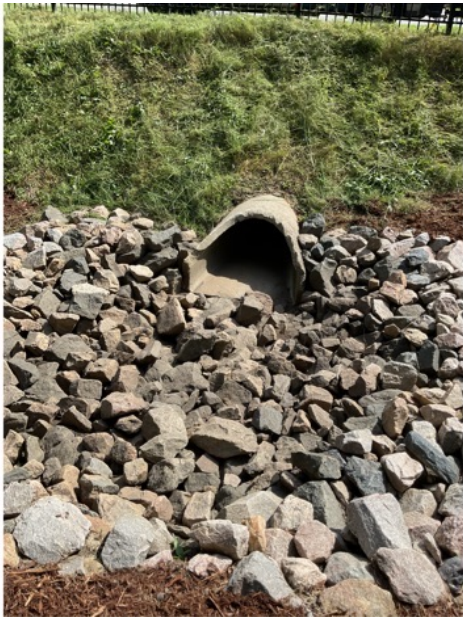
**Photo 17:**

BMP3 inlet

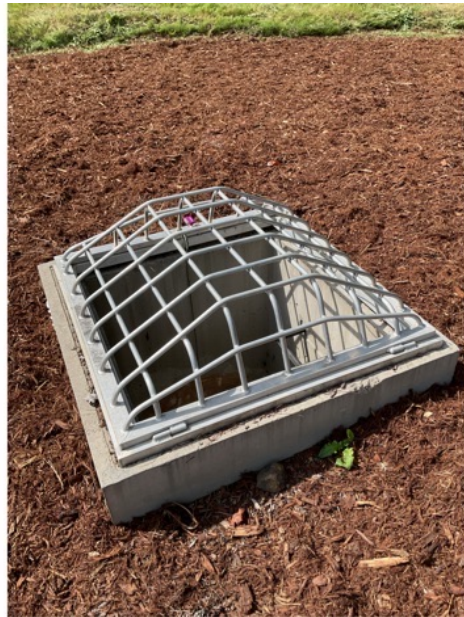
**Photo 18:**

BMP3 riser

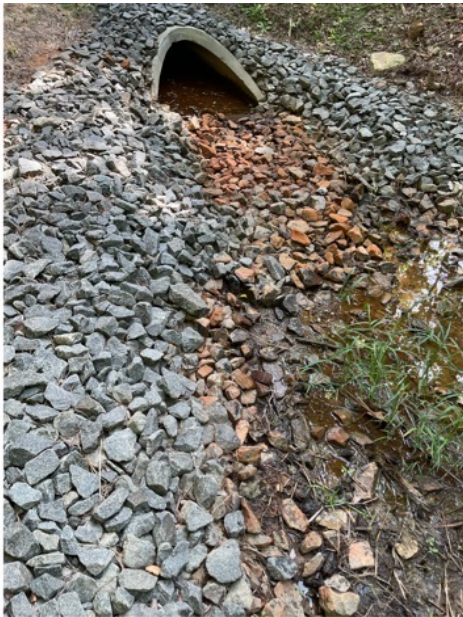
**Photo 19:**

BMP3 outlet
