Triangle Pond Management
 405 S Rogers Ln
 Raleigh, NC 27610
 (919)398-3221
 Office@TrianglePondManagement.com
 www.TrianglePondManagement.com
Maintenance Service Report

| Chandler Woods MOA | | 2/21/2024 | |
| BMP 1, BMP 2, BMP 3 | | | |

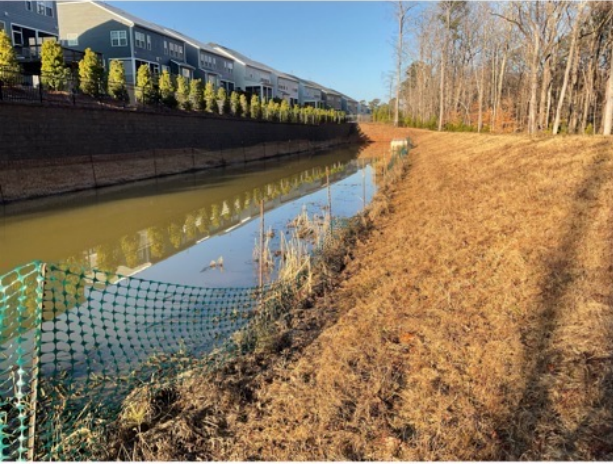
| Photo 9: | Photo 10: |

| Additional Notes: |
|--|
| <p>The devices were walked and all trash and debris was removed.</p> <p>Riprap was clear of leaves.</p> <p>Water level was appropriate.</p> <p>No woody vegetation was seen.</p> <p>Inlets were cleared of sediment.</p> <p>Goose fence needs to be repaired at bmp 1 and 2, there are some parts that are down.</p> <p>Recommend re-mulching bmp 3, a lot has washed out and a build up of sediment is in front of the inlet recommend removal.</p> <p>Please contact our office with any additional questions, concerns, or to schedule repairs.</p> |

| Photo 9: | Photo 10: |
|---|--|
| BMP 2 fencing down | BMP 2 fencing down |

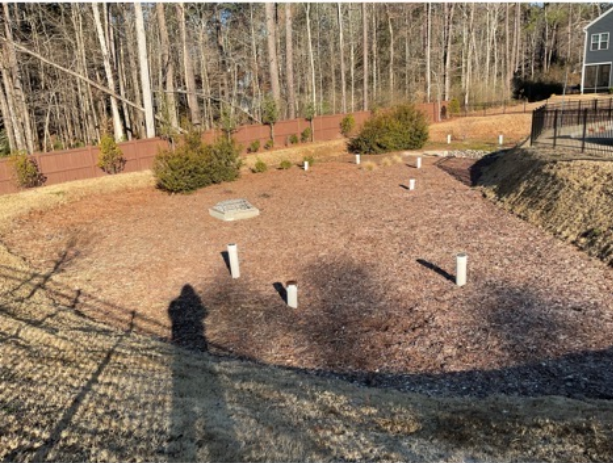
| Photo 9: | Photo 10: |
|---|--|
| Photo 11: | Photo 12: |

| Photo 9: | Photo 10: |
|---|--|
| BMP 3 overview | BMP 3 riser |

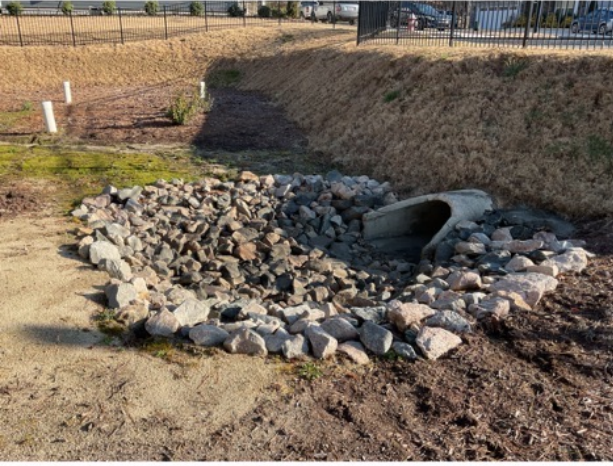
| Photo 13: | Photo 14: |

| Photo 13: | Photo 14: |
|---|--|
| BMP 3 inlet | BMP 3 sediment build up in front of inlet |

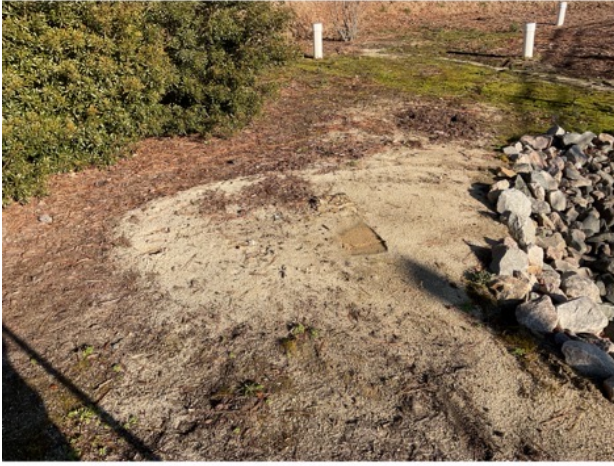
| Repairs? | Comment: |
|---|---|
| Are repairs required? Yes | Sediment, mulch |

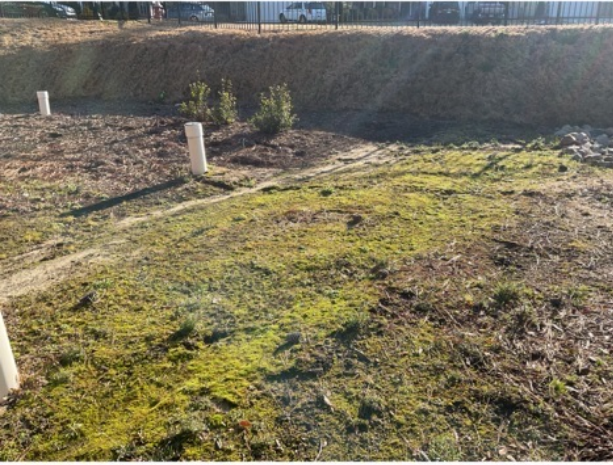
| Photo 13: | Photo 14: |
|---|--|
| Photo 15: | Photo 16: |

| General Inspection: | | Comment: |
|---|---|---|
| Was any erosion observed during the visit? | Yes | Wash out |

| Photo 13: | Photo 14: |
|---|--|
| BMP 3 mulch wash out | |
