**Triangle Pond Management**  
 405 S Rogers Ln  
 Raleigh, NC 27610  
 (919)398-3221  
 Office@TrianglePondManagement.com  
 www.TrianglePondManagement.com  
**Maintenance Service Report**

<b>Customer Name:</b>		<b>Date:</b>	
Chandler Woods MOA		12/19/2022	
<b>Address:</b>			
214 Abbot Pl			
<b>Aquatic Technician:</b>			
Justin Tripp			
<b>Time of Arrival:</b>	<b>Time of Departure:</b>	<b>Drive Time:</b>	
11:24 AM	1:00 PM	22 min	
<b>Type of Device(s) Maintained:</b>			
BMP 1, BMP 2, BMP 3

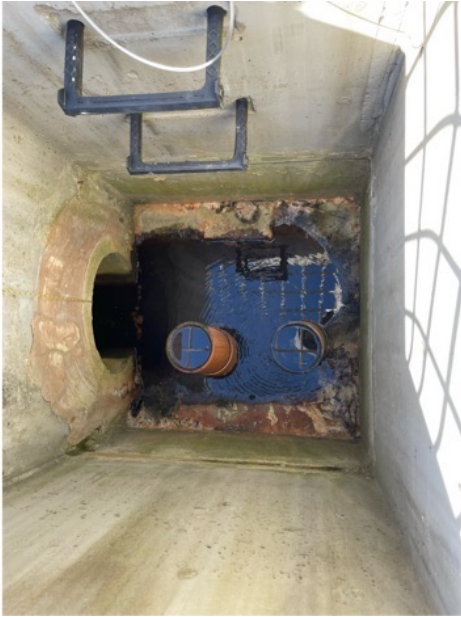
**Photo 5:**

Additional Notes:
<p>The devices were walked and all trash was removed.</p> <p>Filamentous algae was controlled.</p> <p>Observed bare areas at BMP3.</p> <p>Observed leaks within the risers of BMP1 and BMP2. Recommend repairing.</p> <p>Please contact our office with any additional questions or concerns.</p>

BMP3 inside riser

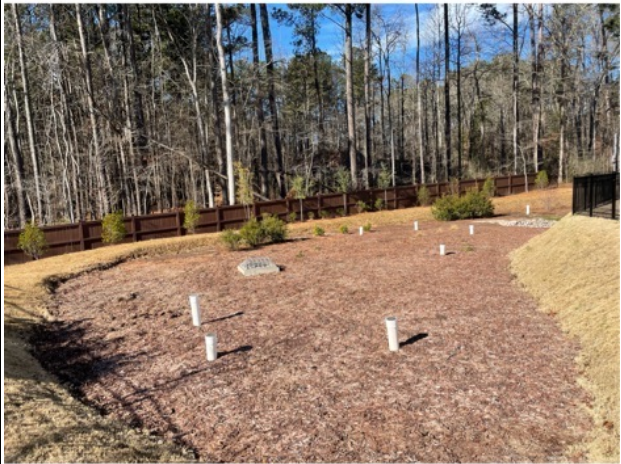
**Photo 6:**

BMP3

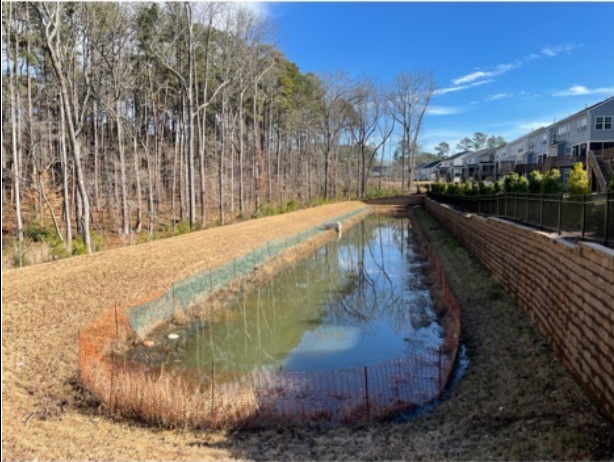
**Photo 7:**

BMP2

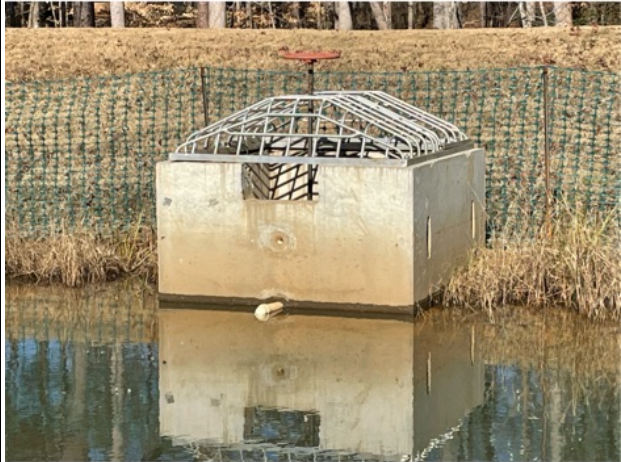
**Photo 8:**

BMP2 riser
