**Triangle Pond Management**  
 405 S Rogers Ln  
 Raleigh, NC 27610  
 (919)398-3221  
 Office@TrianglePondManagement.com  
 www.TrianglePondManagement.com  
**Maintenance Service Report**

| Chandler Woods MOA | | 10/24/2025 | |
| BMP 1, BMP 2, BMP 3 | | | |

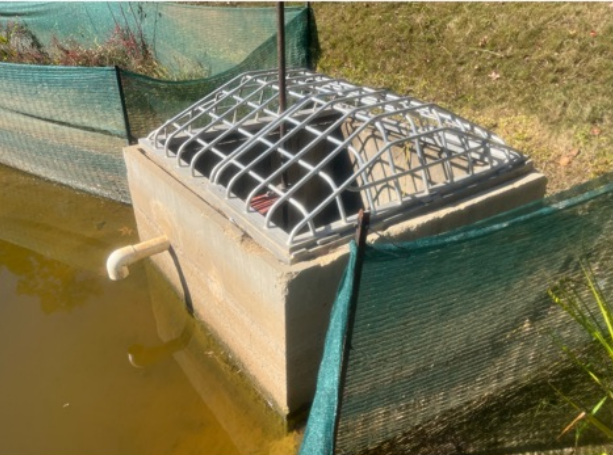
| Photo 1: | Photo 2: |
|---|---|
| Photo 3: | Photo 4: |

| General Inspection: | Comment: |
|---|---|
| Was the water at the proper elevation? | No      Low due to drought |

| Photo 1: | Photo 2: |
|---|---|
| BMP1 riser<br>note: low water level | BMP1 riser interior |

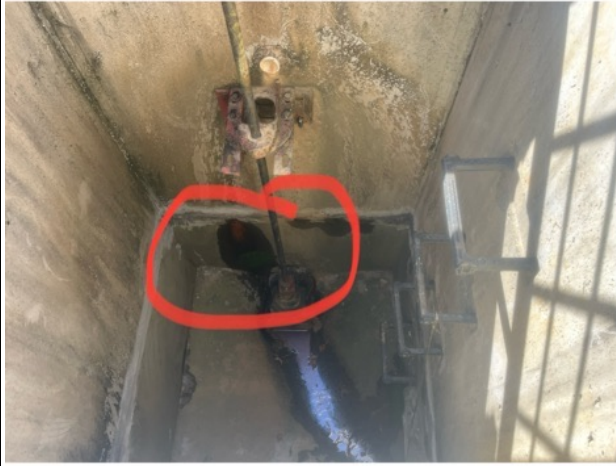
| Photo 13: | Photo 14: |
|---|---|
| BMP2 riser | BMP2 riser interior<br>note: leak/seepage near bottom of riser |
