**Triangle Pond Management**  
 405 S Rogers Ln  
 Raleigh, NC 27610  
 (919)398-3221  
 Office@TrianglePondManagement.com  
 www.TrianglePondManagement.com  
**Maintenance Service Report**

<b>Customer Name:</b>		<b>Date:</b>	
Chandler Woods MOA		6/16/2025	
<b>Address:</b>			
214 Abbot Pl			
<b>Aquatic Technician:</b>			
Andrew Doyle			
<b>Time of Arrival:</b>	<b>Time of Departure:</b>	<b>Drive Time:</b>	
9:53 AM	1:14 PM	5 min	
<b>Type of Device(s) Maintained:</b>			
BMP 1, BMP 2, BMP 3

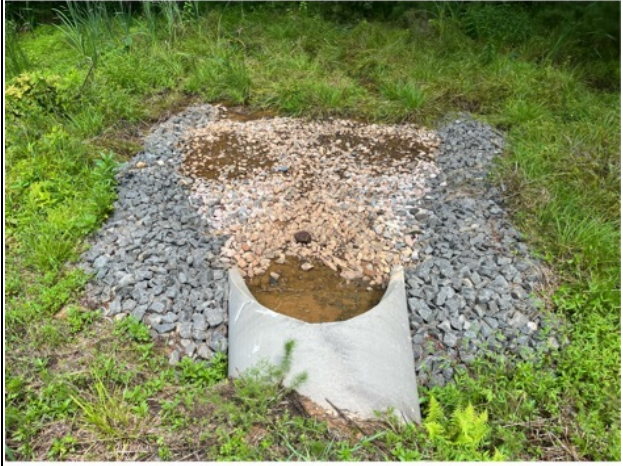
Photo 13:	Photo 14:

BMP2 outlet	BMP3 overview
Photo 15:	Photo 16:

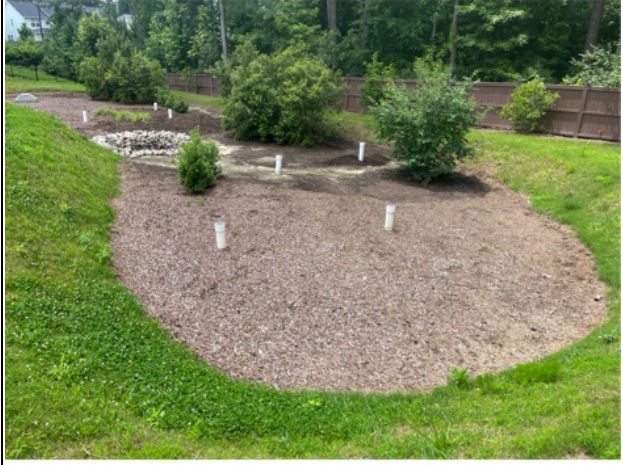
BMP3 overview	BMP3 riser interior

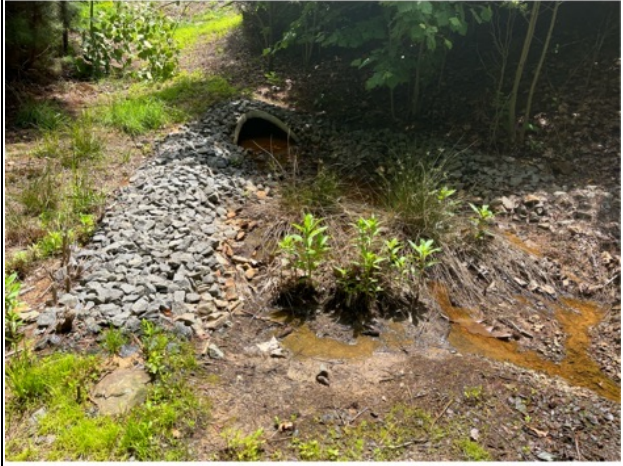
BMP3 outlet	BMP3 outlet
Photo 23:	Photo 24:
