**Subject: Society Turn Parcel**

**RE: Geohazard Report**

**GEOLOGIC HAZARDS ASSESSMENT**

**February 4, 2020**

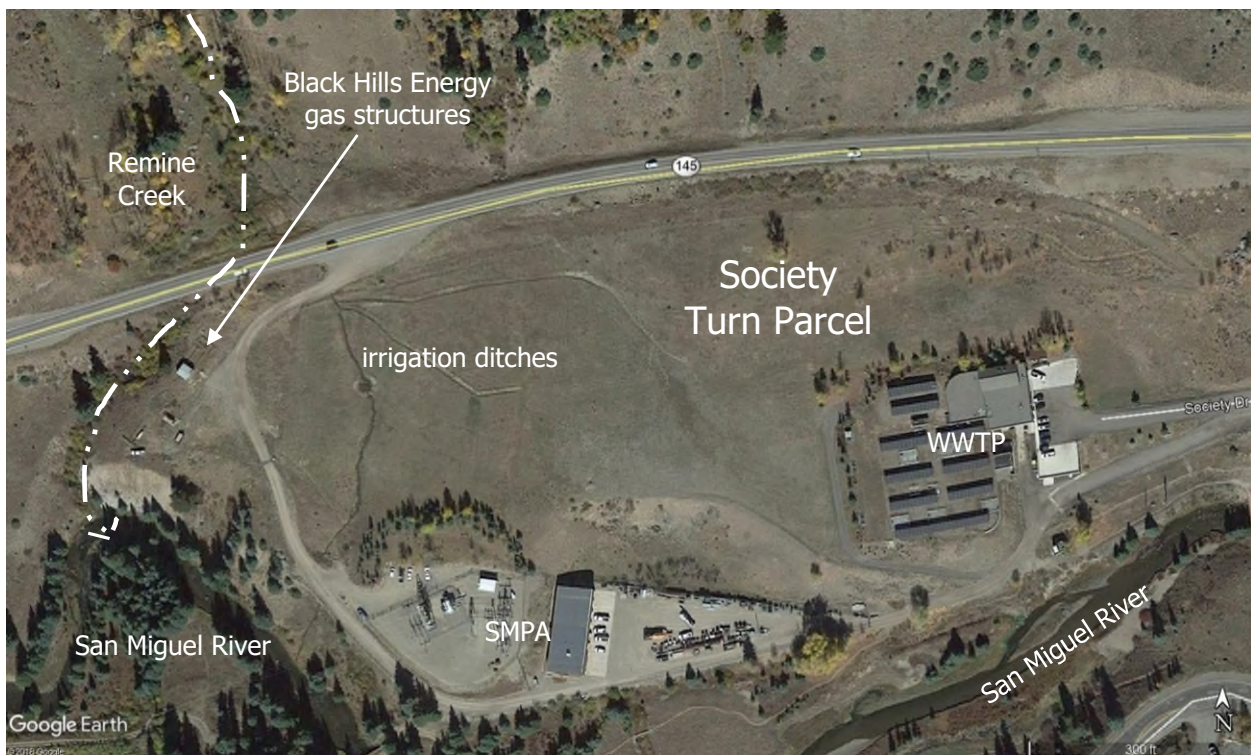
**Photo 1. Aerial image of western portion of Society Turn Parcel.** Note the location of the San Miguel River along the southern margin, the Remine Creek channel along the western portion of the Society Turn Parcel, and the three irrigation ditches in the western portion of the open field (Google Earth image, 10/12/15).

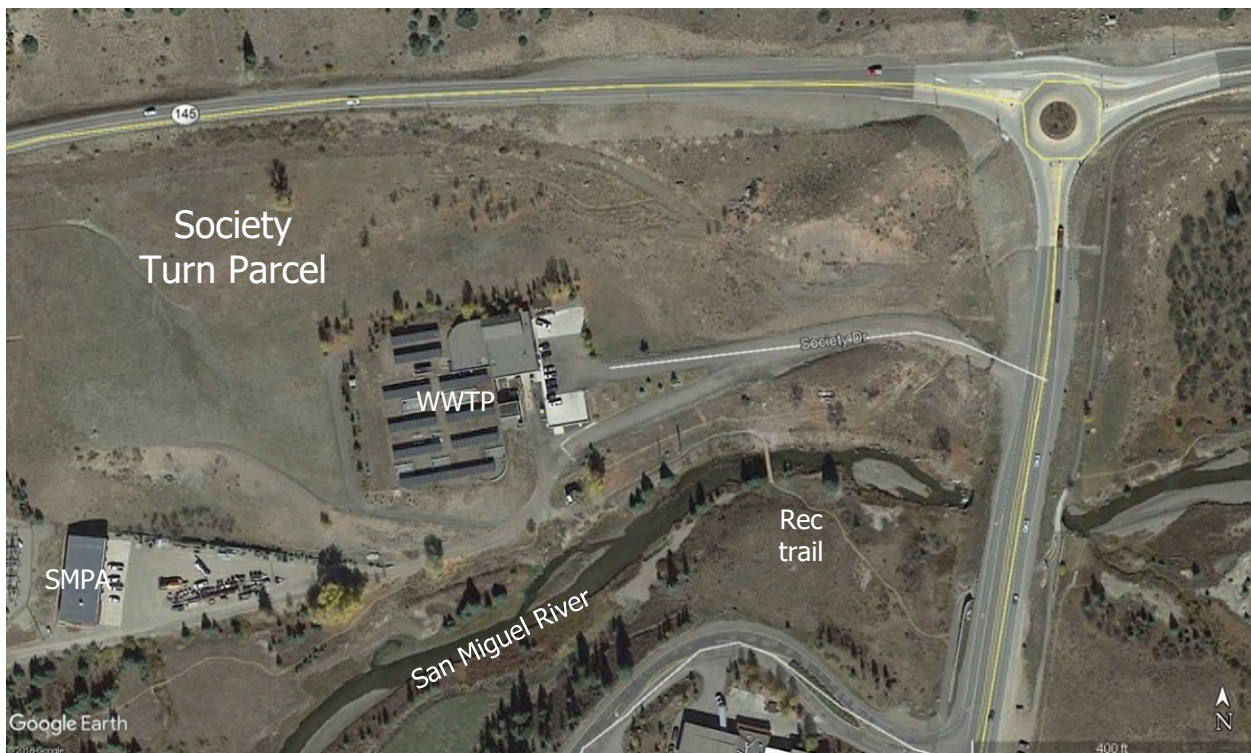
**Photo 2. Aerial image of eastern portion of Society Turn Parcel.** Note the location of the San Miguel River, nearby facilities, Highway 145 on the north and east, and part of a recreational trail and bridge. (This Google Earth image is from 10/12/15).

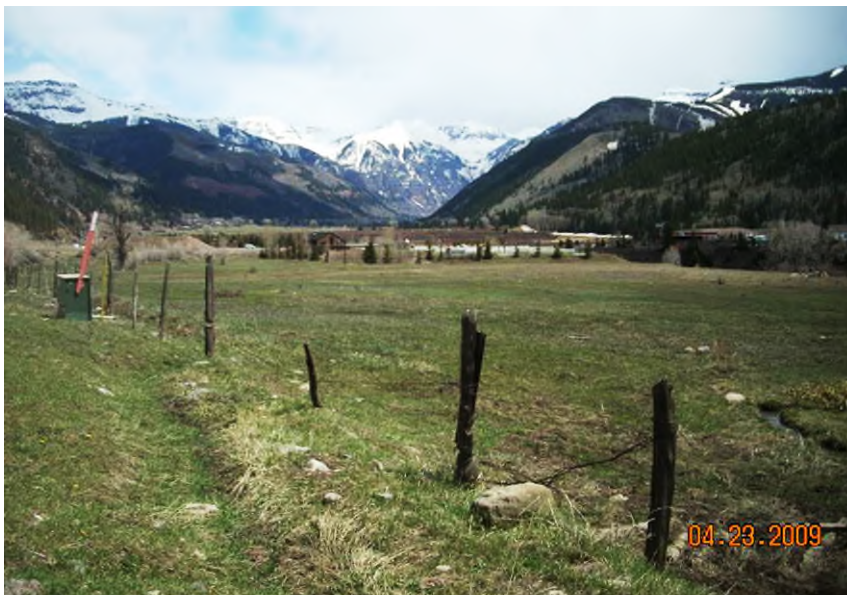
**Photo 3.** Looking east across the Remine Creek fan towards Telluride from near the northwest corner of the Society Turn Parcel shows the vegetative cover and the gentle slope of the alluvial fan. Highway 145 is to the left of the image.

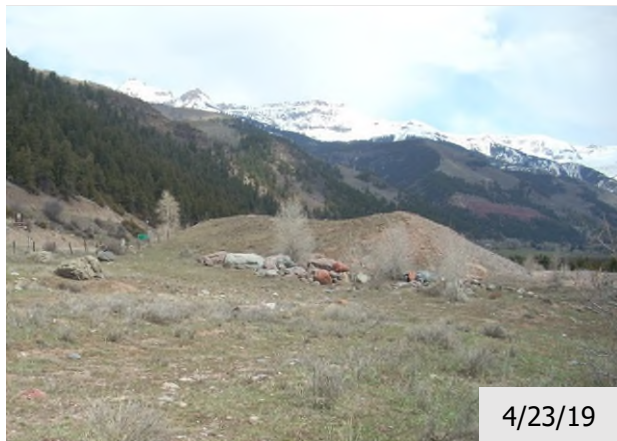
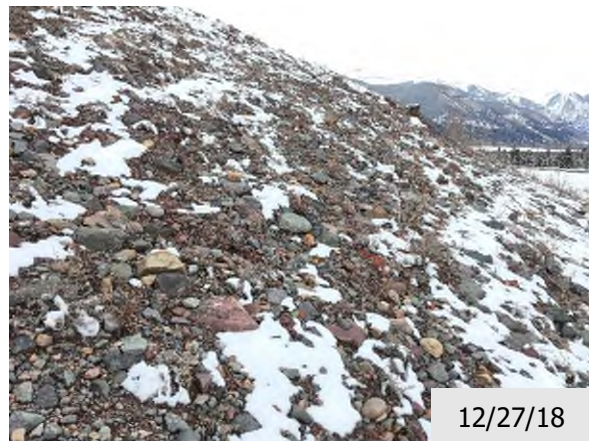
**Photo 4 (left)** is a view east towards the glacial moraine in the northeast corner of the Society Turn Parcel. Note the large boulders at the base, which were likely reworked to this area by man, are also likely remnants of the moraine located on this Society Turn Parcel. **Photo 5 (right)** is a close-up of the sandy gravel and cobbles composing the moraine. This glacio-fluvial deposit contains river alluvium that was incorporated into the moraine as the glacial scoured the river channel.

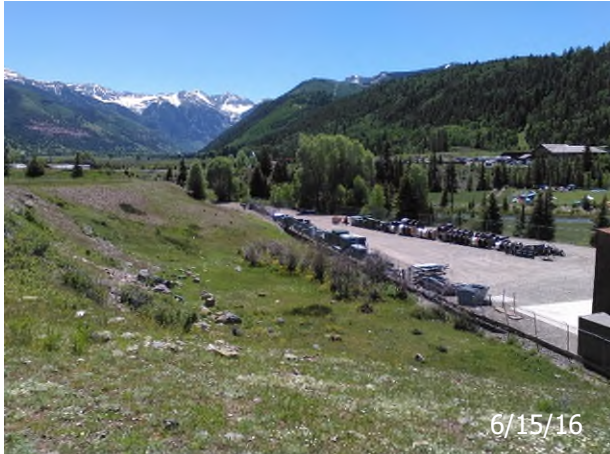
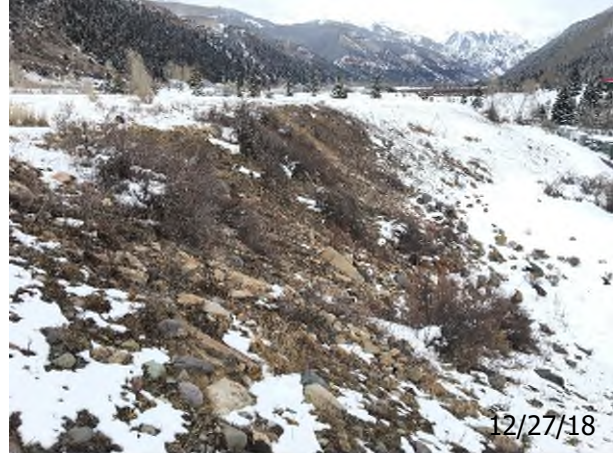
The Slope Classes Map (Map 6, based on aerial topographic survey) was generated for the Society Turn Parcel and the slopes over 30% clearly show up on this map as darker browns. The steep areas are associated with the San Miguel River, Remine Creek, and the morainal hill in the northeast corner. Additionally, a 30% slope boundary is shown as a jagged blue line on our geologic hazard maps (Maps 8 and 9). As seen on Map 6, the majority of the Society Turn Parcel contains slopes of less than 10%. Generally, the areas with slopes over 30% were mapped as PUS slopes (previously discussed) due to the unconsolidated nature of the alluvial

**Photo 6 (left)** is a view east at the steeper slopes within the WWTP Expansion area and the southern edge of Planning Area 2. This curved area is a former cutbank of the San Miguel River when the river was at a higher elevation. **Photo 7 (right)** is a close-up of the soil materials in this relic cutbank. Note the many rounded to subrounded cobbles and boulders in this sandy gravel deposit with low cohesion.

and glacial deposits and steep to very steep slopes. Some areas with slopes over 30% are included in the general areas to be developed (see Map 9). We recommend slope stability analysis be conducted on the slopes that will be developed. Results of these analyses can identify the need for and provide alternative mitigation measures necessary for stabilizing the slopes. The following photographs (Photos 6 and 7) show an area with slopes >30% and which were also mapped as PUS slopes. This site is the abandoned cutbank of the San Miguel River north of the SMPA facility.

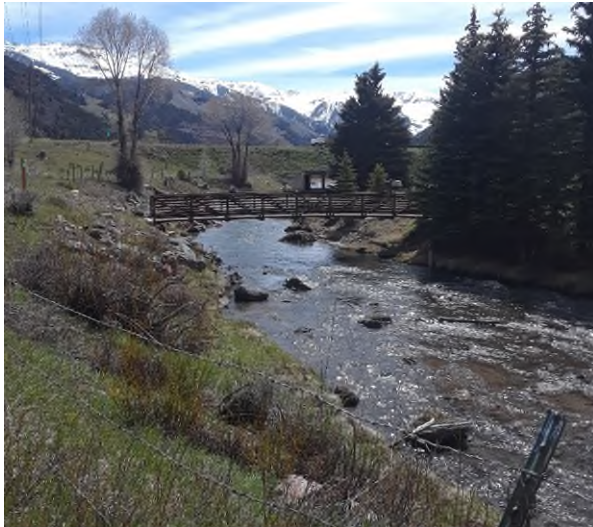
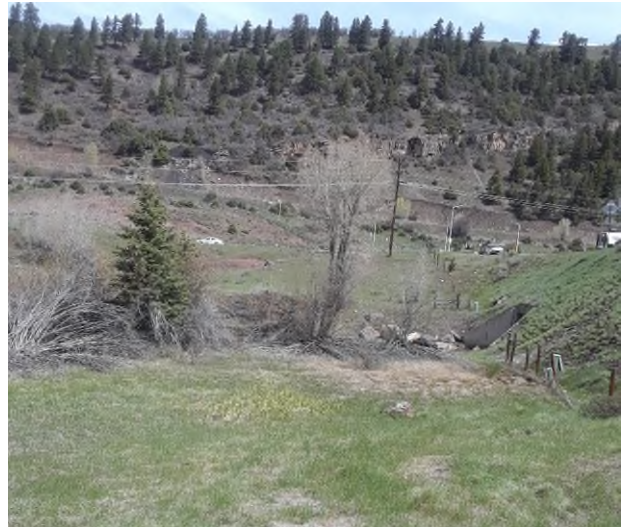
**Photo 8 (left)** is a view of the San Miguel River and associated wetlands looking east towards the pedestrian bridge and Highway 145. **Photo 9 (right)** is looking north at the wetlands near the southeast corner of the Society Turn Parcel.

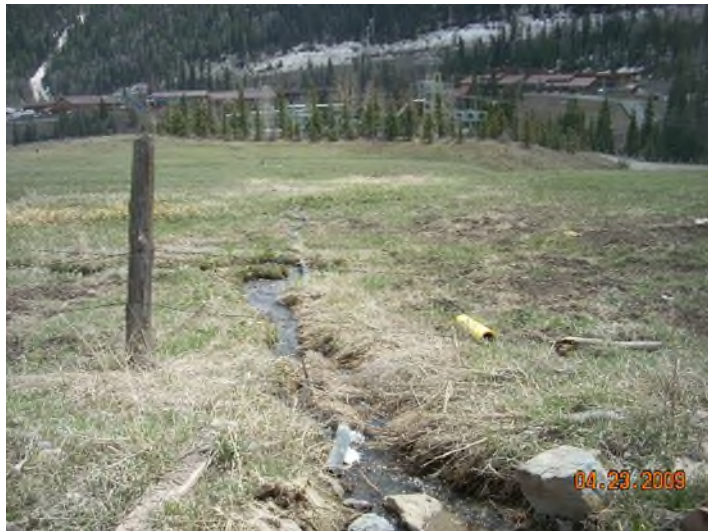
**Photo 10.** This is a view to the south at the irrigation ditch shown on Map 2 that enters PA1. The source of this water is from Remine Creek that is conveyed through a culvert under Highway 145, which is behind the photographer. There are no wetlands associated with this man-made irrigation ditch.

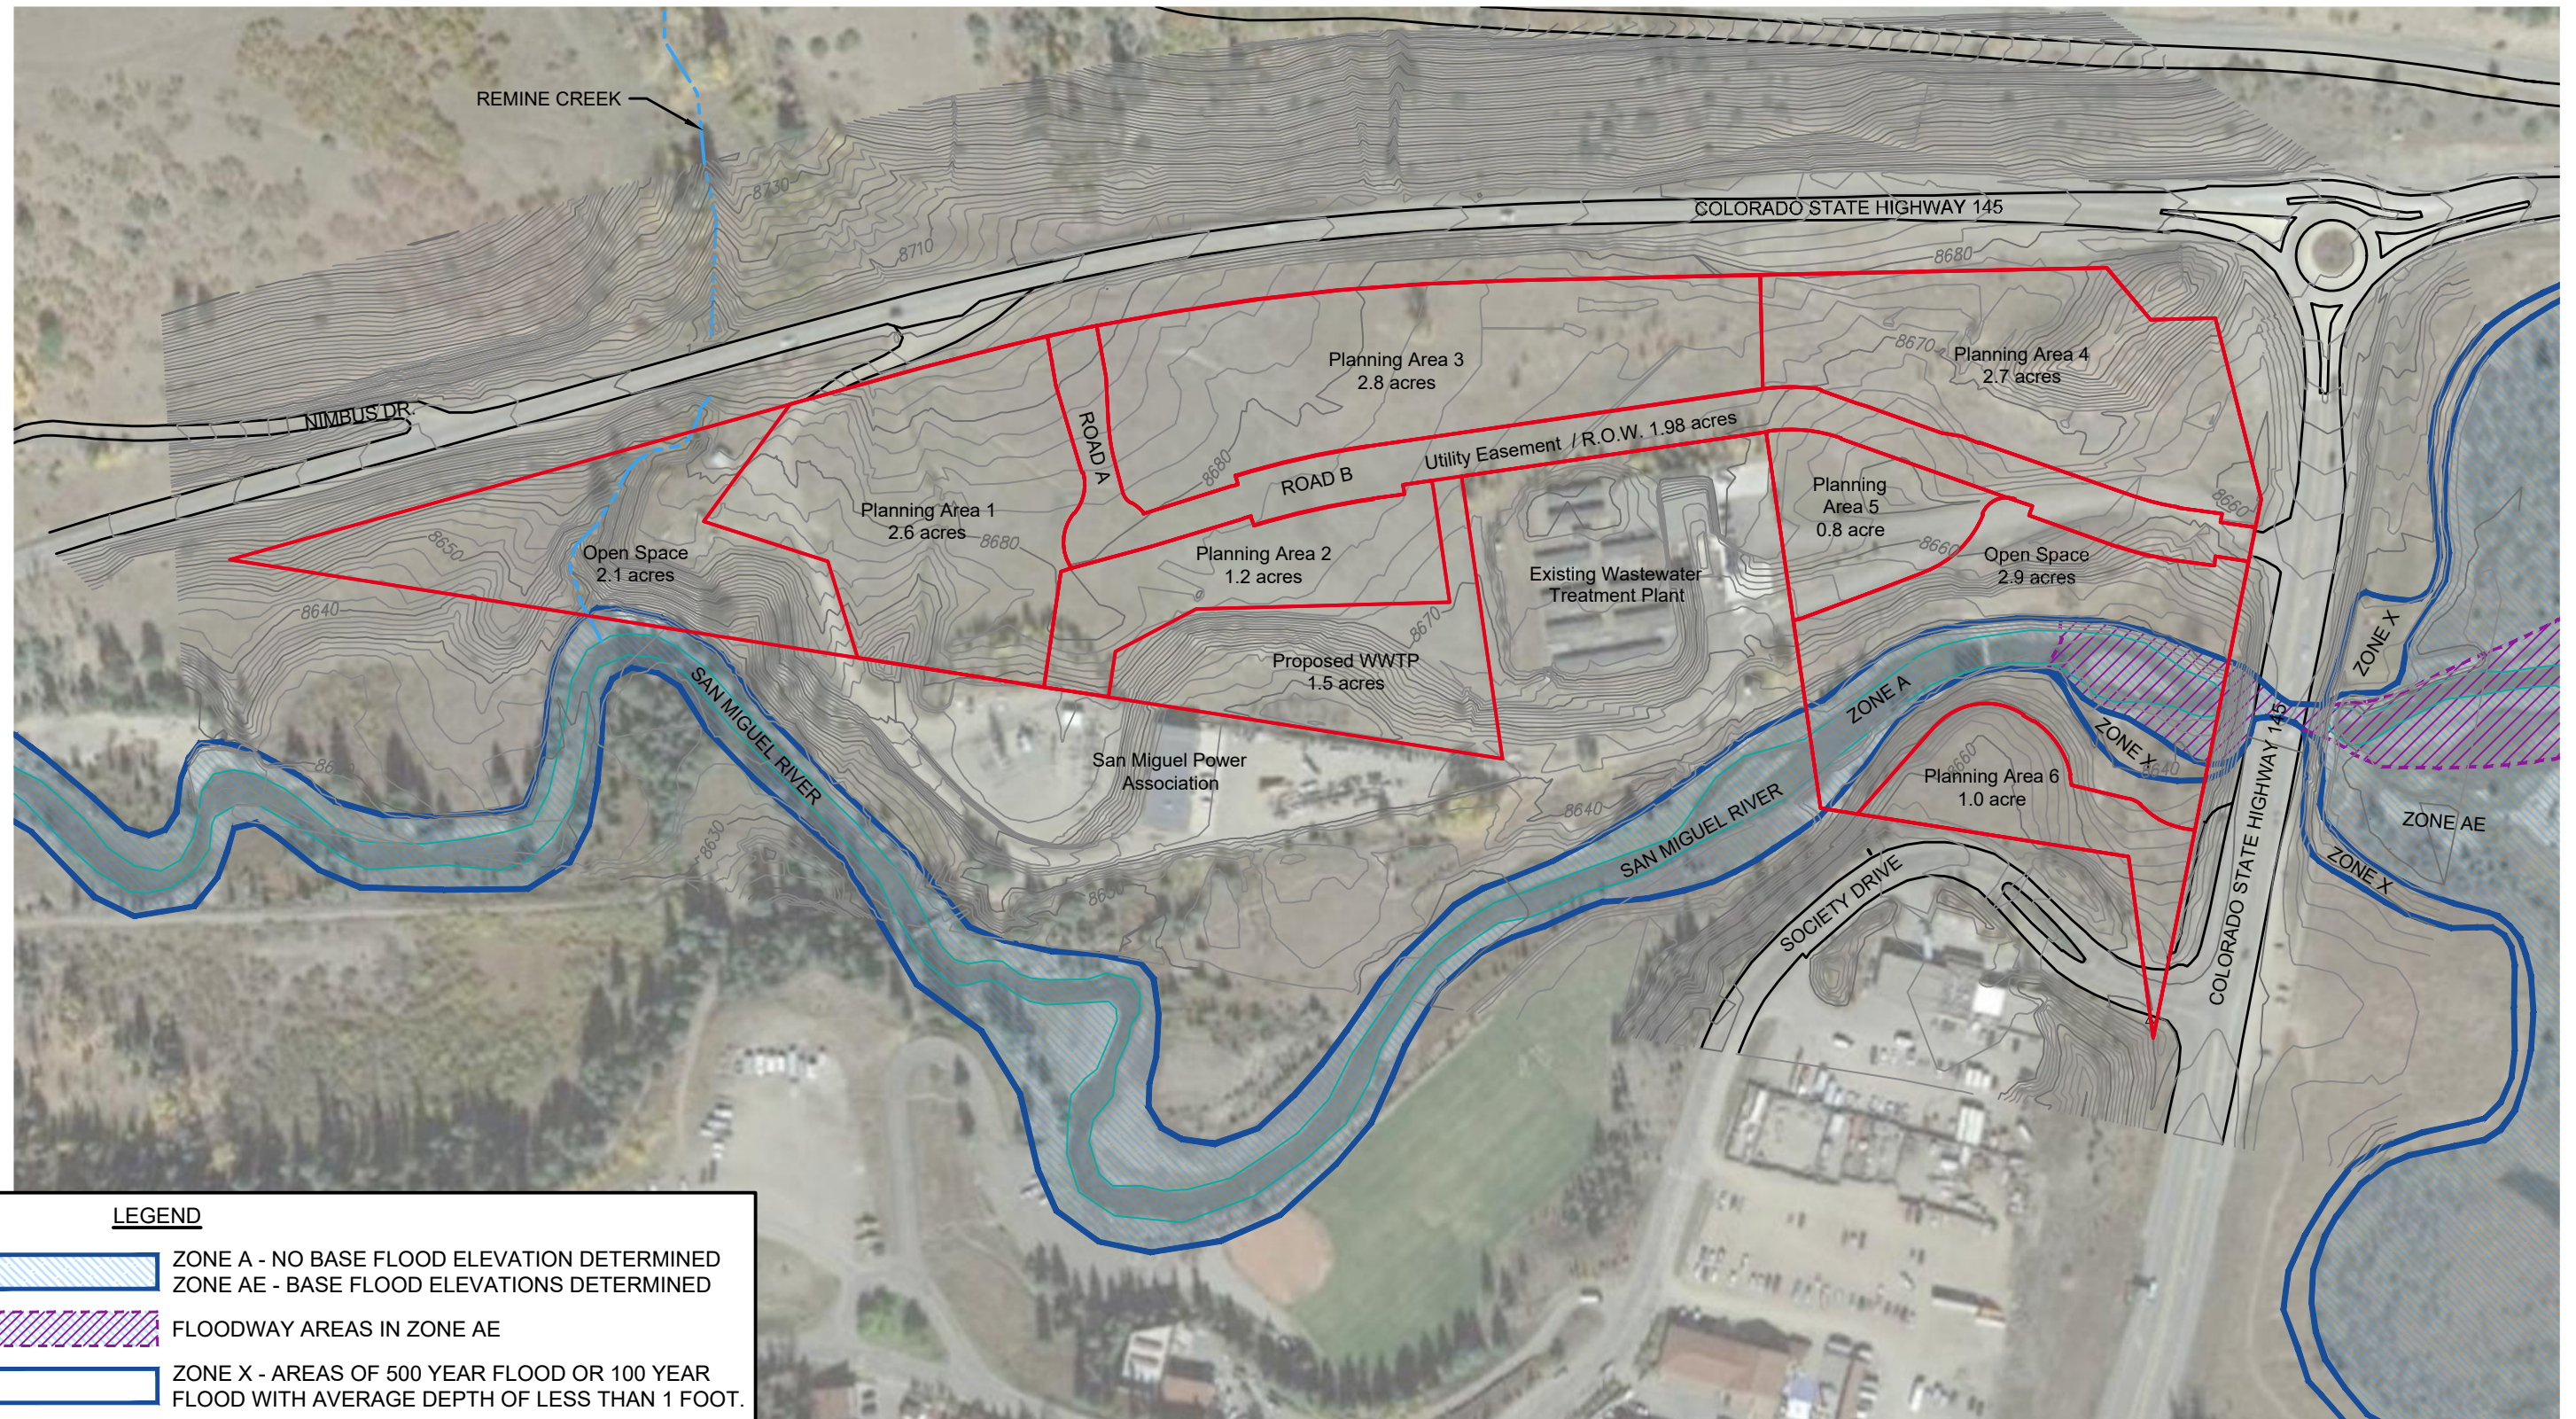
**MAP 7**

No flood elevations have been determined by FEMA for Remine Creek. Since the area where the creek crosses the Society Turn Parcel will be reserved for open space, no development would be impacted by flooding that occurs within the channel. Both StreamStats© and USDA TR-55 models were run for Remine Creek as part of our geologic hazard assessment. Based on these models, flows of 263 and 316 cfs were determined for 50 and 100-year events. Based on calculations of the two 48-inch corrugated metal pipe (CMP) culverts that cross Airport Road and Remine Creek using Manning's equation, both culverts pass the estimated 100-year event flow of 316 cfs without overtopping. It is our understanding that the Colorado Department of Transportation (CDOT) will review the Remine Creek culvert capacity in their 2020 regional drainage audit and confirm its ability to pass the 100-year flow.

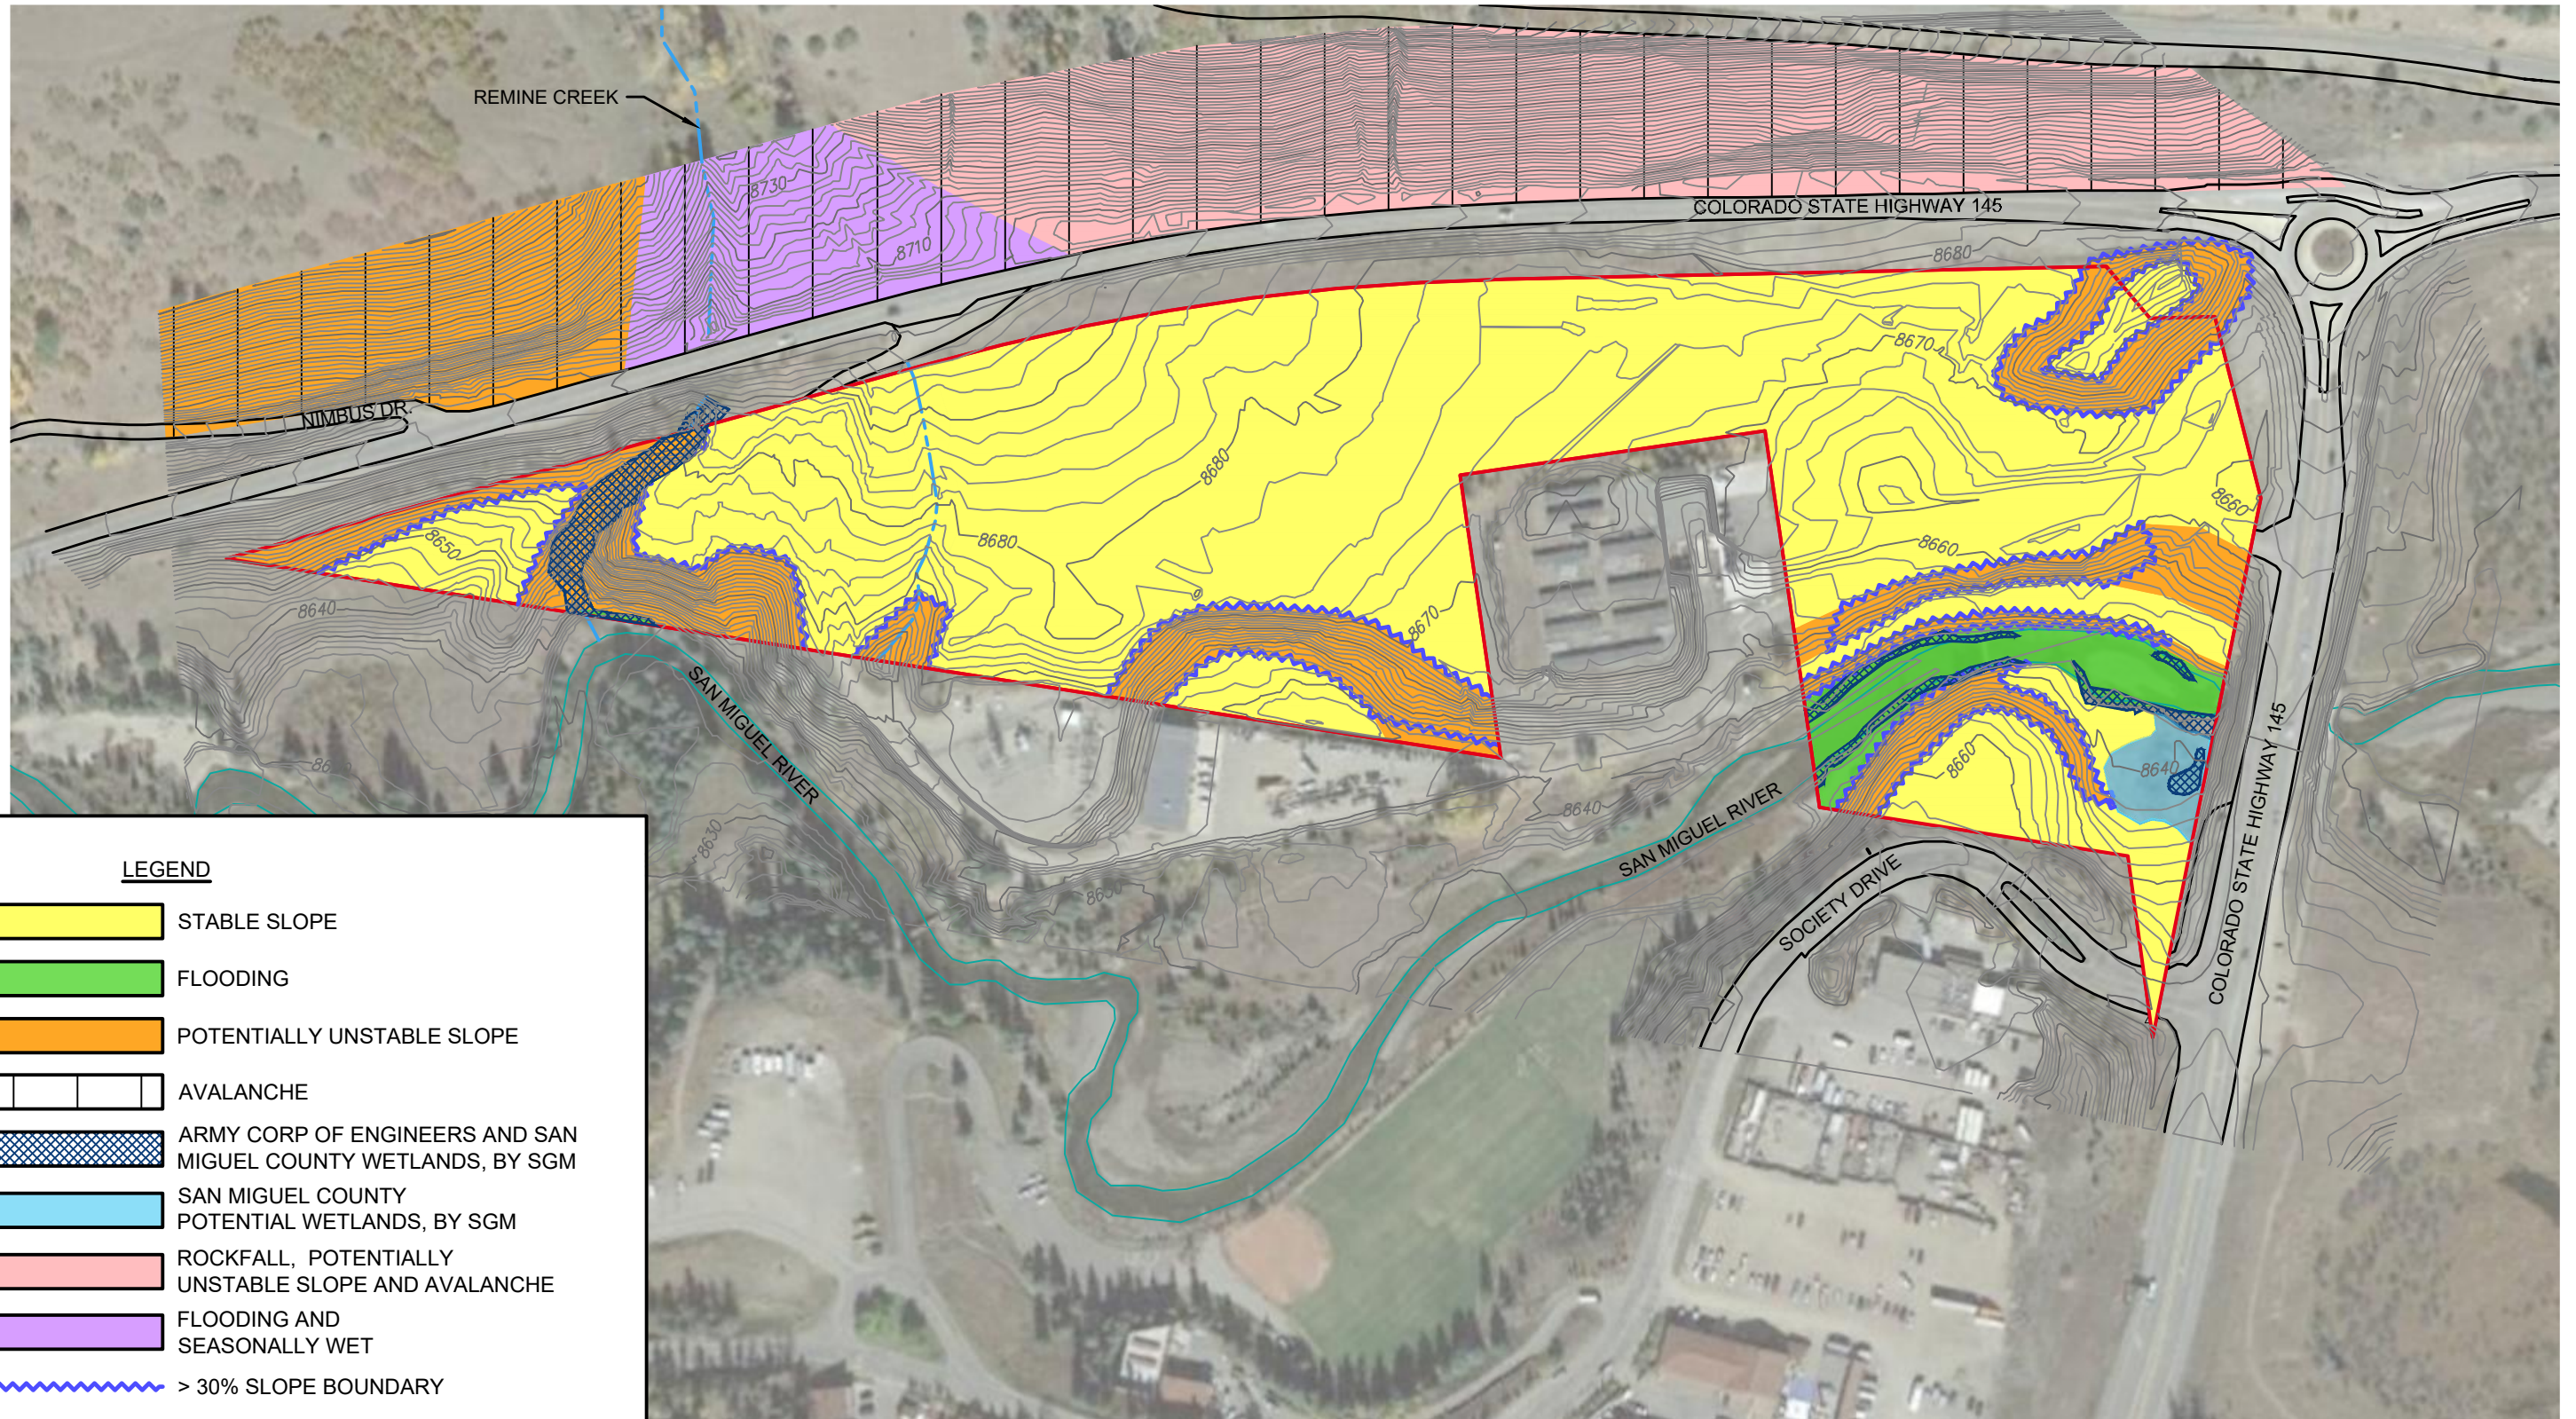
MAP 8

Most of the property is mapped as “Stable Slopes” (Maps 8 and 9) and the four primary hazards identified on the Society Turn Parcel are flooding (Map 7), wetlands (Map 8), potentially unstable slopes (PUS) and slopes >30% (Map 6). It is important to note that the presence of these hazards is for existing conditions, not permanent developed conditions. It is the intent of the development plan to address each of these hazards and reduce or eliminate them through avoidance, geotechnical methods, or site modifications and improvements.

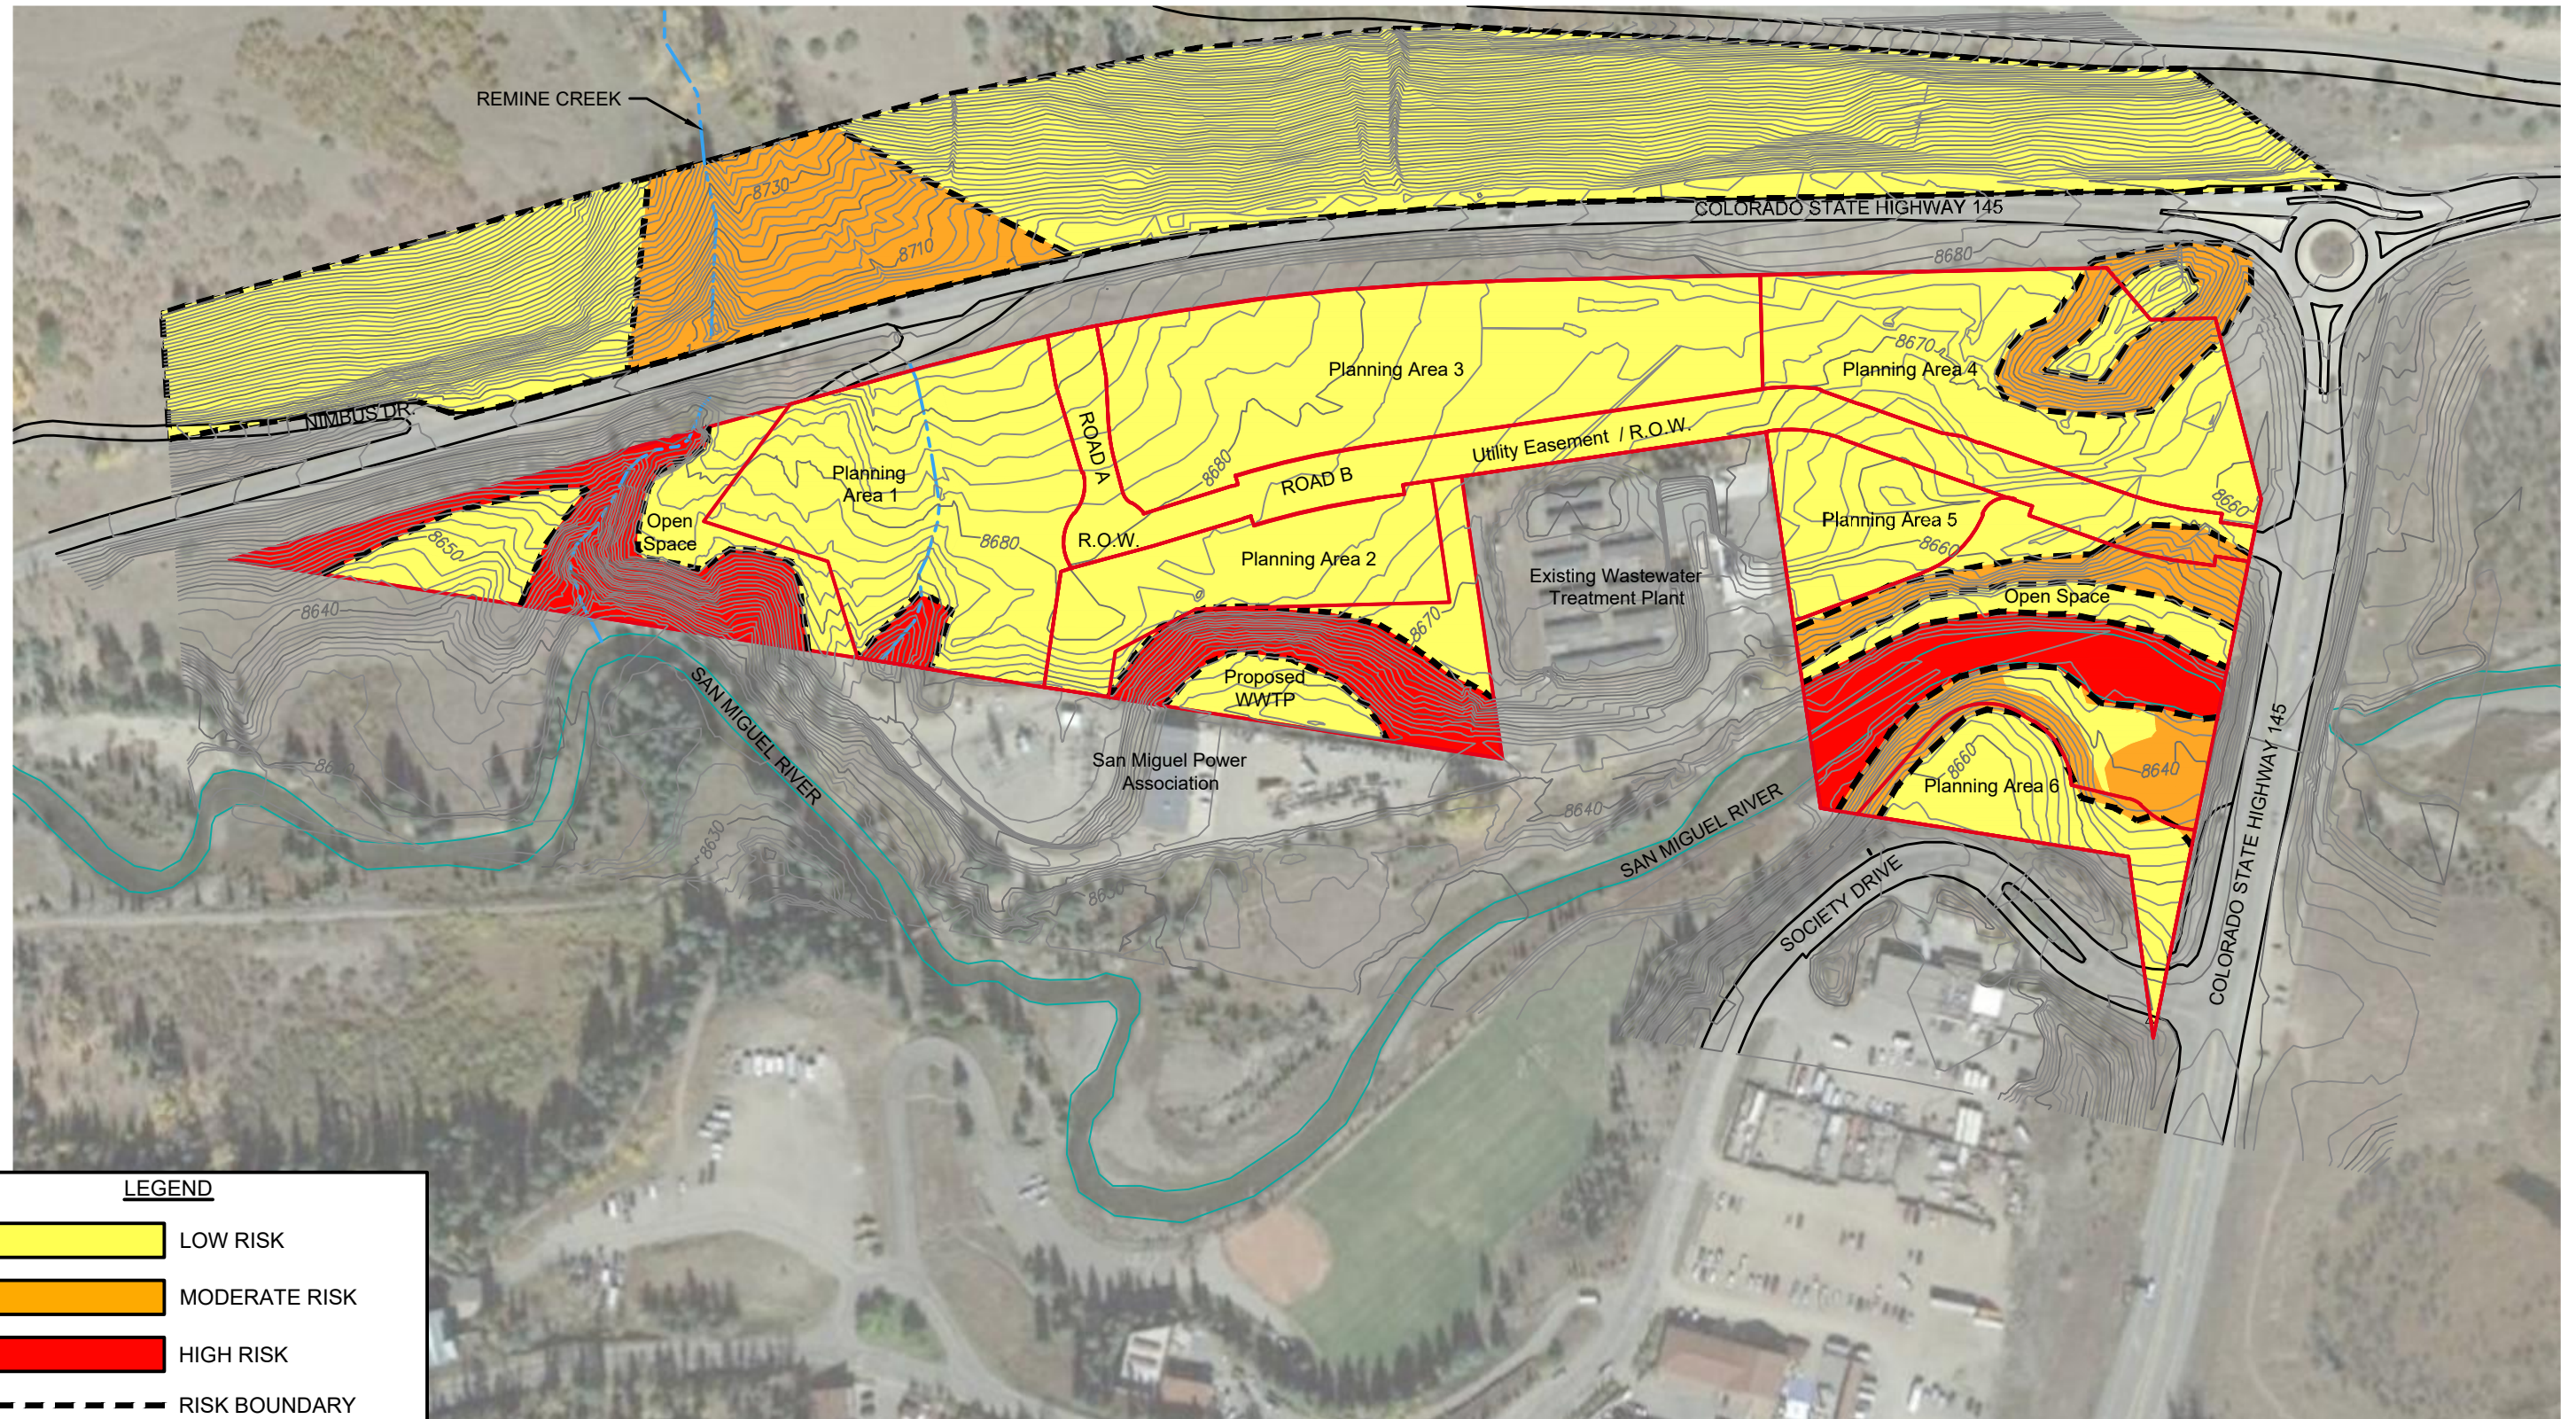
MAP 10

These areas of low risk (shown in yellow on Map 10), are generally the most suitable for development because there is low risk from geologic hazards that could limit building site or roadway construction. However, site-specific geotechnical testing would be necessary to determine soil, bedrock or groundwater conditions that may impact foundation design. The majority of the Society Turn Parcel has low risk relating to sheetflow flooding over the lower reach of the Remine Creek alluvial fan (shown in yellow on Map 10). An analysis of Remine Creek flood potential determined that flood events are accommodated by the culvert under Highway 145 and within the natural "detention basin" created by the road embankment. Sheetflow flooding of water and mud can be accommodated by elevating the ground floor elevations of all structures on the north side of the river. Site-specific geotechnical investigations should be performed for all proposed development to determine if any areas of shallow groundwater exist and mitigation methods and design recommendations can be made at that time specific to the intended construction.

Moderate risk areas (shown in orange on Map 10) have one or more geologic hazards, but with the use of common mitigation measures the risk generally can be reduced to "low" and are suitable for development. Careful building and roadway placement and site-specific evaluations to determine the potential hazard impacts and mitigation options will be necessary. There are small areas with moderate risk, which are associated with Remine Creek and the San Miguel River (flooding and shallow groundwater) and PUS slopes. These areas will need further evaluation and/or mitigation appropriate for the level of site disturbance and proposed uses. The primary concerns are preservation of slope stability, dewatering or waterproofing, and designing to accommodate hydraulic pressures.

High risk areas (shown in red on Map 10), have one or more geologic hazards that severely limits development. Generally, an area designated with "high" risk should be avoided. However,

Areas of high risk due to flooding along the San Miguel River have been avoided in the development plan. However, there is some high risk due to PUS slopes associated with the steep banks of unconsolidated alluvial material along the San Miguel River, Remine Creek, and the relic cut bank scarp on the south side of PA2. These areas will need slope stability analyses tailored to intended uses and degree of site disturbance. Mitigation, if necessary, may include one or more of the following: shoring methods (reinforced slopes, soil nails, retaining walls, etc.), deep foundation systems, setbacks to avoid disturbing the edge of slope, and drainage improvements. Controlling drainage in areas of high risk also is important for maintaining slope stability on these steep slopes.
