Subject: Society Turn Parcel

RE: Geotechnical Investigation Report

FEASIBILITY GEOTECHNICAL REPORT

August 21, 2020

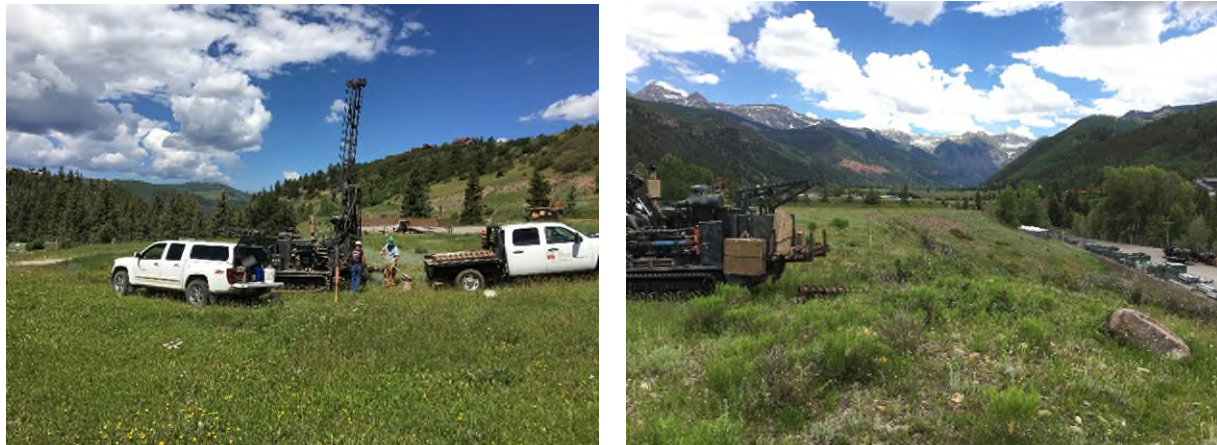
Photo 1 (left) view west at Borehole #2 (BH#2) and Photo 2 (right) view east at BH#3, show the vegetative cover, the local topography, and the conditions at the time of our drilling.

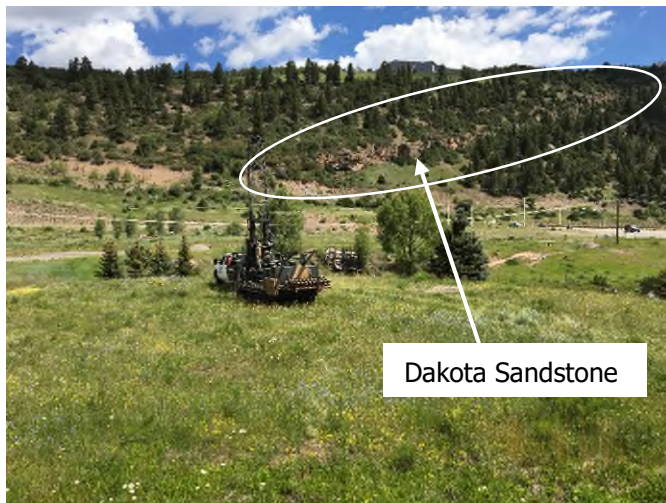
Photo 3. View north as BH#10 was being drilled, shows the dipping outcrop of Dakota Sandstone on the north side of the valley adjacent to the Parcel. Due to deep valley fill, no bedrock was found during our drilling and none is anticipated at any reasonable depth underlying the Parcel.

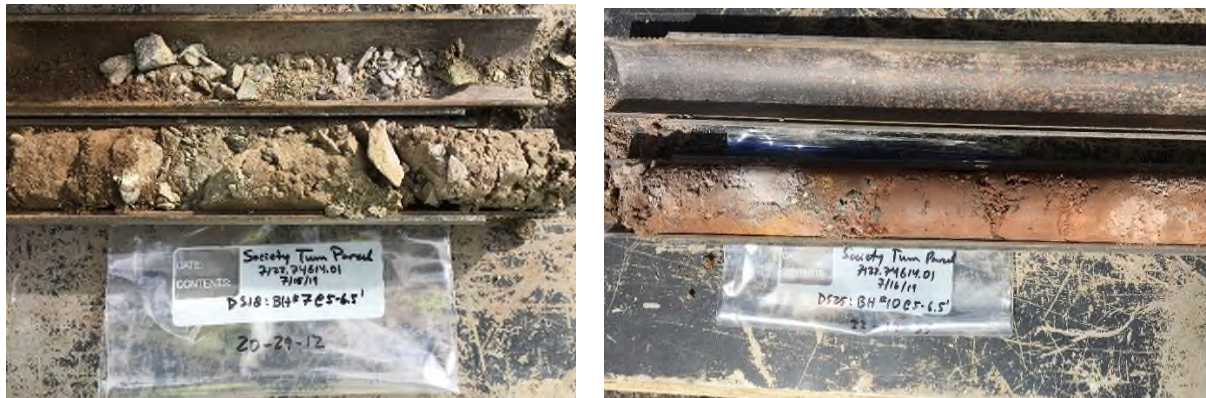
Photo 4 (left) shows the native soils from BH#7 at 5-6.5 feet and Photo 5 (right) shows the soil from BH#10 at 5-6.5 feet. Soils range from light brown to red-brown and are generally silty/clayey sand and gravel.

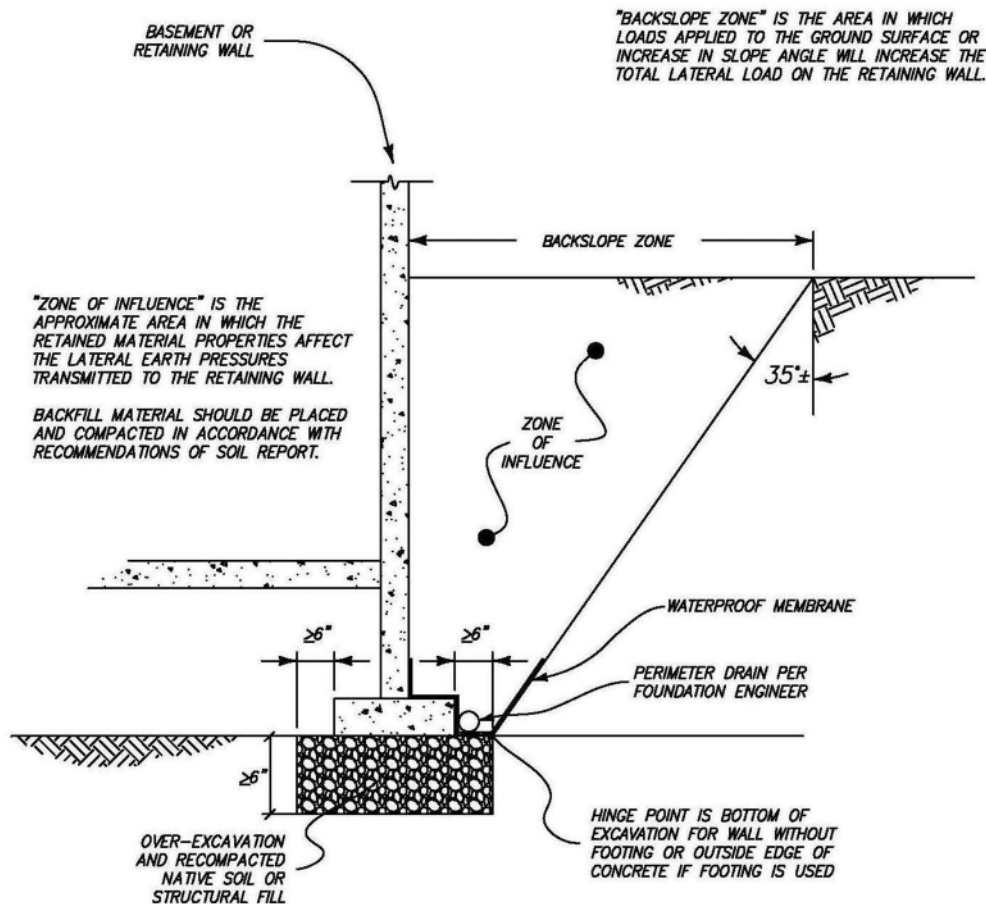
Figure 1. Foundation Excavation Sketch

- Please note that the Foundation Excavation Sketch (Figure 1) is schematic only, is not to scale and site-specific details are to be provided by the foundation design engineer.

- Excavations for retaining and foundation walls should be laid back a minimum of 35° from the vertical prior to backfilling against retaining structures (Figure 1). For safety, excavations should also be in accordance with OSHA Regulations 29 CFR 1926. Consequently, gentler excavation faces may be required.
- Fill material placed behind the walls should consist of free-draining granular material (specified below) compacted as per the design engineer's specifications. Clean native soil material (less than 10% passing the #200 sieve and rocks larger than 6-inches removed) can be used for this purpose if approved by the design engineer. Compaction to 90 to 95% of Standard Proctor maximum dry density is typically used to minimize post-construction settlement of the backfill. Over-compaction of the backfill immediately
