Electronic Leak Detection Survey

Site address:
Example Place
London
EXC

Survey Date:
27th February 2026

Client:
Example Client

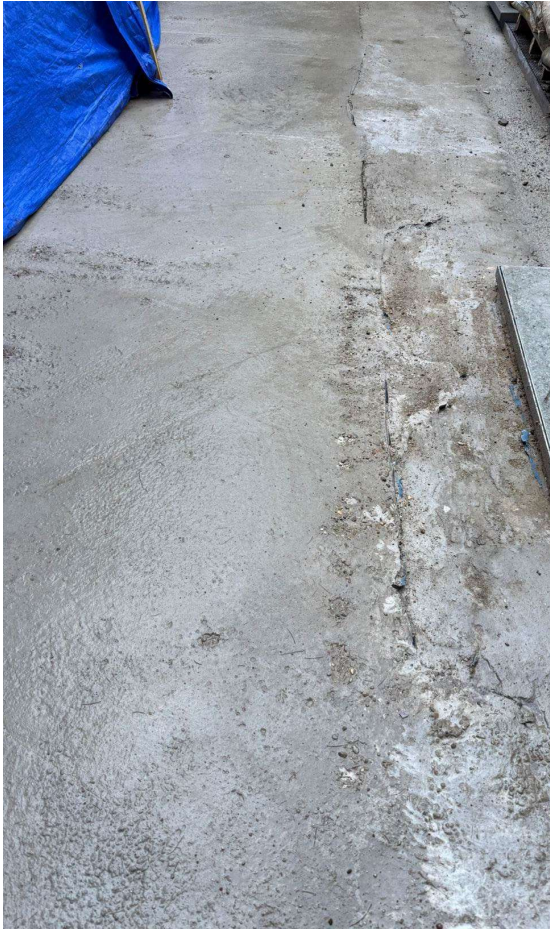
Page 5 – Area prior to waterproofing application

The above picture shows the concrete slab prior to any waterproofing works. Multiple repairs were carried out to facilitate the waterproofing works.

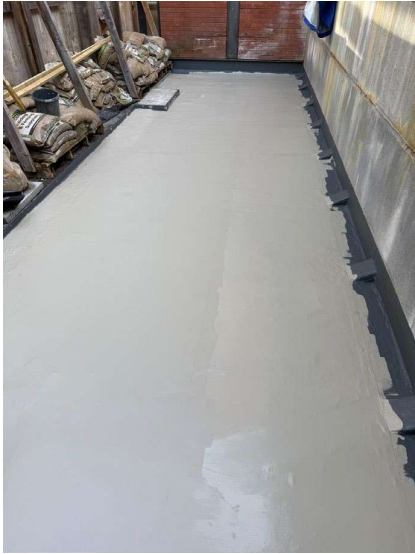
Page 6 - Area after waterproofing application

The above image shows the area fully waterproofed with the Example Liquid system including Example Liquid to the upstands.

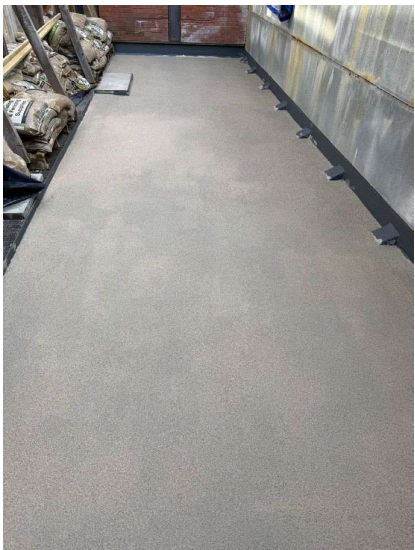
The above image shows the area fully broadcasted with quartz

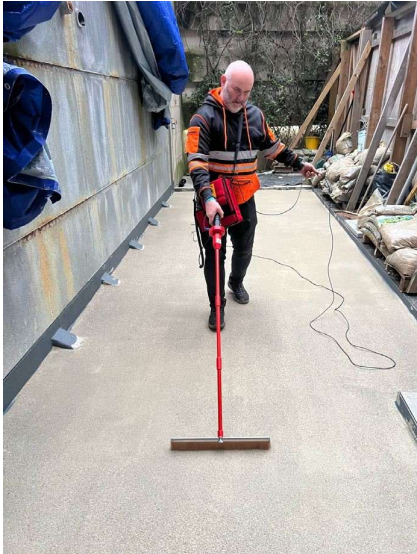
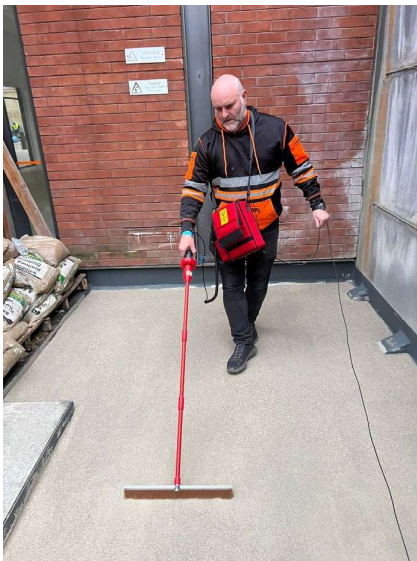
Page 7 – Area 1 - ELD to field area

The above images show the Buckley's Dry Roof Pro2 being carried out in the field area of the slab. No defects were found

The Buckleys Dry Roof Pro2 Electronic Leak Detection equipment (ELD) found zero defects in the field area of the slab

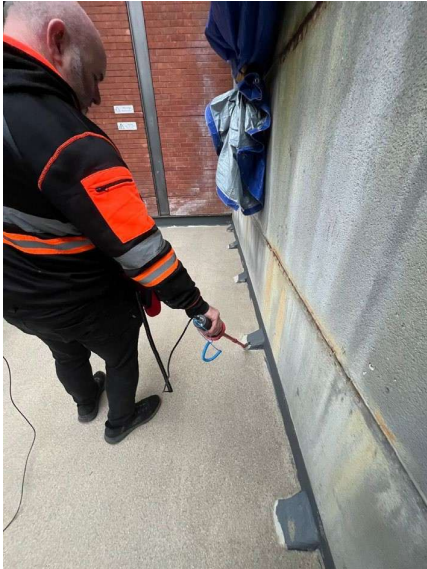
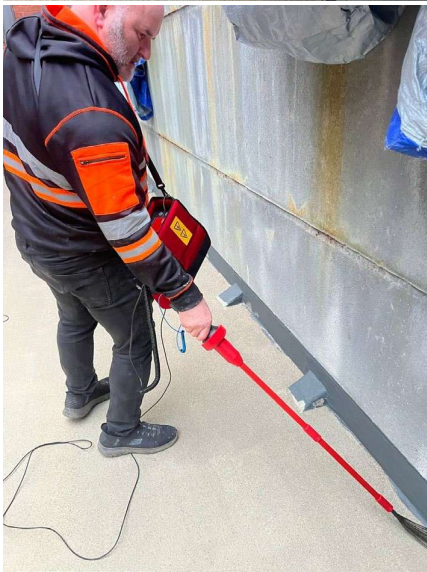
Page 8-9 - Area 2 – ELD to upstand detail area

The above images show the Buckley's Dry Roof Pro2 being carried out to the upstand detail of the slab. No defects were found.

The Buckleys Dry Roof Pro2 Electronic Leak Detection equipment (ELD) found zero defects in the upstand details.

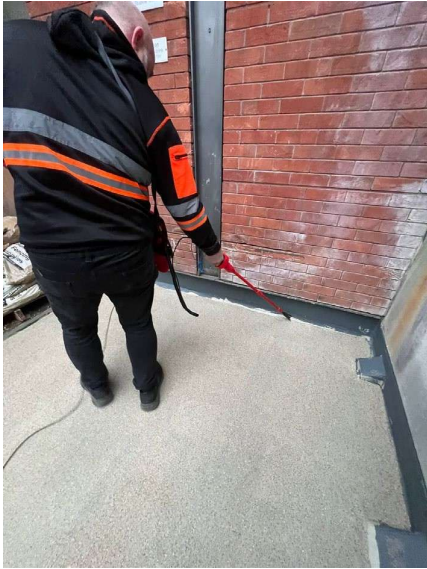
The above image shows the Buckleys Dry Roof Pro2 being carried out to the RSJ section to the back of the slab. No defects were found.
