Project	Example End Lane 80,82
Client Name	Example Client– Example Construction
Site Address	80,82 Example Lane, EX6 2LX
Date of Survey	23.02.26
Surveyor	Paul Connolly
In Attendance	Example C (Contractor). Example M (Manufacturer)
Equipment	Camera, Drill, Borescope, Core sample kit
Scope of Work	Intrusive survey of roofs to property no's 80 & 82. Visual survey 82e
Weather	Dry, overcast

1.0 Overview

3.0 Core Sample Findings

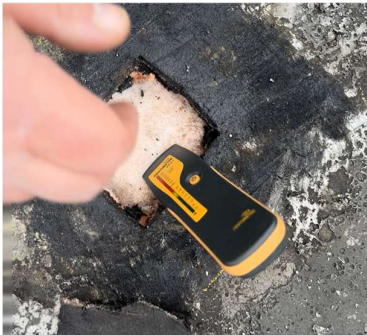
Layer	Depth	Photo	Condition
Waterproofing – Mastic Asphalt (Solar Reflective Paint)	Circa 20mm

No major defects noted. Solar reflective paint has deteriorated across the roof area
PIR (Polyisocyanurate) Insulation	Circa 50mm

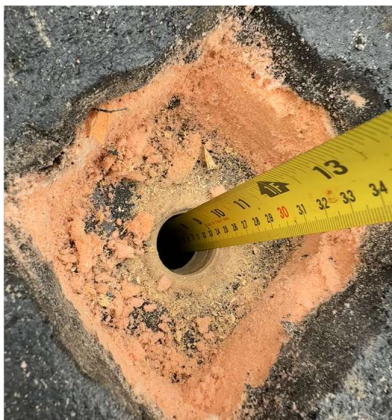
No moisture was detected within the insulation
2 x 20mm Plywood boards	Circa 40mm

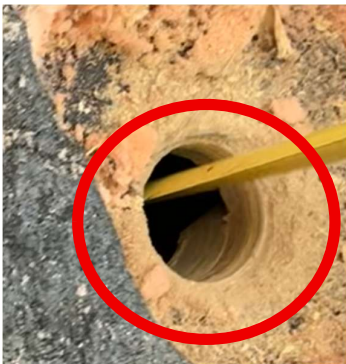
The core sample revealed there was a build up of two 20mm boards, adjacent to a build up of one 20mm board. We would recommend inspection from below to

determine build up
Void (Timber construction)	Circa 200mm (void below underside of second plywood board)

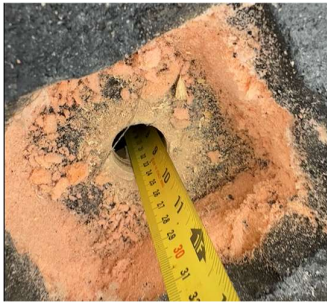
No insulation present below deck

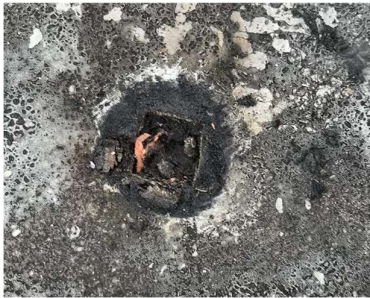
Layer	Depth	Photo	Condition
Waterproofing – Mastic Asphalt (Solar Reflective Paint)	Circa 20mm

No major defects noted. Solar reflective paint has deteriorated across the roof area
PIR (Polyisocyanurate) Insulation	Circa 50mm		Insulation was found dry. Did not penetrate the deck

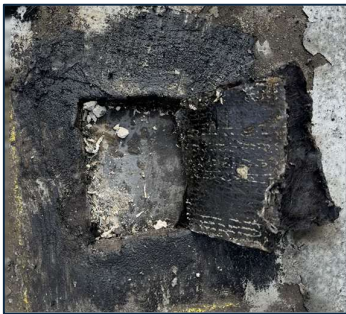
Layer	Depth	Photo	Condition
Waterproofing – Mastic Asphalt (Solar Reflective Paint)	Circa 20mm

No major defects noted
Screeded Woodwool Slab	Circa 75-80mm

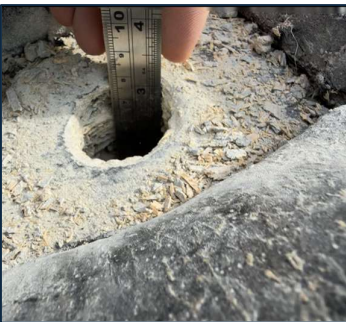
Dry – No major defects noted Reinforcement to underside of slab noted from borescope
Void (Timber construction)	Circa 700mm

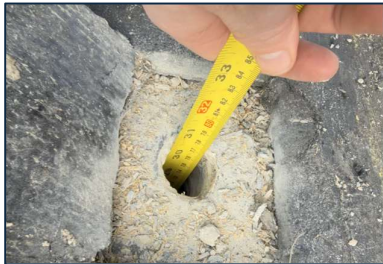
Insulation was detected above ceiling. It was impossible to determine exact thickness. It is assumed circa 50mm

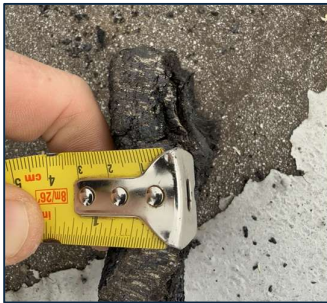
Layer	Depth	Photo	Condition
Waterproofing – Mastic Asphalt (Solar Reflective Paint)	Circa 20mm

No major defects noted
Screeded Woodwool Slab	Circa 75-80mm

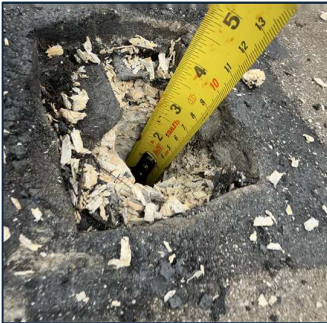
Dry – No major defects noted Reinforcement to underside of slab noted from borescope
Void (Timber construction)	Circa 575-625mm (an internal investigation would be required to determine exact thickness.

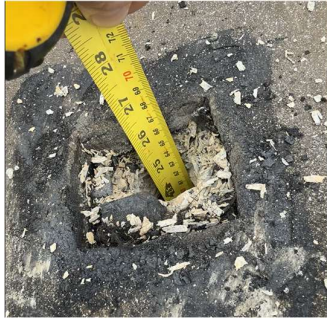
Insulation was detected above ceiling. It was impossible to determine exact thickness. It is assumed circa 50-75mm

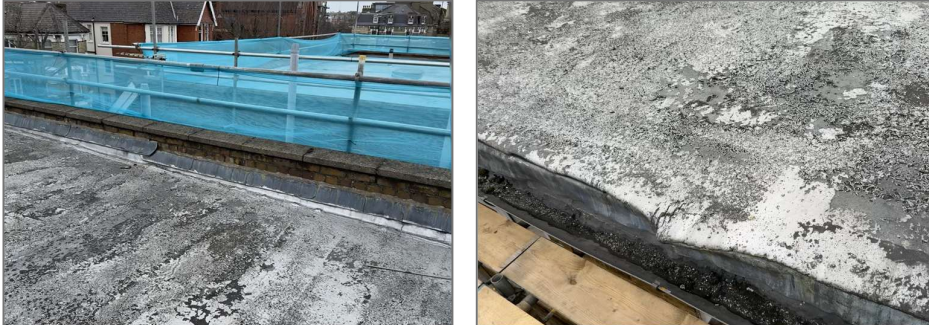
4.1.1 Drainage

Rainwater drains from front to back of the roof into an external gutter. Falls are effective.

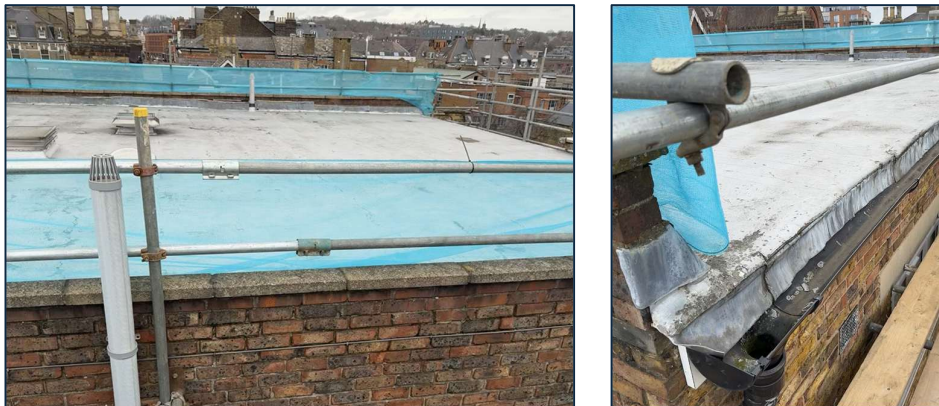
4.2.1 Drainage

Rainwater drains from front to back of the roof into an external gutter. Falls appear adequate with one small section potentially holding water.

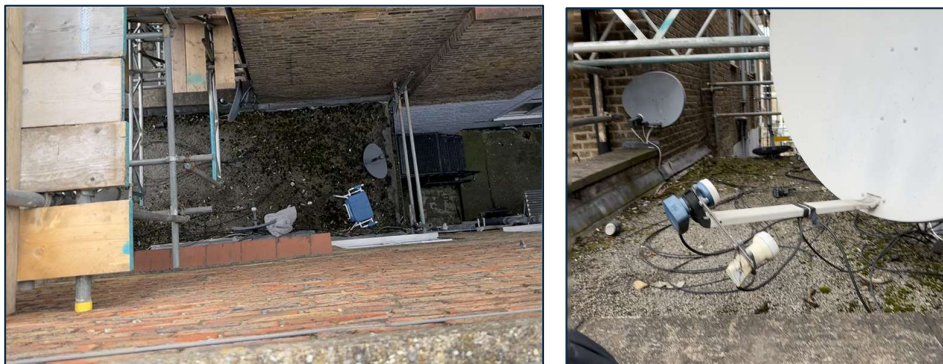
4.3 Number 82e

No access available to carry out the survey. Example Manufacturer will make assumptions and allow for within their specification.
