## Maintenance Report – Example Address, Example Street, EX1

Example Borough Council

### 1.0 Overview

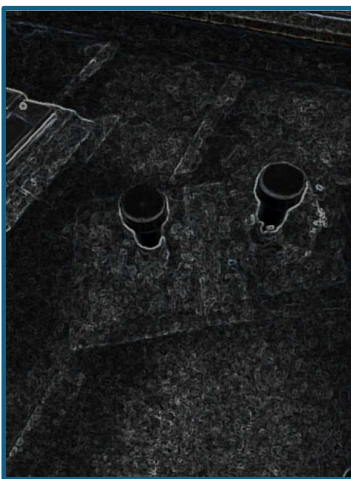
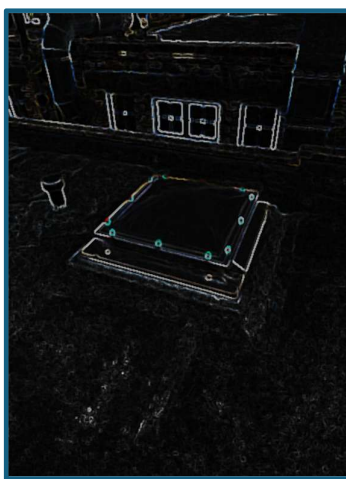
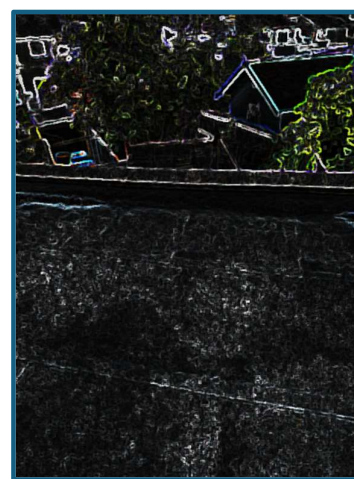
The roof surface is in reasonable condition, however there is large areas of silt build up in the centre of the roof, likely to be water ponding due to inadequate falls. There are signs of mineral migration located across the roof surface. The laps are well sealed and no obvious signs of delamination.

Using a soft bristle brush and proper disposal methods to remove silt off a flat roof is a safe and effective way to prevent damage. This approach minimizes the risk of harming the roof's waterproof membrane, while a careful disposal plan prevents the silt from blocking the chutes and external hoppers.

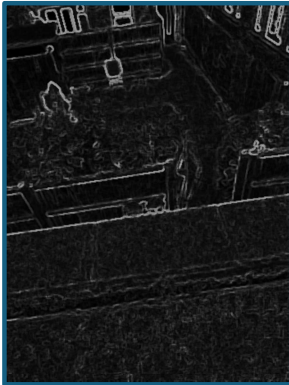
The upstands are in satisfactory condition, and no immediate maintenance is required. The waterproofing is correctly terminated to the underside of the coping stone, and the upstand height of approximately 150mm meets the minimum recommendations of BS 6229:2018.

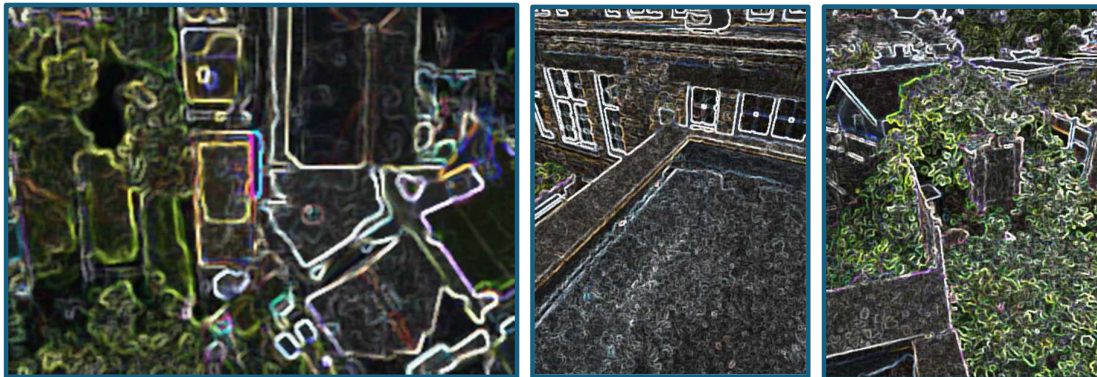
The 'once-weathered' coping stones are bonded well to the top of the parapet walls and pointed with a sand/cement-based mortar. However, there are signs of erosion on six number copings as highlighted on the aerial view below.

To prepare for repointing, joints must be raked out to a depth of at least 25mm and thoroughly dampened to prevent the new mortar from drying too quickly. A mortar mix of three parts clean building sand to one part Portland cement should then be prepared, with a plasticiser added to improve its workability and weather resistance. Once mixed to a cohesive consistency, the mortar is pressed firmly into the joints using a pointing iron and finished to a smooth, compressed surface before it hardens.

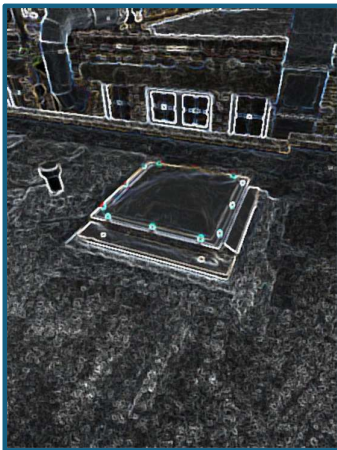
The rooflights are in satisfactory condition, and no maintenance is currently required. A visual inspection revealed no evidence of defects, damage, or water ingress.

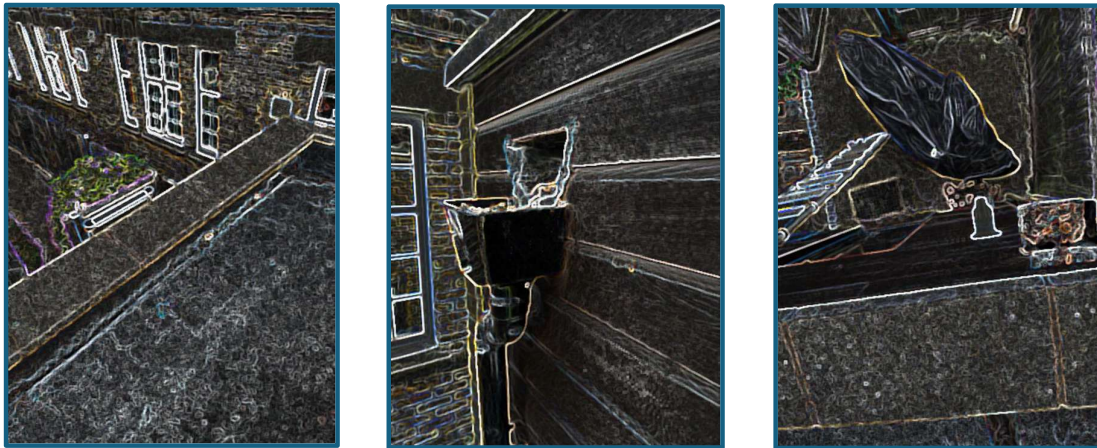
The building's drainage system comprises two external downpipes fed by corresponding hoppers. Running parallel to the lead chutes are internal gutters, approximately 100mm in width, which were observed to be completely obstructed with silt and leaves. Both hoppers were also blocked with leaf debris. While the downpipes and the lead sections of the chutes remain in a serviceable condition, the significant blockages in the gutters and hoppers present a high risk of overflow and water ingress.

To clear the blocked gutters and hoppers, first, use a glove-protected hand or a small gutter scoop to manually remove the bulk of the leaves and silt, depositing the waste into a bucket to avoid mess. Next, flush the internal gutters, chutes, and downpipes with a garden hose on a low-pressure setting to wash away any remaining debris and test that water is flowing freely. If a downpipe remains blocked, use a drain rod or snake to physically dislodge the obstruction, after which you should perform a final flush. For the hoppers, make sure to clear the large leaf deposits before flushing.
