## Condition Report – Example, Address, GU50

### 1.0 Overview

This report has been prepared exclusively for Example client to support the refurbishment of the specified roof areas at the aforementioned property. It is based on our site inspection of Example project conducted on 6<sup>th</sup> October 2025, and should be read in conjunction with the enclosed photographs.

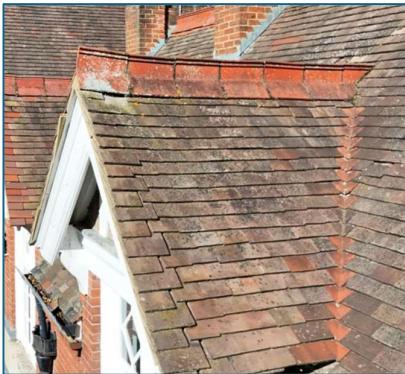
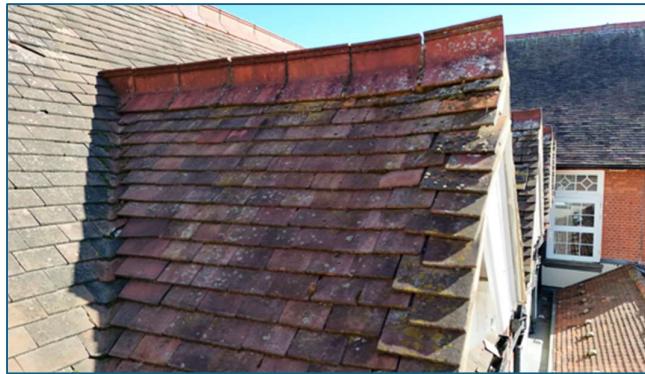
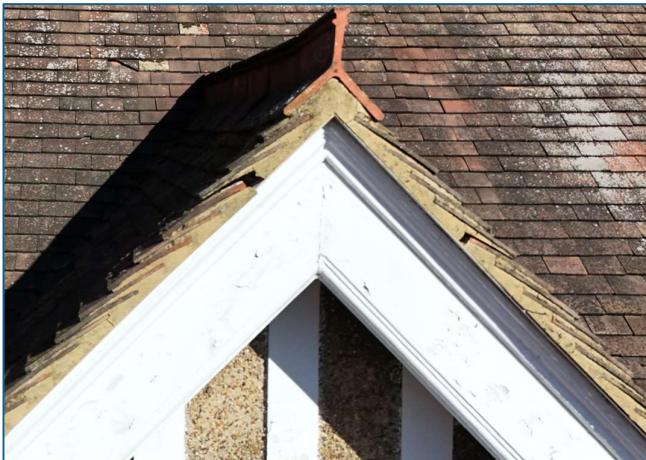
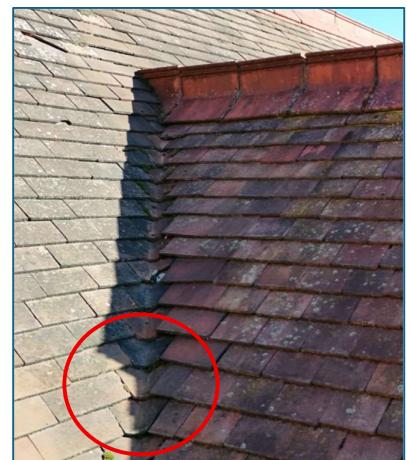
### 4.1.1 No.1 – Defects

Either side of the dormer is showing signs of fatigue with the mortar eroded between the ridge tiles, and tiles have slipped particularly around the verge of the apex. We were advised during survey that there has been water ingress within this area below.

The mortar between the undercloak and verge tiles has deteriorated as a result of tile slippage. The tiles are not lapped correctly into the valley of the dormers, leaving small gaps that increase the risk of capillary water ingress beneath the tiles. The valley should ideally have tiles cut to follow its contour with a consistent overlap ensuring tight abutment and free water flow, however this doesn't appear to be the case in the valley area.

### No.1

As detailed in section 6, we recommend replacing the roof, and the dormer would form part of the works. In the interim, replacing the dormer would be our advice. We recommend replacing the existing pitched roof including battens, membrane and insulation back to the rafters, then install an insulated system (insulation location to be advised by manufacturer) with a clay tile to match the existing appearance. We would recommend contacting a manufacturer such as Marley who will be able to prepare a specification and design tendering contractors can tender against. Marley (or similar) will be able to provide a warranty upon completion of works.

An alternative would be to replace the verge (two tiles back) including verge mortar, temporary remove ridge tiles and reinstate on mortar once tiles have been replaced, and replace any loose/slipped tiles within the nearby area. However there will be no guarantee that the water ingress issues will be addressed.

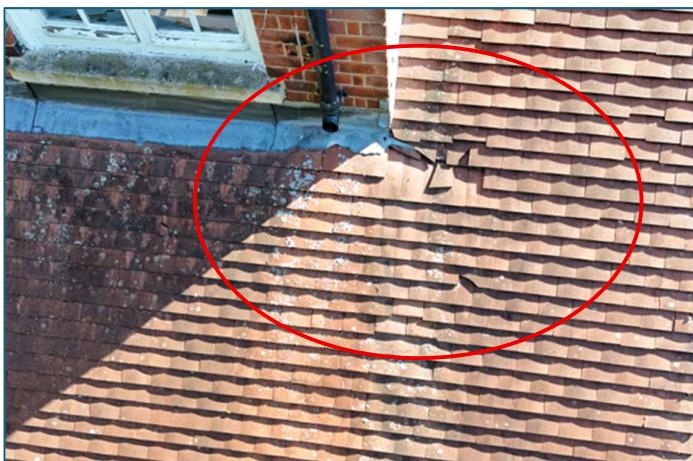
#### 4.1.2 No.2 Defects

Lead is defective in this area. Tiles are broken and dislodged and are vulnerable to falling onto the area directly below.

### No.2

As detailed in section 6, we recommend replacing this roof as detailed earlier in this section. In the interim, replacing the slipped/loose/missing tiles would be our advice. We recommend replacing the defective lead with code 4 lead, in line with BS6915 (code of practice for leadwork).

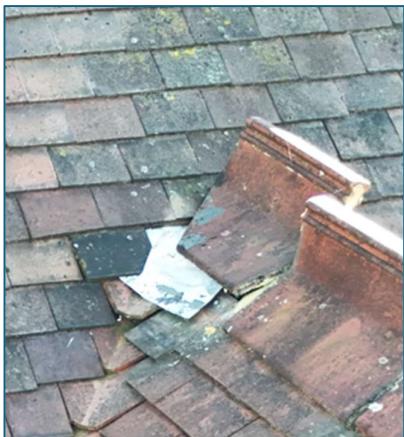
#### 4.1.3 No.3 – Defects

Ridge tile has dislodged leaving a possible route for water ingress. Also vulnerable to falling during high winds.

### No.3

As detailed in section 6, we recommend replacing this roof as detailed earlier in this section. As a short term measure, if intact reinstate the original ridge tile on a bed of mortar or replace tile if defective.

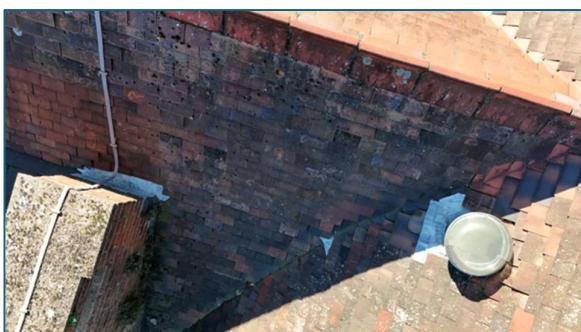
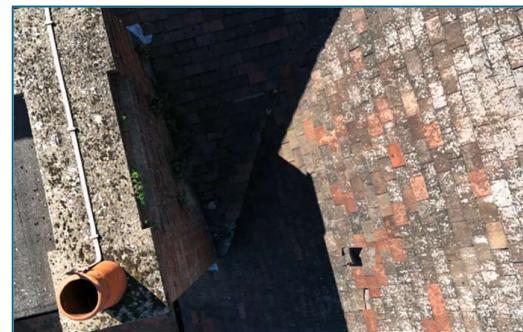
#### 4.1.4 No.4 – Defects

A number of defects are visible within this area; missing tiles, lead repairs and dislodged tiles.

We were advised during the survey that there has been water ingress within this area below.

### No.4

As part of the re-roofing program, this section will be fully replaced. In the interim, the defective stepped flashing and associated damaged tiles should be rectified. Upon establishing safe access, the appointed roofing contractor can assess the extent of slipped or damaged tiles and implement necessary repairs.

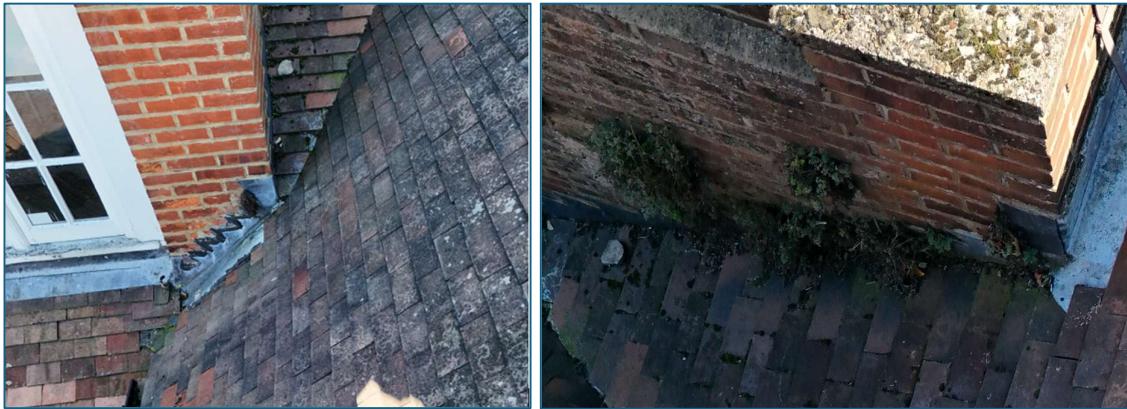
Repairs have been carried out to the lead flashing to the base of the chimney stack. There is moss build up to the side of the chimney stack which hampered the view of the lead flashing.

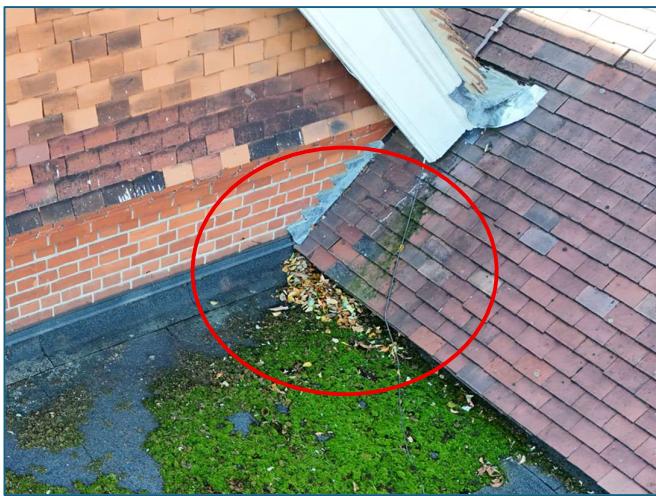
#### 4.1.5 No.5 – Defects

The kerb at the junction between the flat & pitched roof should have an upstand of at least 150mm as indicated on the drawing below. This could be a possible route for water ingress which has been identified directly below this detail.

## No.5

As part of the re-roofing program, this section will be fully replaced. In the interim, tiles should be removed around the highlighted areas; the flat roof kerb raised and weathered with bituminous membranes; and a new stepped Code 4 lead flashing installed directly above the existing Code 4 lead, in accordance with BS 6915 (Code of Practice for Leadwork). Defective or damaged tiles must then be replaced, with others reinstated.

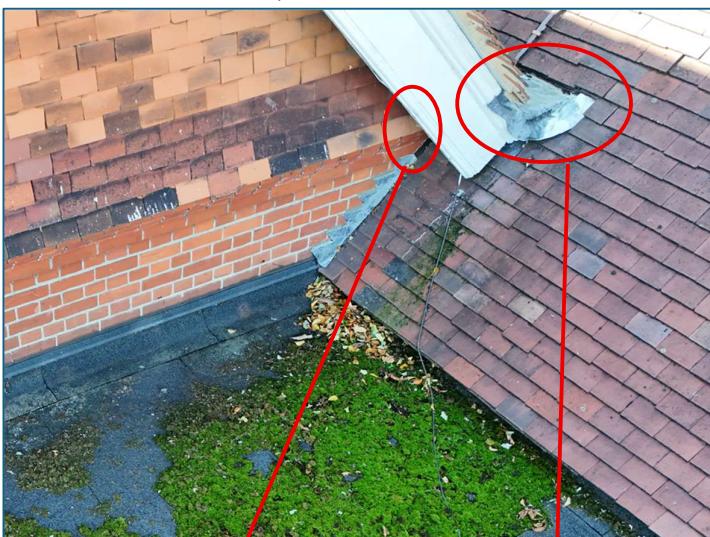
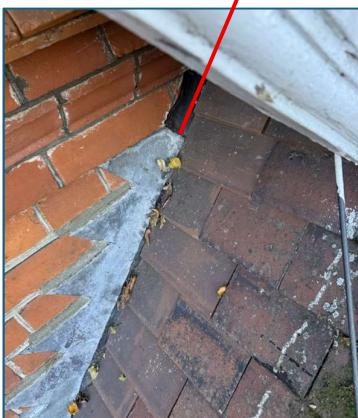
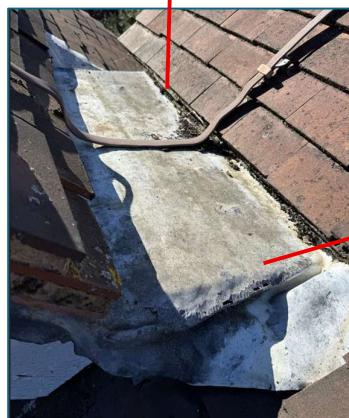
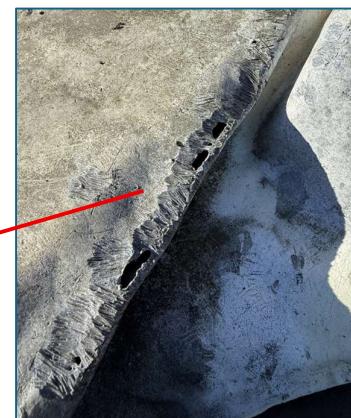
Stepped lead flashing is dislodged and top section is missing. The lead valley is also defective with holes visible, leaving a route for water ingress into the building. We were advised during the survey that there has been water ingress issues directly below this defected area.

Above this section, tiles should be temporarily removed directly over the lead valley, followed by installation of a new Code 4 lead valley per BS 6915. Defective or damaged tiles must be replaced, with others reinstated. Prior to work commencing, as a temporary measure the lead can be coated in liquid, however this would not be a long term solution.

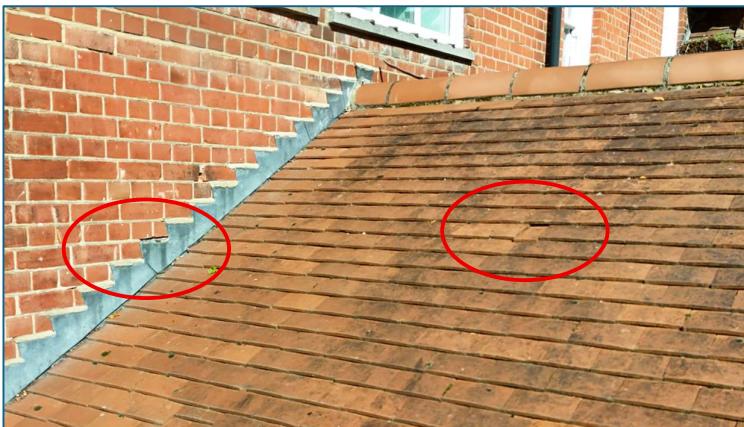
Example of missing mortar to lead stepped flashing, and a tile that has slipped.

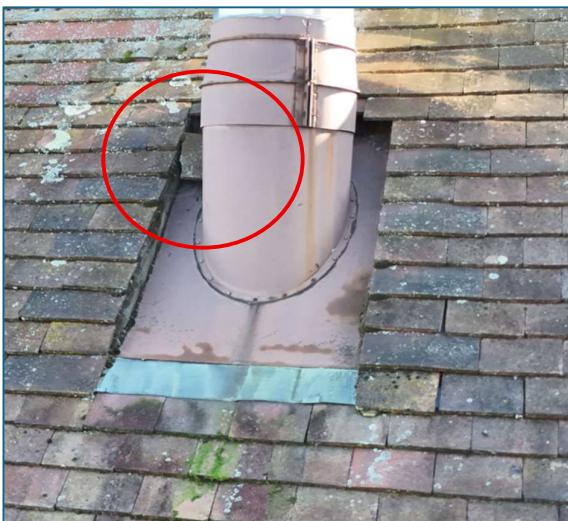
Example of tile that has dislodged.

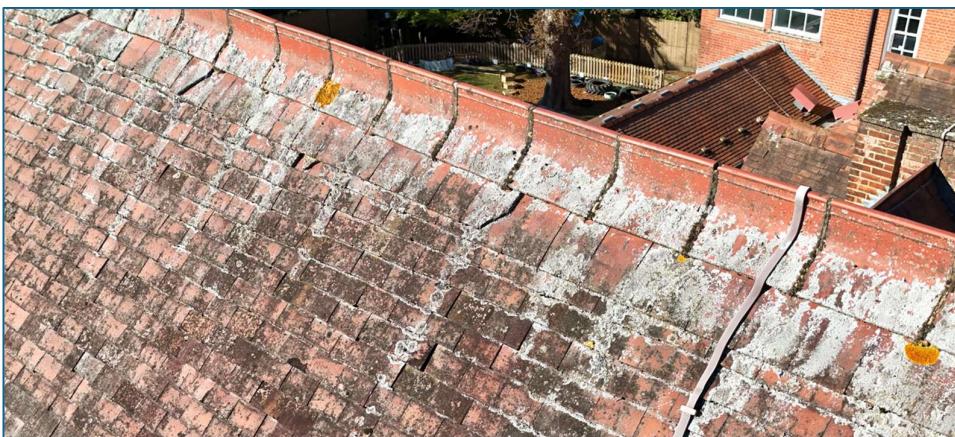
Example of broken tiles across the top row.

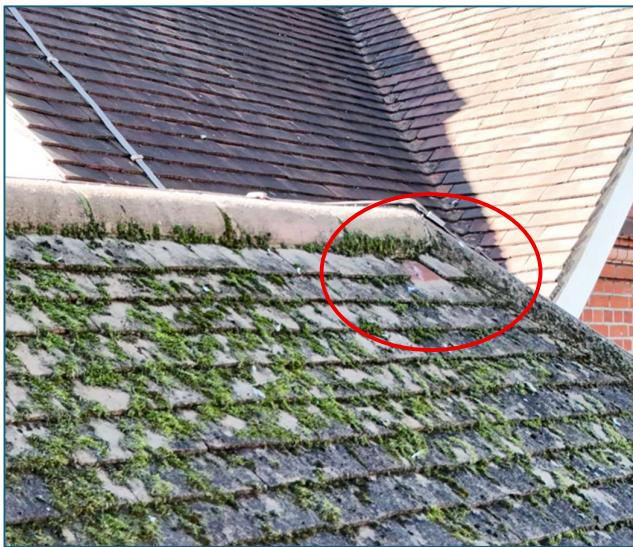
Another example of missing tiles.

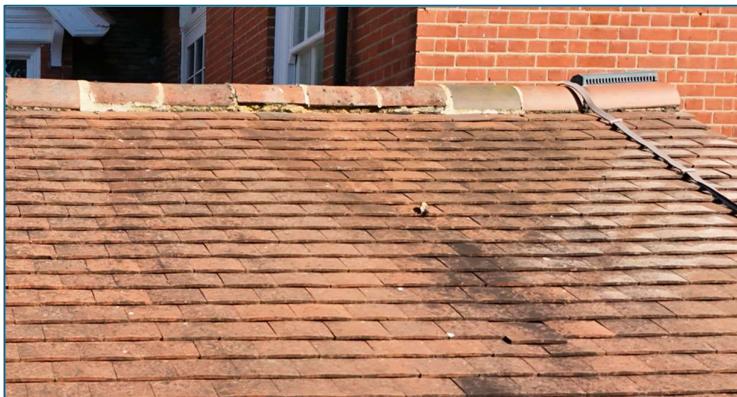
Mortar missing below ridge tiles, evidence of previous re-bedding of ridge tiles.

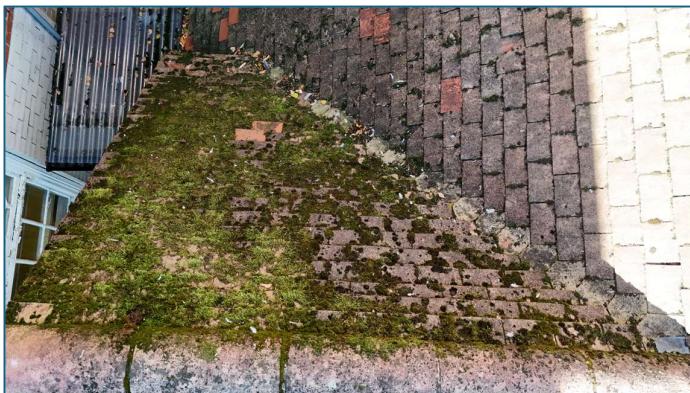
Moss/lichen build up visible. Evidence of previous tiles replacement.

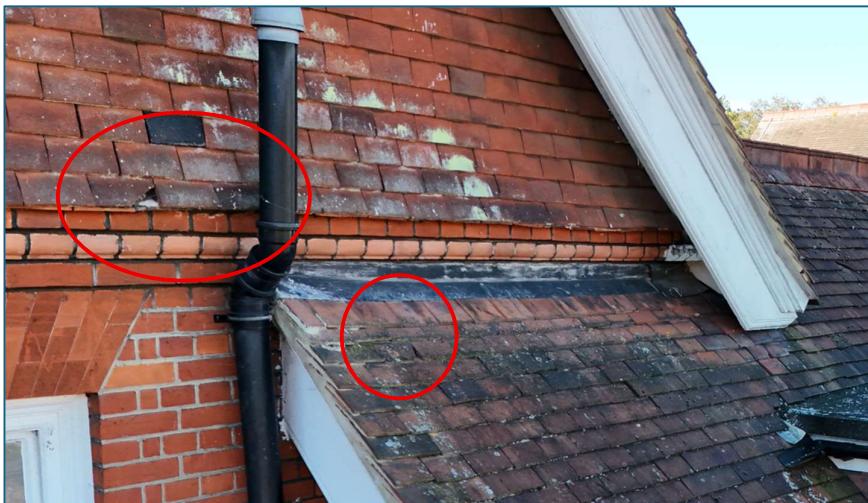
Example of broken tiles, leaving a possible route for water ingress.

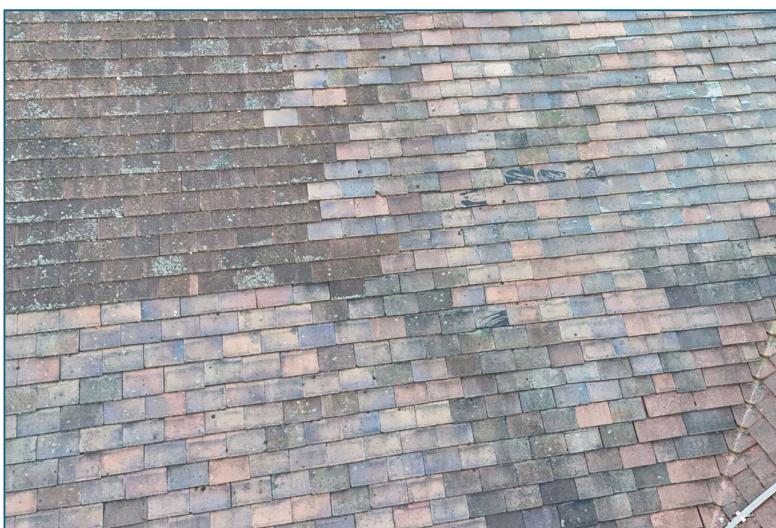
Various examples of defective tiles that are broken/slipped.

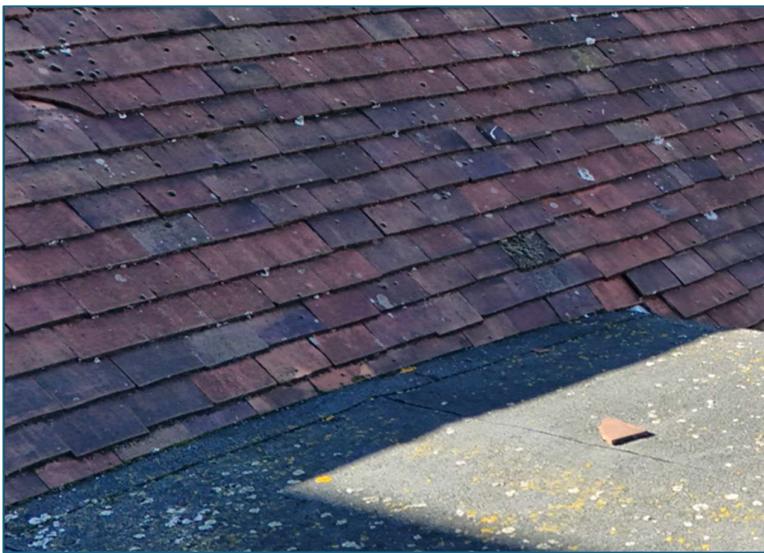
Example of where a broken tile has fallen onto the dormer roof below.

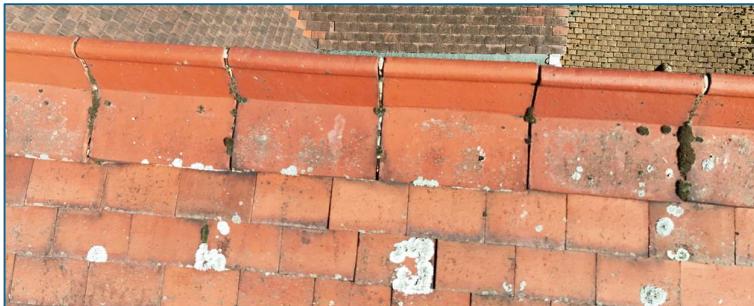
Example of eroded mortar between ridge tiles.

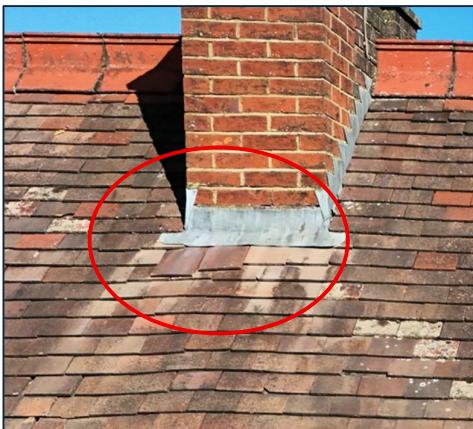
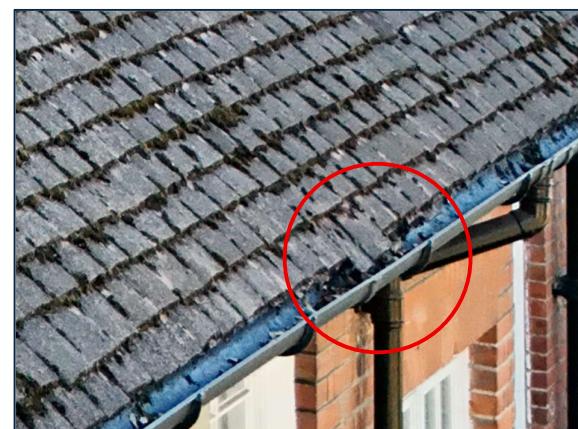
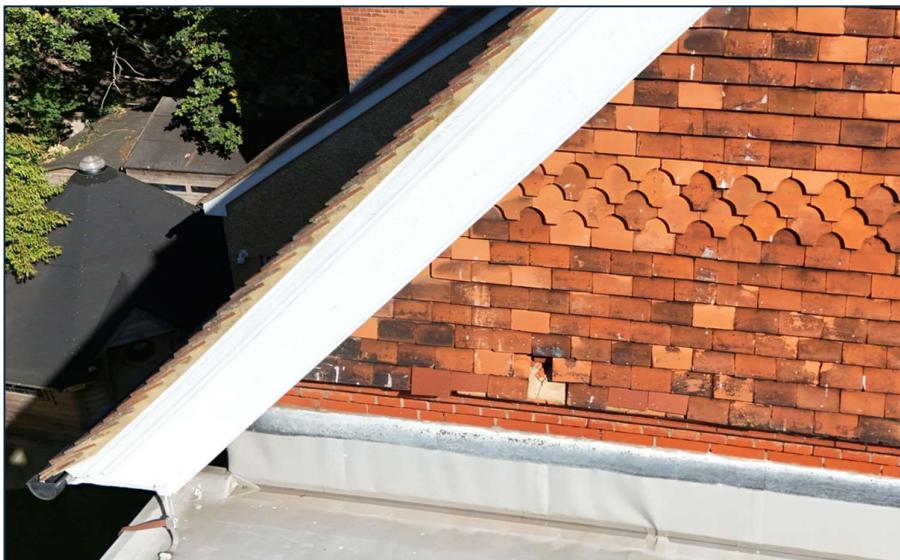
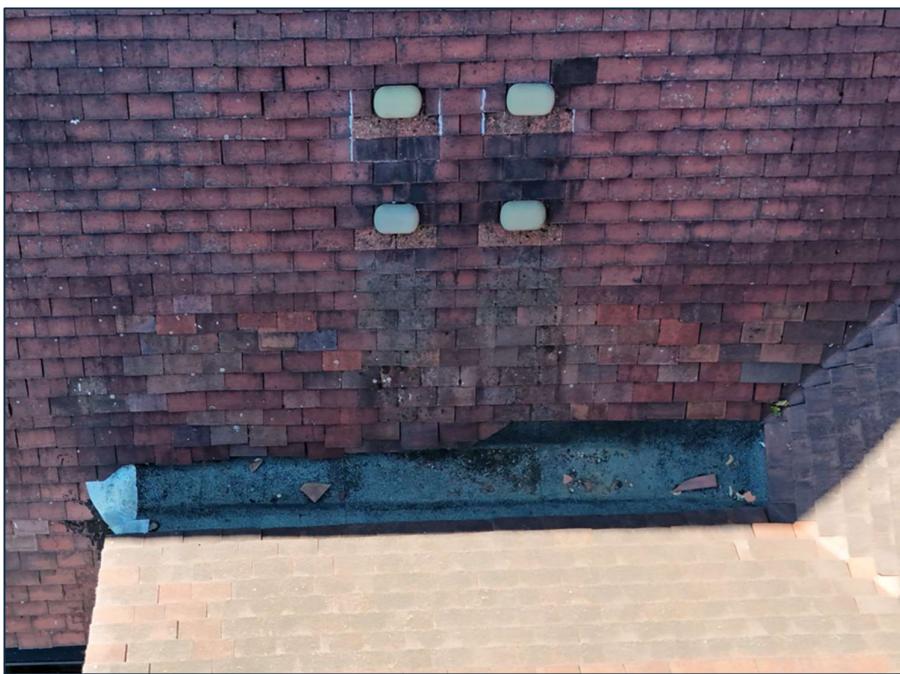
Further examples of slipped tiles.

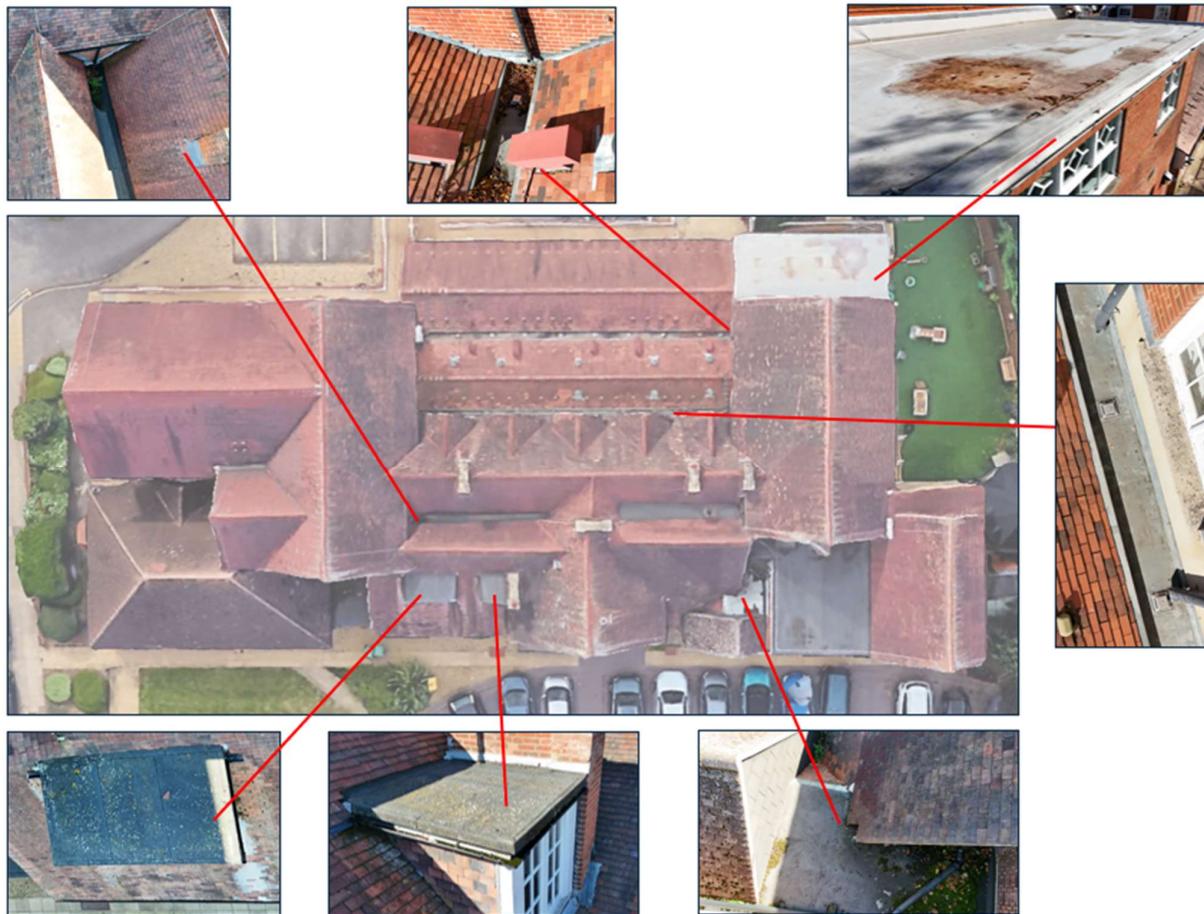
### Fig.3 Photosheet of Flat Roofs / Flat Gutters

The flat roofs are generally in good condition from the visual inspection, with a mixture of bituminous membrane, liquid coating and Single Ply type coverings. No major defects were noted upon the time of survey.

We recommend that the roofs are cleared of debris/leaves, and maintenance is carried out twice annually in accordance with BS 6229:2018.

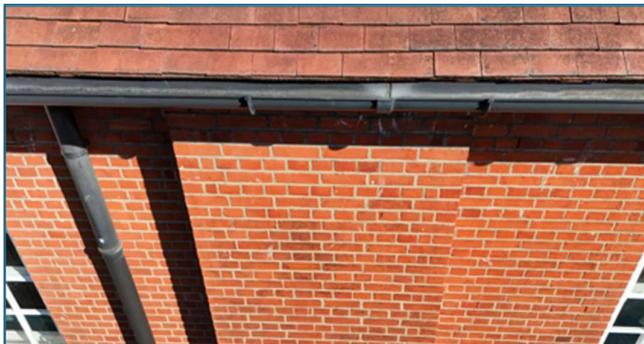
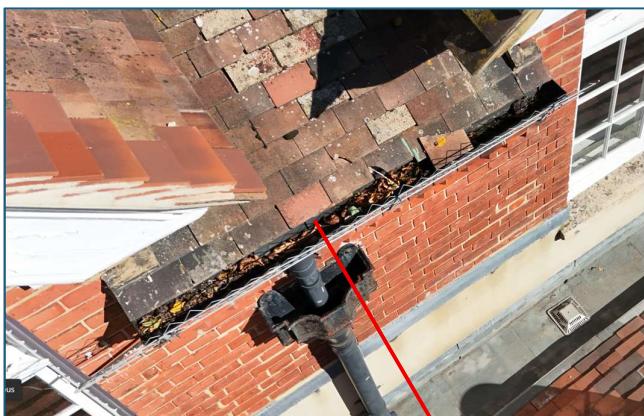
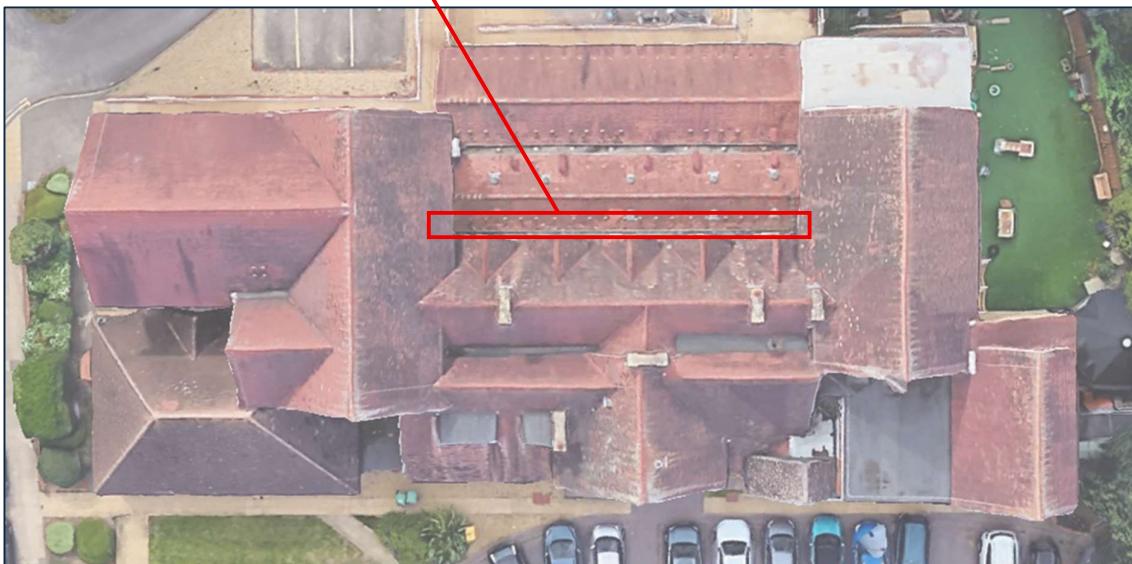
#### 4.3 Guttering

Generally the gutters appeared functional and free from debris, however, since the inspection was conducted in dry conditions, any defective joints would not be apparent. The gutters between the dormers contained debris.

We recommend ensuring all the gutters / hoppers are free from debris, and washed through thoroughly, particular attention is to be paid to the gutters between the dormers identified at section 4.3 of this report.

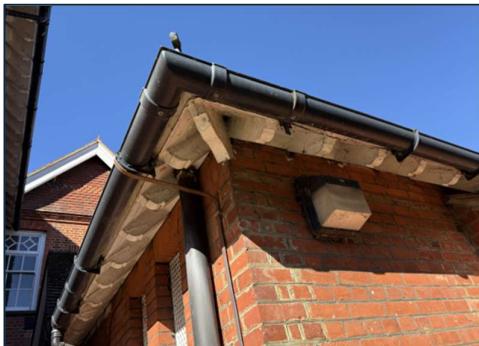
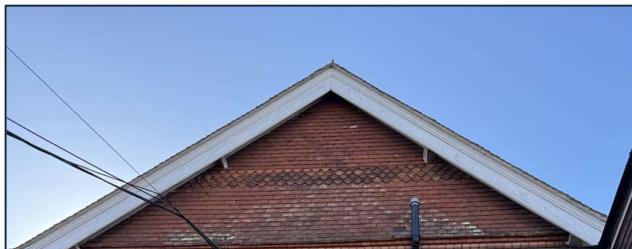
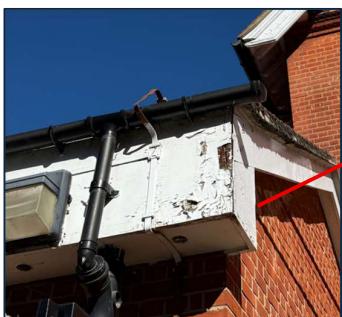
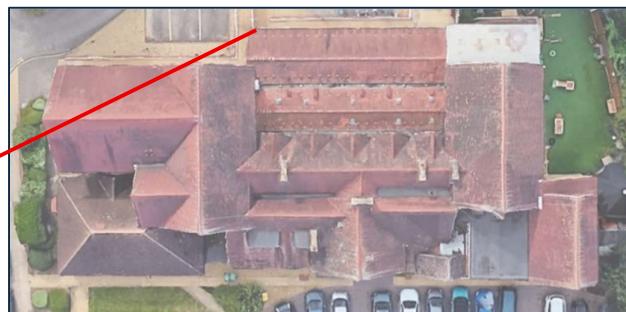
#### 4.4 Fascias & Soffits

Generally the fascias and soffits appear to be in good working order with defects noted in only one location as highlighted below. Paint has started to flake off some fascias, and should be redecorated as part of cyclical works.

As detailed elsewhere in this report, the fascias and soffits are generally in satisfactory condition. One localised area (section 4.4) requires targeted repair. The paint finish on the fascias exhibits variable deterioration across the roof sections and should be renewed as part of routine cyclical maintenance.

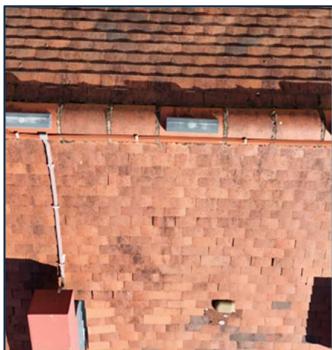
##### 5.1 Lightning Conductor System

There is a lightning conductor system in place, and should be tested in accordance with British Standard BS EN 62305.

We recommend engaging with Nimbus (or similar approved) [www.nimbus.co.uk](http://www.nimbus.co.uk) / 0845 8802 464 who will be able to carry out the inspection and advise on requirements.
