<b>Project</b>	Sample Report
<b>Client Name</b>	Sample Consultants
<b>Site Address</b>	137 Sample Rd, London W14
<b>Date of Survey</b>	14.03.26
<b>Surveyor</b>	Paul Connolly
<b>Equipment</b>	Drone 249g, Camera, Protimeter,
<b>Scope of Work</b>	Non-Intrusive survey of main roof, visual survey internally
<b>Weather</b>	Dry, sunny

## 1.0 Overview

This report has been prepared exclusively for Sample District Council to support the refurbishment of the specified roof areas at the aforementioned property. It is based on our site inspection of 17-24 Sample conducted on 9<sup>th</sup> December 2025, and should be read in conjunction with the enclosed photographs.

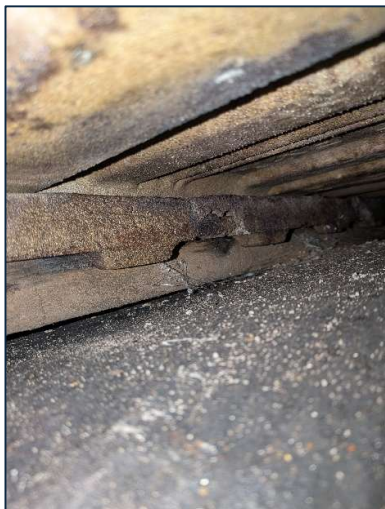
The original rafters are visible with only approximately 40mm of aged mineral wool insulation loosely laid between them. There is no insulation above the rafters or at rafter level. Directly below the rafters is the original bituminous roofing felt (sarking felt), which is now brittle. Above the sarking felt are traditional tiling battens supporting the Marley concrete interlocking tiles.

Photo 1. Underside of interlocking tiles

We recommend replacing the existing pitched roof including battens, membrane and insulation back to the rafters, then insulation is to be installed between and above the joists to achieve a u-value of 0.16W/m<sup>2</sup>k. Then install membrane, battens and concrete tiles to match the existing appearance. We recommend liaising with a manufacturer who will be able to specify and design a system that will achieve a warranty for at least 20 years. Redlands (BMI) or similar. The local representative is Joseph Musungu / [joseph.musungu@bmggroup.com](mailto:joseph.musungu@bmggroup.com) / 07394 031 304.

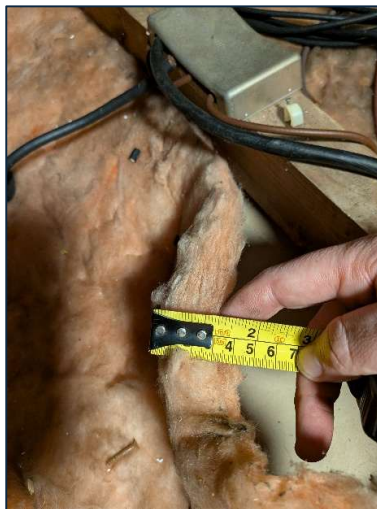
Because the total depth of insulation is only circa 40mm and there are significant air gaps and thermal bridging around the rafters, the current U-value of the roof is estimated to be in the region of 2.0–3.0 W/m<sup>2</sup>K. Therefore the existing required U-Value in accordance with Building Regulations Part L2 0.35W/m<sup>2</sup>K is not being met. In accordance with Building Regulations Part L1B, the roof must be upgraded to achieve a maximum U-Value of 0.16 W/m<sup>2</sup>K, and supplementary insulation will therefore be required to bring the roof into compliance.

Photo 2 Existing mineral wool between joists

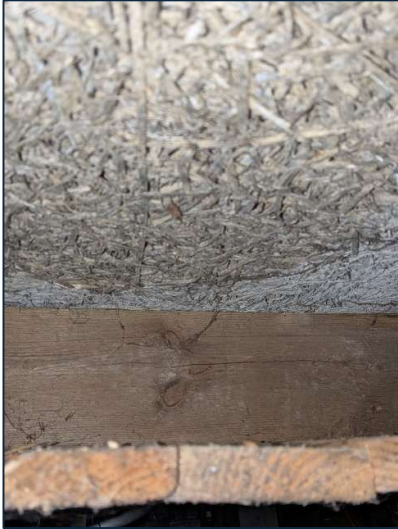
The existing roofing system appears to consist of traditional woodwool slabs, over which two layers of bituminous roofing felt have been laid (visual survey only). This construction is visible from below and remains appropriate for an unheated outbuilding. No insulation upgrade is required.

Photo 3. Underside of woodwool slab

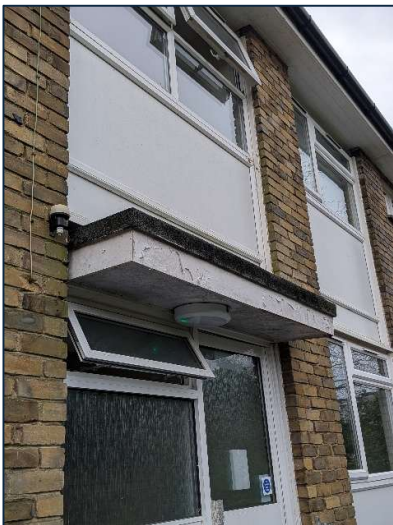
The canopy roofs are likely to be a two layer bituminous membrane system on a plywood/OSB deck.

Photo 4. Typical Canopy Roof

We recommend contacting a supplier such as Langley waterproofing, who will be able to core sample the existing waterproofing and who will be able to specify and design a system that will achieve a warranty for at least 20 years. The local representative is Ben Timewell / [b.timewell@langley.co.uk](mailto:b.timewell@langley.co.uk) / 07761 054426.

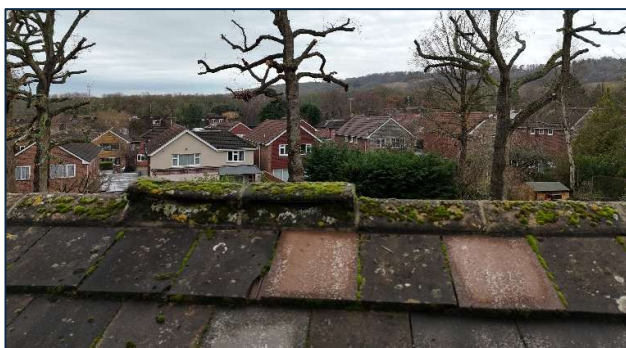
The ridge vents appear to be in a deteriorated condition and likely needs attention. The upstand and surrounding area are heavily mossed, indicating prolonged moisture exposure, and the lead flashing looks lifted or poorly sealed, which increases the risk of wind-driven rain getting underneath the tiles.

Photo 5. Defective Ridge Vent

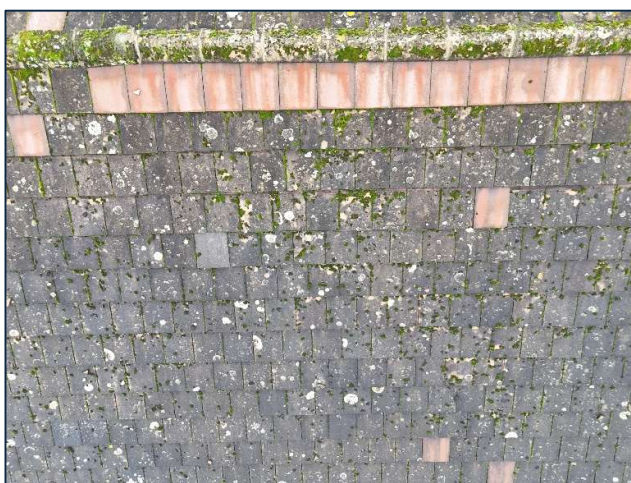
The coverings are showing signs of fatigue, with chips at the end of tiles visible. There have been numerous repairs carried out across the roof area, with replacement of tiles evident. There has been reports of leaks to the properties below.

Photo 6. Example of replacement tiles across the roof area

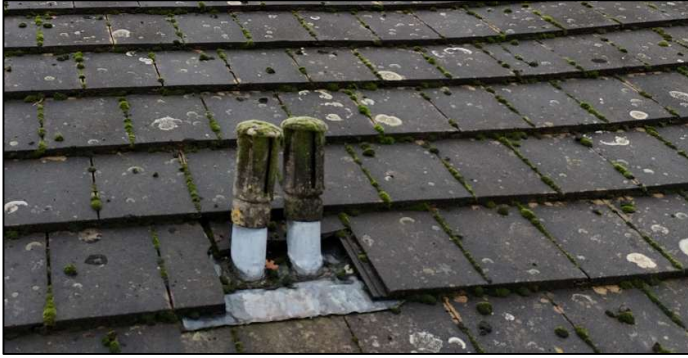
The asbestos-containing cowl vent pipe housing is showing significant signs of deterioration, with apparent weathering. There is a clear risk of water ingress into the building due to the lead around the pipe penetrations appearing to be compromised or inadequate. This condition increases the likelihood of water damage into the building.

Photo 7. Example of inadequate lead detailing around (asbestos containing) cowls

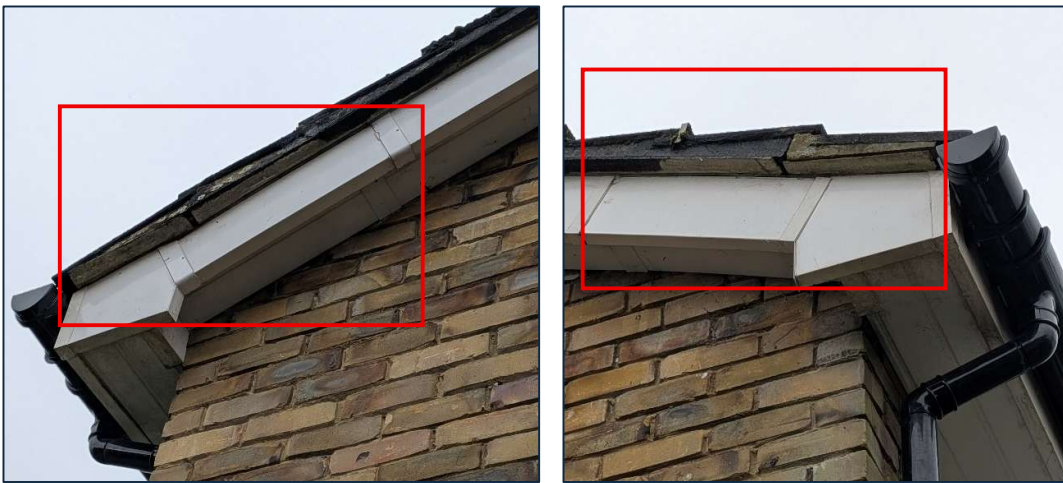
There are defects noted to the under cloaking of the tiles at eave level, with missing mortar between under cloaking and tiles.

Photo 8: Deficient under cloaking and deteriorated mortar joints.

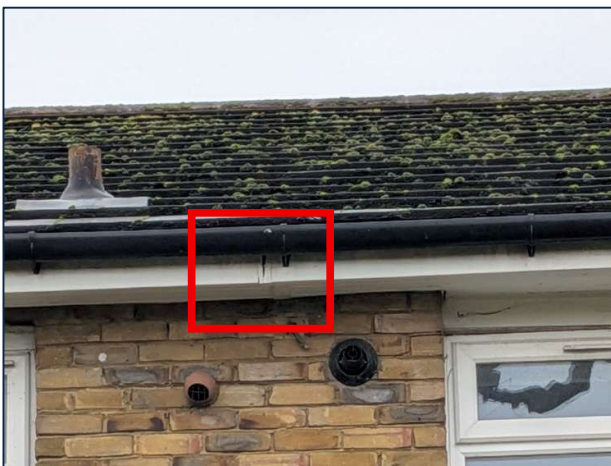
The fascia soffits and PVC gutter system are relatively new, however there was evidence of dripping water at bracket joints of gutter system, and splits evident at joint between fascia boards.

Photo 9: Split visible on join between fascia boards.

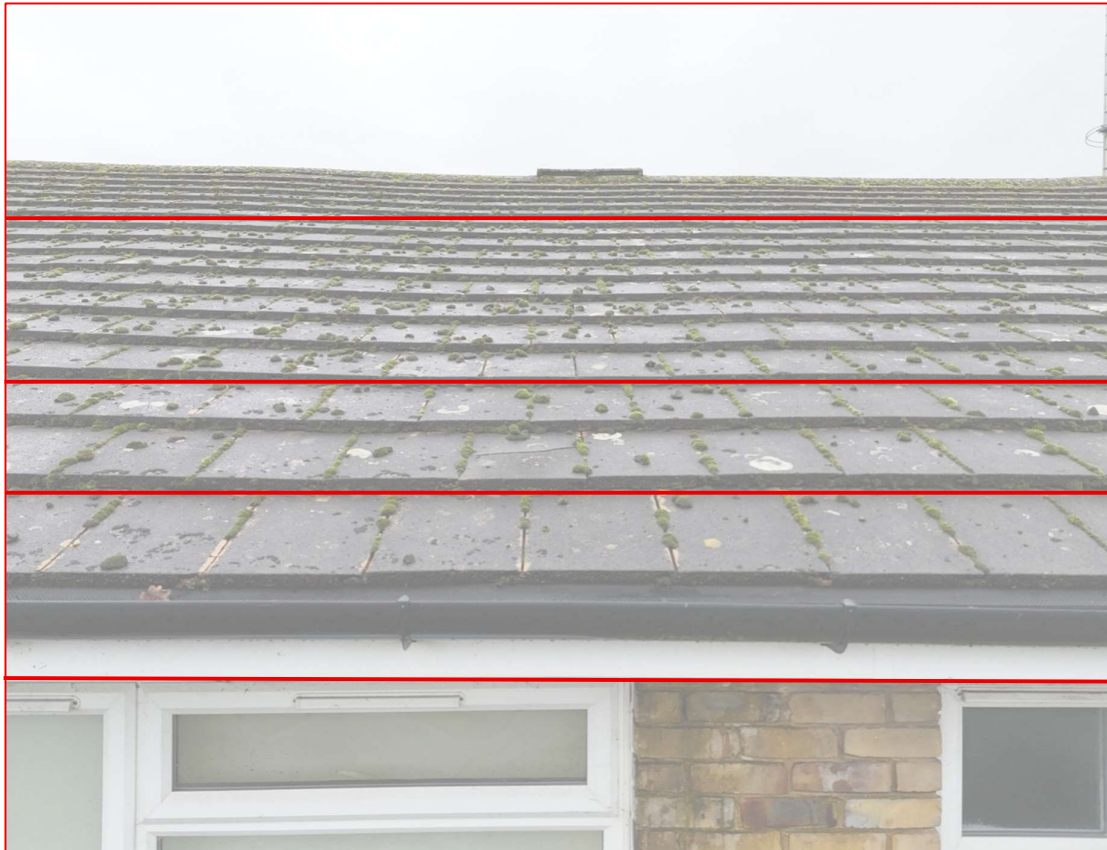
Observations made from the ground floor revealed significant visible deflection in the roof structure; consequently, an internal investigation was initiated.

*Photo 10: Straight lines drawn to demonstrate the deflection of the roof tiles.*

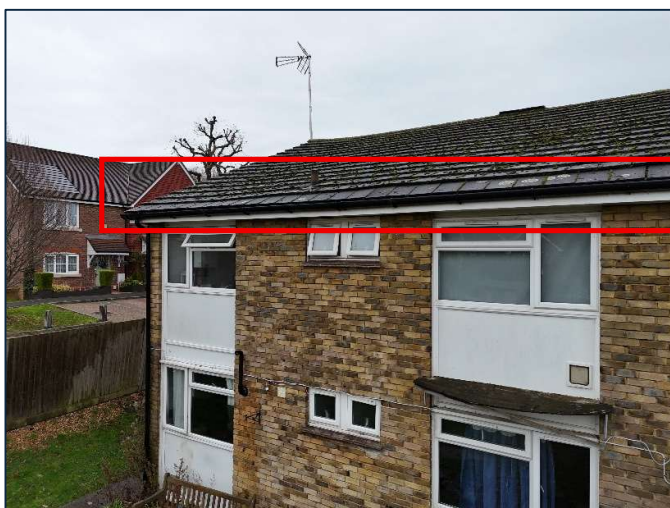
The bottom course of tiles exhibited inconsistent alignment along certain sections of the roofline, resulting in a visually irregular or uneven appearance.

*Photo 11: Bottom course of tiles with inconsistent alignment.*

Erect a tower scaffold to the area highlighted below, and temporarily remove two courses of tiles to expose the wall place and investigate the area where the bottom course of tiles have exhibited inconsistent alignment.

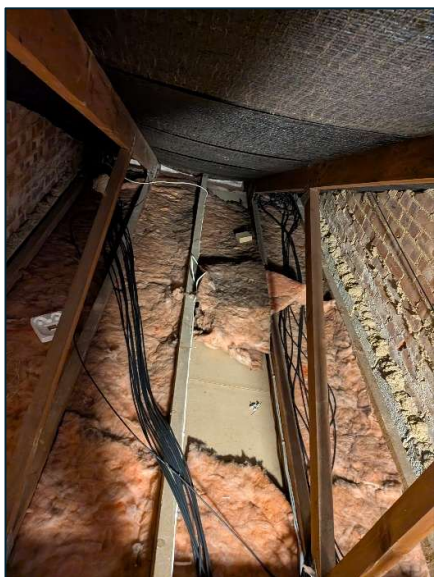
An inspection of the loft space revealed trussed rafters situated between masonry walls, extending to the underside of the sarking felt. The visible sections of the rafters did not exhibit signs of damage at the time of the survey. However, significant irregularities were noted in the rafter spacing (centre-to-centre). Approximately 900mm was measured between rafters above the loft hatch, while narrower spacings of circa 580mm were measured adjacent to the masonry walls. The installed roof battens measured approximately 40mm x 40mm. Of immediate concern, light was visible between the tiles when viewed from the underside, indicating potential water ingress, which was confirmed by the presence of moisture detected on the surface of the timber battens.

The structural adequacy of the existing rafter configuration must be evaluated against Eurocode 5 (BS EN 1995-1-1) standards. Standard prescriptive span tables, such as those published by the Timber Development UK (TDUK), are designed for typical domestic construction using regular spacings of 400mm, 450mm, or 600mm. The measured 900mm spacing significantly exceeds these standard parameters. This wider, non-standard spacing dramatically increases the required load-bearing capacity and necessitates a site-specific assessment.

Photo 12: Example of rafter spacings

Therefore, the current configuration requires verification by a qualified structural engineer. The engineer's assessment will determine the necessary remedial action, which may include several options: the introduction of additional rafters to regularise the spacing to standard 400mm or 600mm centres; the use of larger battens to increase localised strength; the installation of a structural layer such as plywood sheeting on top the rafters; or specifying a lighter weight tile system to reduce the overall dead load on the existing timber frame, or a combination of the above.

A structural engineer will also need to be consulted with to advise on the structural integrity of the existing rafters and whether additional rafters, plywood/OSB, or thicker battens (or a combination) will be required prior to installing the new system.

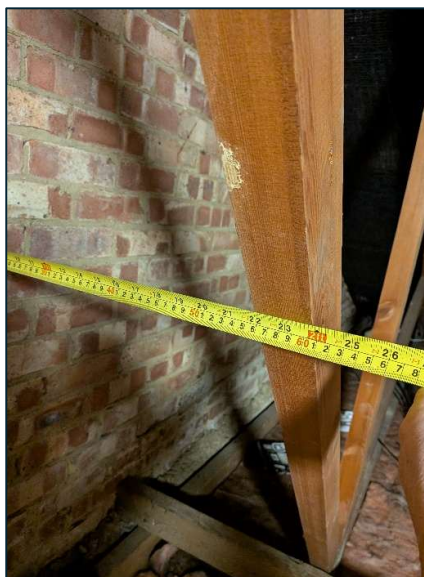
Photo 13: Distance between masonry wall and rafter

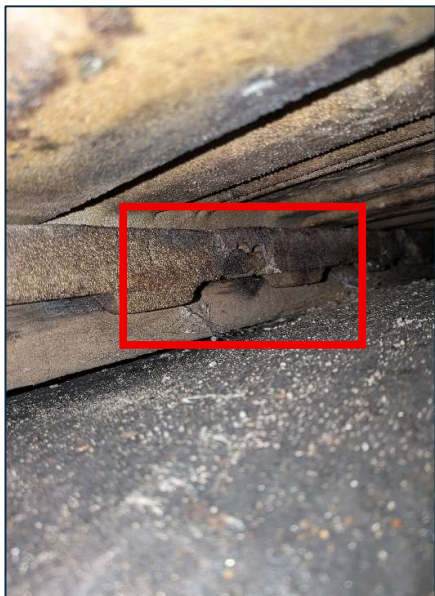
Photo 14: Example of moisture on battens

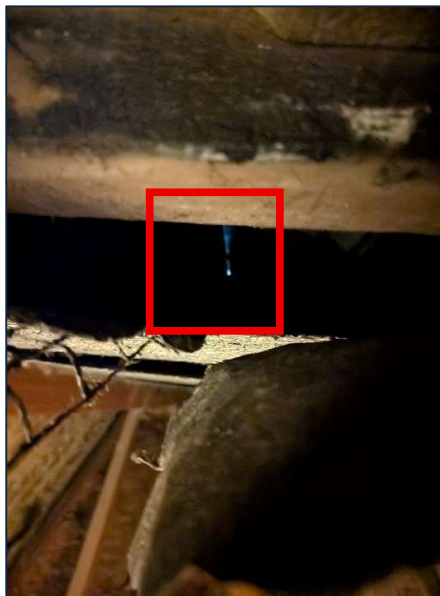
Photo 15: Example of light shining through tile joint

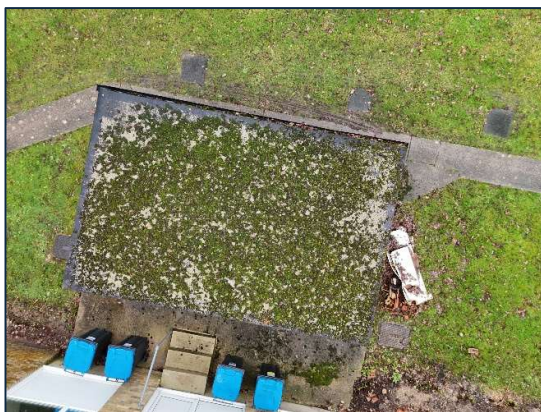
The bin shed roofs were covered in moss and silt so a full survey was not carried out. In accordance with British Standard BS 6229:2018 for flat roofs, the recommended practice, is to perform inspections at least twice a year, ideally in autumn and spring, and after any extreme weather events.

Photo 16: Aerial View of Bin Shed

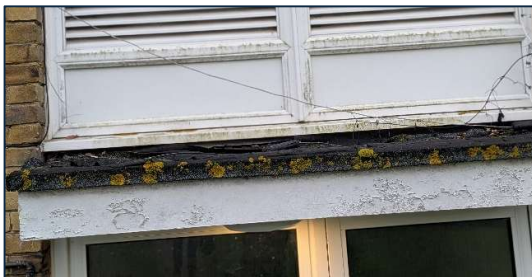
The existing canopy roof coverings are in a dilapidated state and require complete replacement. Furthermore, the fascia exhibits areas of flaking paint, indicating a need for redecoration and maintenance.

Photos 17: Canopy Roof – Typical Example
