SERVICE BULLETIN

WORL DLAWN POWER EQUIPMENT, INC.
2415 Ashland Ave
Beatrice, NE 68310
(402) 228-4255

Bulletin Number: SB1405
Date: 8/15/14

Product Affected: X-Treme, Prowler, and Fuzion mowers with serial number 58436 and above.

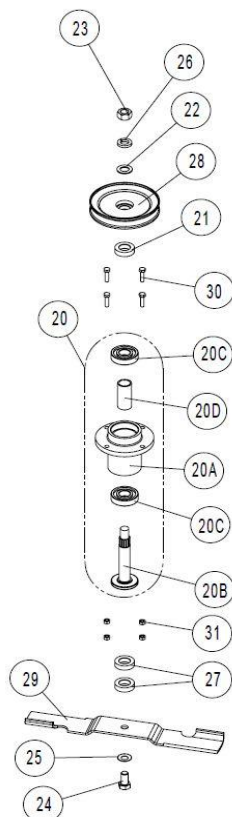
Situation: We had several field failures of the top spindle pulley. The description usually included that the pulley and or spindle shaft splines stripped out.

Solution: We found some parts variances that could cause the flat washer to contact the top of the spindle spline when the top nut was tighten. Should that occur then there would be insufficient clamp load on the top pulley. The insufficient clamp could allow the top pulley to wobble resulting in spindle shaft to pulley failure.

Parts Required: 823015 machined spacer reference Item 22 below
 One per spindle.

Warranty: Should a warrantable failure occur as described above the addition of the washer is warrantable and encouraged.
