Summary of Issues that May Need Attention

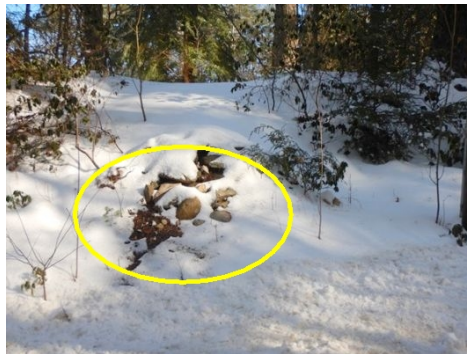
Discharge point

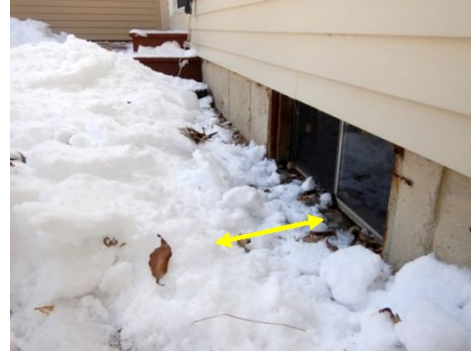
- **CORRECTION:** Grade was level with some basement window sills. This risks storm water and snow melt entering the basement through the windows. Recommend installing window wells or lowering the grade.

Even with basement windows

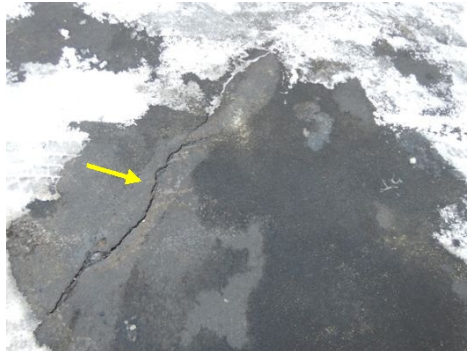
- **MAINTENANCE:** Cracks in the driveway that had been sealed were beginning to open. Cracks greater than 1/4" should be sealed to prevent further damage.

Opening cracks

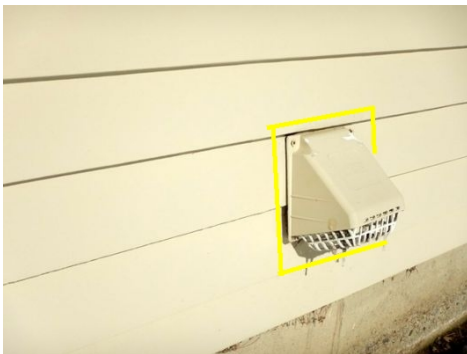
No mounting block

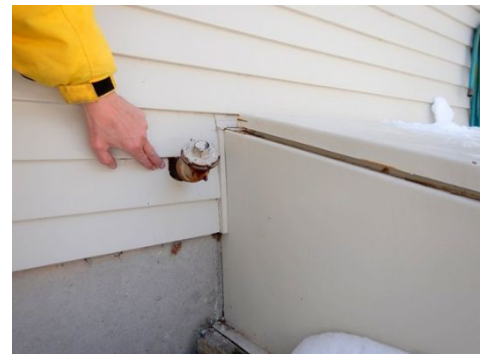
• **CORRECTION:** Some penetrations were lacking a sealant. Recommend caulking to prevent water entry and damage to the substrates and framing.

Missing sealant

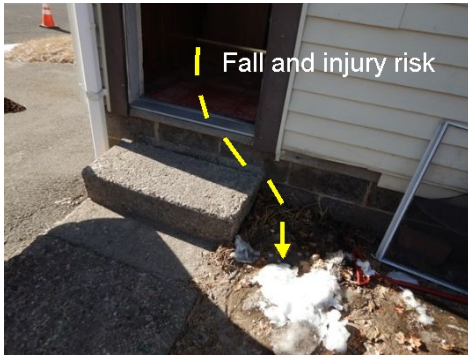
• **IMPROVEMENT:** No hand or guard rails to provide safe passage and protect against falls. Although not required in most municipalities because of the limited height and steps, they are recommended for improved safety.

No handrails

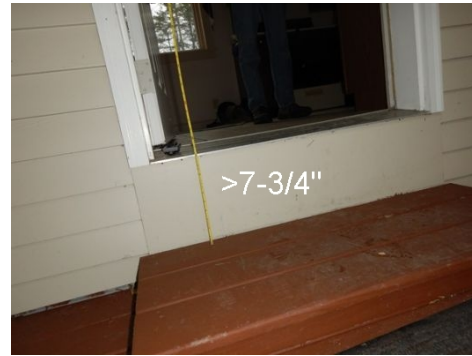
• **CORRECTION:** Excessive riser height leading to the kitchen from the porch. The height should be no greater than 7-3/4" if feasible. Correction needed to reduce the risk of falls and injury.

Excessive step height

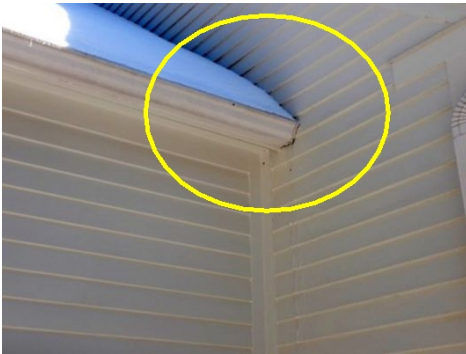
• **IMPROVEMENT:** No kick-out flashing where the roof ends next to a wall. This allows excess water from heavy rain to flow down along the siding and foundation. Recommend consulting a roofing contractor for possible installation.

No kickout flashing

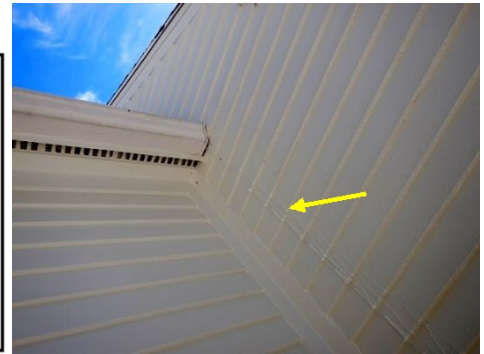
Water wash along siding

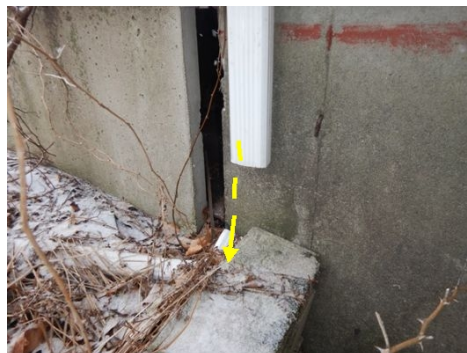
• **IMPROVEMENT:** Some downspouts were discharging near the foundation. The water can increase hydrostatic pressure and frost heaves against the foundation risking cracks and movement. Recommend adding downspout extensions. Splash blocks may help, but they do overflow in heavy weather.

Discharging against foundation

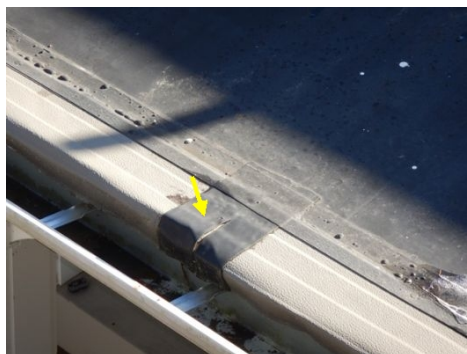
- **REPAIR:** The seams on the metal edge cap were separating. Repair needed to prevent water seepage into the soffit and framing.

Opening seam on metal edge

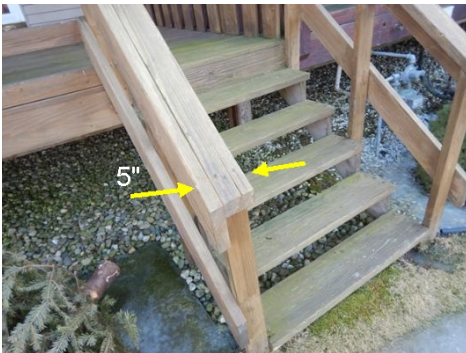
- **IMPROVEMENT:** No graspable handrail. A hand rail needs to be no larger than 2" in diameter to be easily grasped in the event of a fall. Correction needed.
- **CORRECTION:** Stair stringers were spaced more than 18 inches apart. Correction needed.
- **REPAIR:** Weak rail assembly that does not appear sufficient to withstand the requisite 200 lbs of lateral force. Repair needed.
- **CORRECTION:** Horizontal side rails present a climbing invitation to children as well as large openings through which people can slip. This type of construction is not advised. Recommend installing vertical balusters.

No graspable handrail

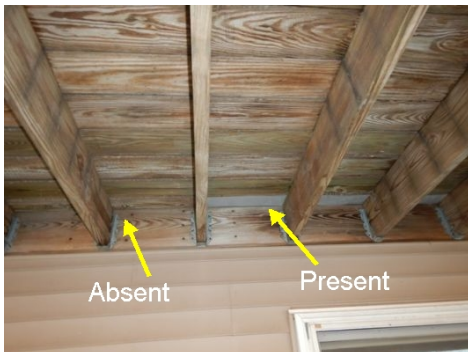
- **CORRECTION:** Incomplete ledger board flashing. Installation along the full length of the ledger is needed to prevent hidden deterioration of the deck support and the house framing.

Missing

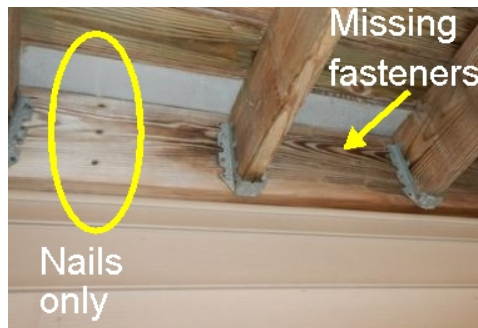
- **CORRECTION:** No structural connections observed (lag screws, LedgerLOK-type, bolts or lateral load connections). Although not required until 2007 in most municipalities, these are recommended preventing lateral load failures as the deck ages.
- **CORRECTION:** Insufficient installation of the existing nails. This weakens the structural attachment and elevates the risks of collapse. Correction needed.

No structural connections; missing fasteners

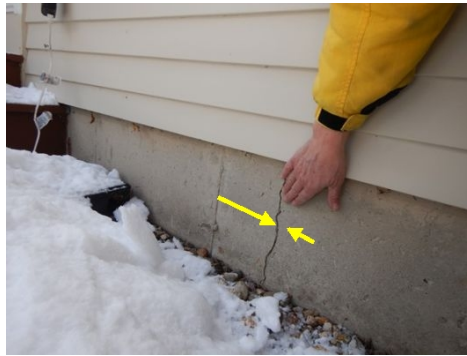
- **REPAIR:** Crack observed on the south wall that had penetrated the full depth of the wall. Repair needed. Recommend consulting a foundation crack company for sealing/patching options that will protect the foundation from water penetration, freezing and damage.

Crack

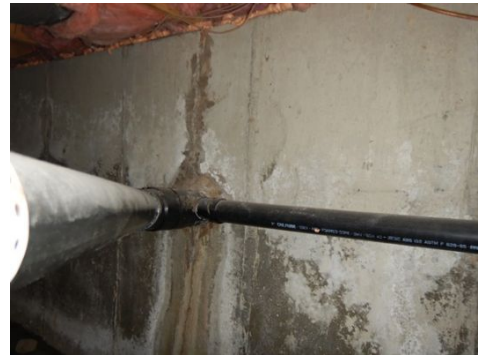
Extends to interior wall

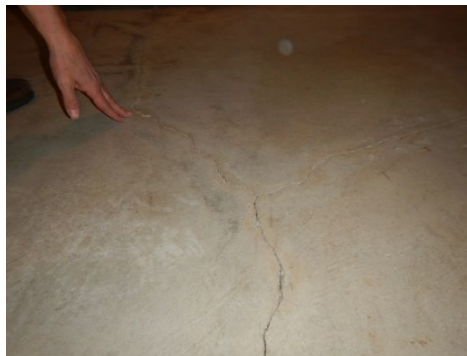
• Cracks observed. These are not uncommon and can be caused by drying shrinkage, thermal contraction, restraint to shortening, subgrade settlement, or applied loads. Recommend monitoring.

Unsealed cracks

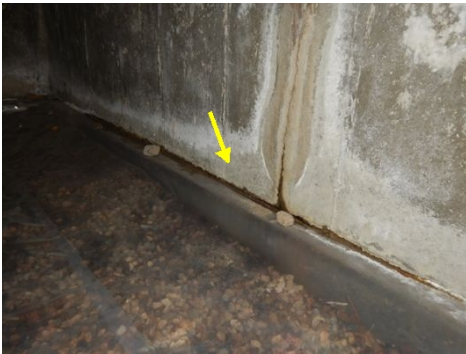
- **REPAIR:** Evidence of active water penetration at the base of the south wall foundation crack. See comment under "Foundation."

Seepage below crack

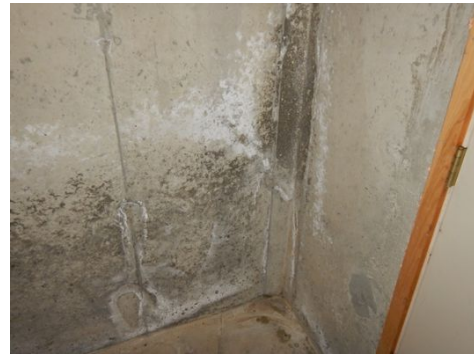
- Basement was dry at time of inspection
- Efflorescence observed along the foundation. This is an indication of accumulating water on the outside of the foundation. The excessive water can create hydrostatic pressure and frost heaves against the foundation. Recommend monitoring.

Efflorescence and dampness in corners

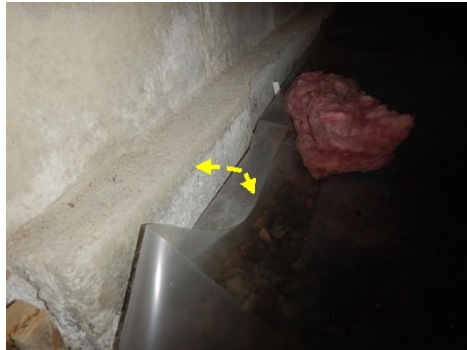
- **IMPROVEMENT:** Plastic vapor barrier present, but without the seams being sealed together or against the foundation. Recommend the seams sealed against each other and the wall. This will help control moisture movement into the home.

Vapor barrier not sealed

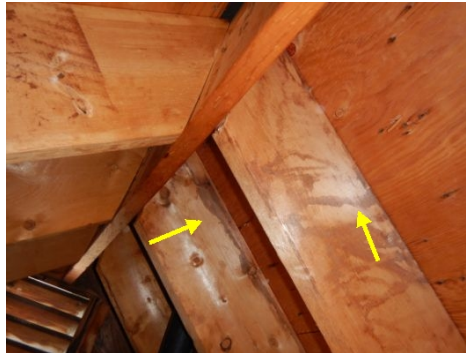
- None visible or accessible
- Evidence of prior water penetration. These areas were dry at the time of the inspection.

Water stains

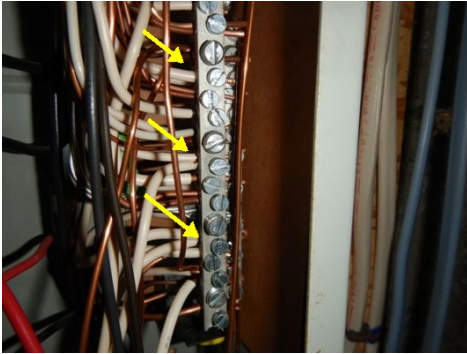
• **CORRECTION:** Multiple common wires were connected to a single lug. In most situation is this not permitted. Correction needed.

Multiple common wires on a shared lug

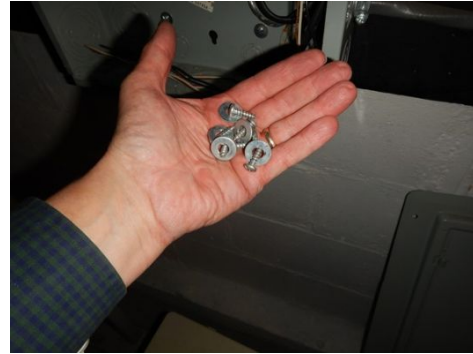
Page 28 Item: 1	Main Panel Condition	<ul style="list-style-type: none"> • CORRECTION: Sharp tipped, sheet metal screw had been used to secure the cover. Screws should be blunt tipped to prevent cutting into the wire insulation. This can result in a shock/electrocution hazard. Replacement with thin-treaded, blunt-tipped screws needed. (To prevent damage to the wires, the inspector only loosely reinstalled them.) • CORRECTION: Multiple common wires were connected to a single lug. In most situation is this not permitted. Correction needed.
Page 29 Item: 2	Main Breaker Condition	<ul style="list-style-type: none"> • CORRECTION: Incomplete labeling of the breakers. This can cause confusion in an emergency, and elevate risk when working on the electrical system. Recommend consulting a licensed electrician to trace the branch circuits and label the breakers. • IMPROVEMENT: No AFCI (arc fault circuit interrupter) protection. Although acceptable in the past, they are advised. If and when an electrician is working in the home's electrical system, it might be advisable to inquire about adding AFCI protection.

Sharp tipped cover screws

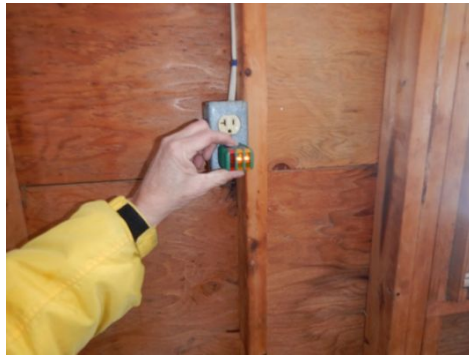
- **REPAIR:** GFCI receptacle did not operate properly when tested. Repair/replacement needed.

Not tripping

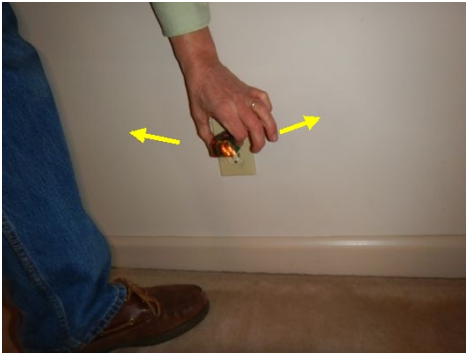
• **REPAIR:** Loose receptacle observed in the first floor bedroom. As these move the connections can become loose and arc. Others maybe present that were not identified by the representative testing. Recommend an electrician evaluate any loose receptacle to confirm the integrity of the wire the connections, and tighten as necessary.

Loose receptacle - 1st floor bedroom

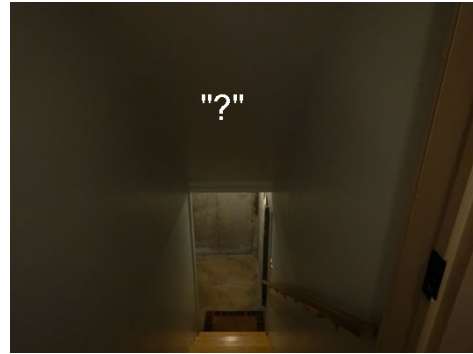
Minimal basement stair illumination

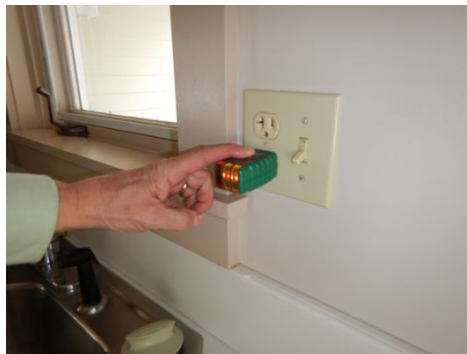
• **CORRECTION:** No GFCI protection. Given today's electrical demands it is recommended that all kitchen receptacles serving a countertop be GFCI protected.

No GFCI protection

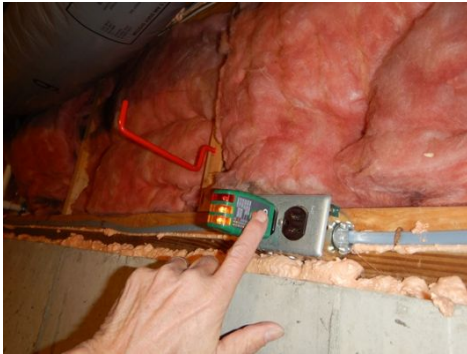
- **CORRECTION:** No GFCI receptacles in the unfinished basement areas. Although acceptable in the past, given today's electrical demands it is recommended that receptacles in unfinished basements be GFCI protected.
- **CORRECTION:** Open electrical boxes. Covers needed.
- **CORRECTION:** Missing cover plates, exposing energized conductors. Installation needed.

No GFCI protection

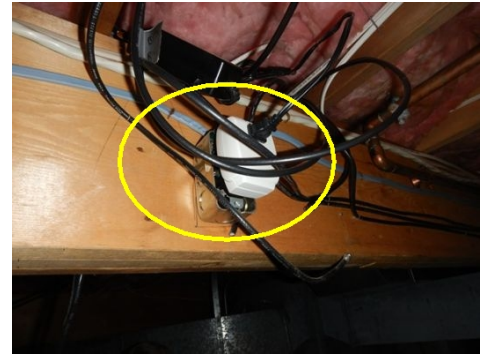
Missing cover plate

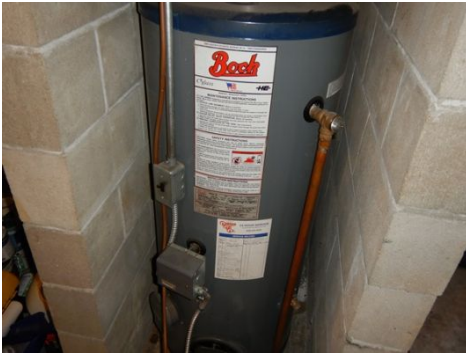
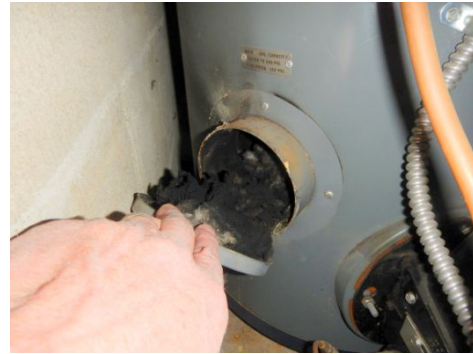
• **IMPROVEMENT:** The inspection port plug was loose allowing soot and exhaust to be pushed out. Some form of improved plug support needed.

Loose inspection port plug

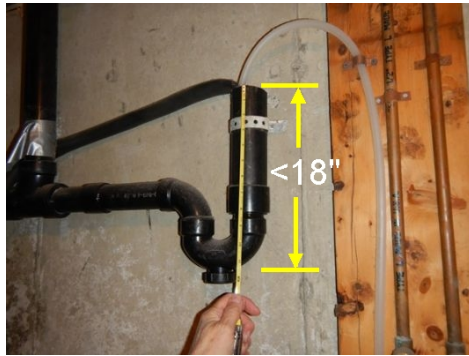
• **CORRECTION:** Stand pipe for the washer drain was shorter than customary. 18" is advised to provide enough volume to keep the pipe from overflowing.

Short stand pipe

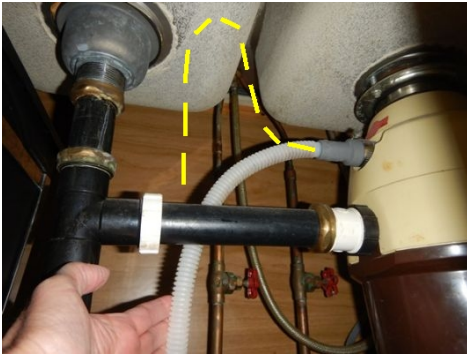
- **CORRECTION:** Insufficient drain loop/air gap provided for the dishwasher. This risks siphoning waste water from the sink into the dishwasher. Recommend installing an air gap, or elevating the drain hose to its highest possible position under the counter.

Insufficient drain loop

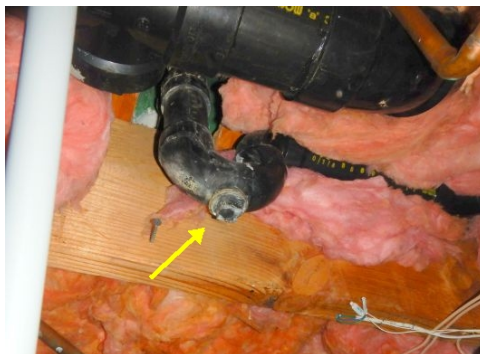
- See comment under "Hot Water Temperature."
- Toilet and sink were in good working order.
- **REPAIR:** The tub trap was leaking in the basement. Repair needed.

Leaking shower trap

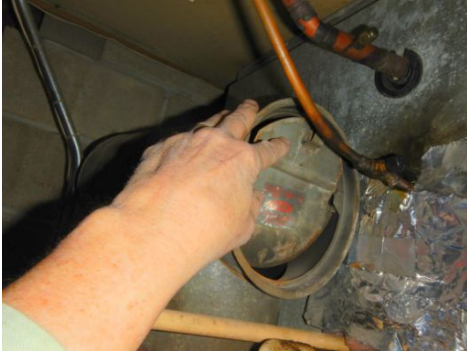
• **MAINTENANCE:** The counter weight on the draft damper was missing. Depending upon the furnace and chimney draft, this may be needed. Recommend consulting an HVAC technician for clarification.

Missing damper counter weight

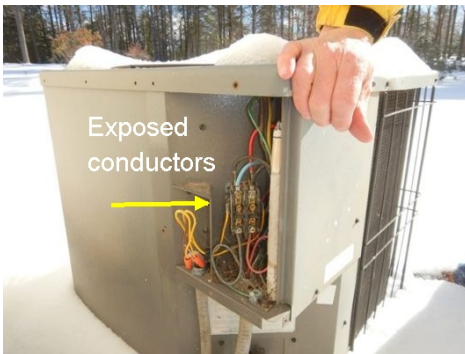
Missing cover panel

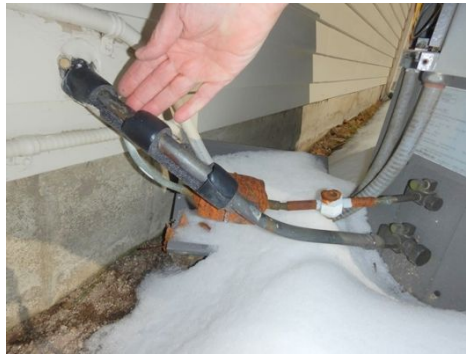
- DOE Home Energy Score Rating: SEER 9
- Compressor, service piping, electrical disconnect, compressor slab and condensate drain inspected
- Visual inspection only. The cold temperature did not allow for operation without risking damage to the components.
- **REPAIR:** The rear panel cover plate had fallen off leaving the energized conductors exposed. Installation needed to protect against electric shock and injury.
- **IMPROVEMENT:** Worn insulation on the exterior service line. Replacement/repair recommended.

Worn insulation

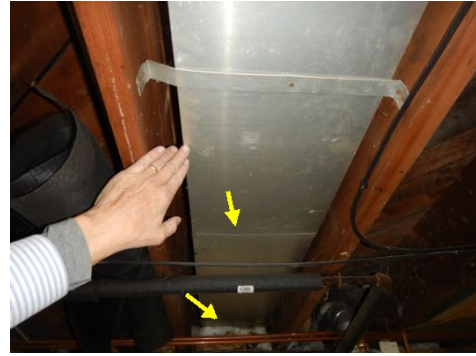
- Insulated and uninsulated areas
- A return register had been cut into the basement return duct. Be sure to keep this closed to maintain balance in the system, as well as to prevent drawing basement mildew and dust into the living areas.
- **IMPROVEMENT:** Duct joints were not sealed. The EPA estimates 20% to 30% of the air that moves through a duct system is lost due to leaks, holes, and poorly connected seams. This will reduce the efficiency of the heating system. Recommend sealing the joints and voids in the ducts.

Unsealed duct joints

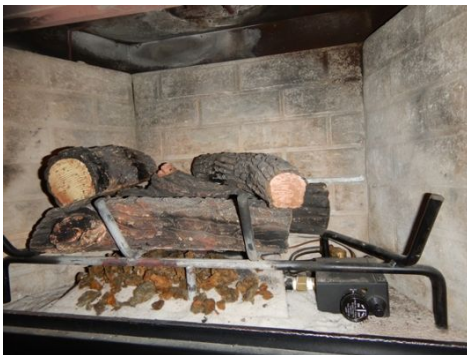
Living room fireplace

- **REPAIR:** The damper was out of alignment. Repair/adjustment needed.
- **MAINTENANCE:** Creosote accumulation was present. Cleaning needed before using to be assured of safe operation.

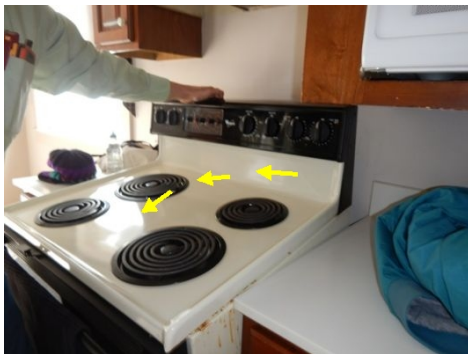
• **CORRECTION:** No anti-tip protection present. The oven was not secured to the floor risking it tipping and spilling hot food. Correction needed for safety.

Missing tip protection

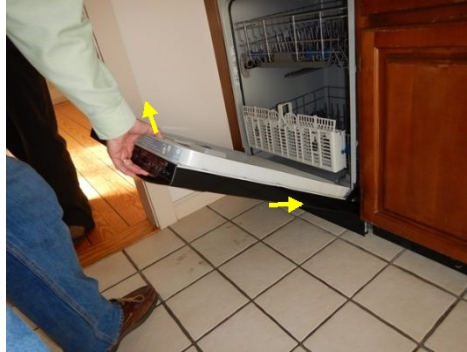
- **CORRECTION:** The Dishwasher was not mounted securely to cabinets allowing it shift. Correction needed.

Loosely mounted

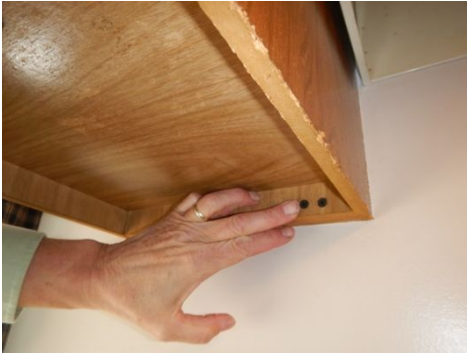
- **CORRECTION:** Wall cabinets were installed with brittle, fluted head drywall screws. It is necessary to have a fastener with significant shear values as well as adequate pull-out resistance to withstand the weight and stress. Correction needed. Recommend replacing with fasteners designed for mounting cabinets.

Drywall screw connections

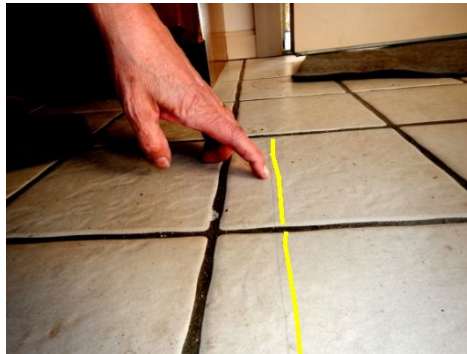
- **REPAIR:** Cracked tiles that present an injury risk to bare feet. Repair needed.

Cracked tile

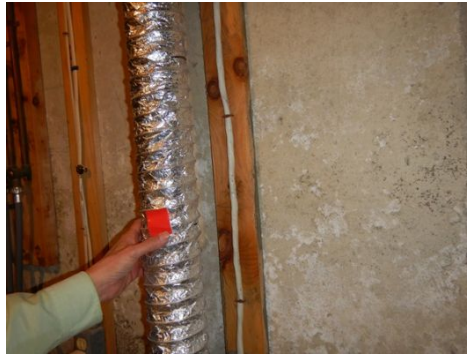
- **CORRECTION:** Flammable mylar/plastic duct present. Replacement with a smooth-walled metal duct needed to reduce fire risk.

Flammable duct

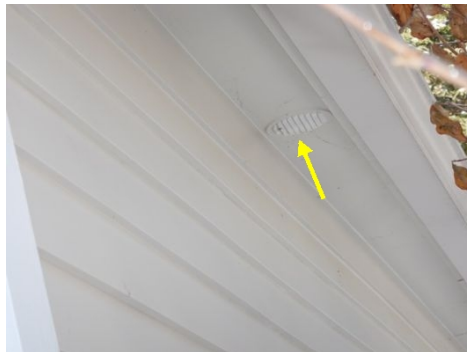
• **CORRECTION:** Tightly louvered exhaust cover. These constrict air flow and offer no backdrafting damper. Replacement needed.

Tightly louvered vent

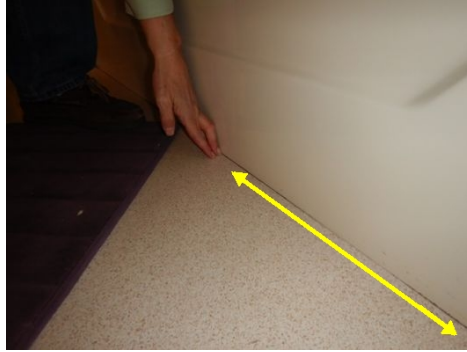
- **CORRECTION:** The floor had not been sealed against the tub. This risks water seeping under the flooring and causing damage. Caulking needed.

Not sealed against tub

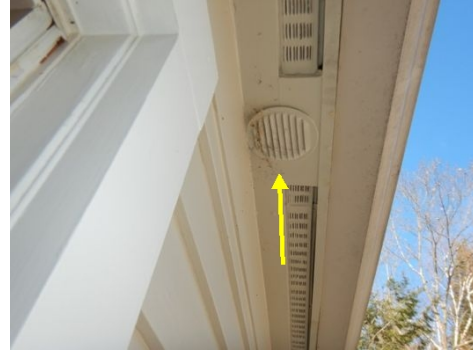
Tightly louvered duct

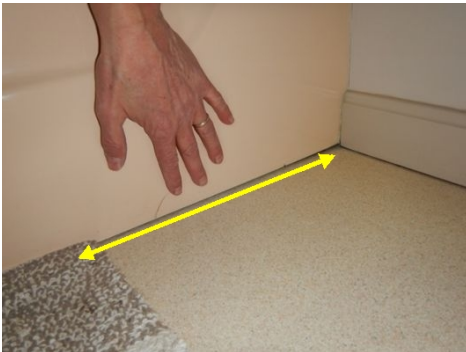
- **CORRECTION:** The floor had not been sealed against the tub. This risks water seeping under the flooring and causing damage. Caulking needed.
- **REPAIR:** Seams were lifting. This risks water seeping beneath the flooring and causing damage. Repair needed.

Not sealed against tub

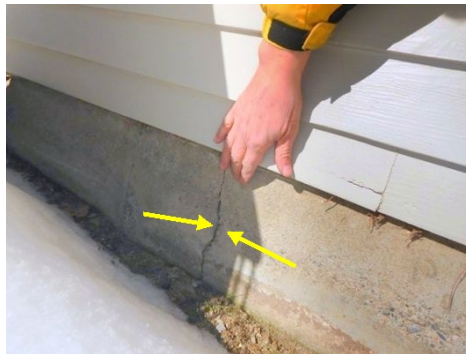
- **REPAIR:** Unsealed crack observed in foundation wall. Recommend sealing to prevent water penetration and further damage.

Unsealed crack

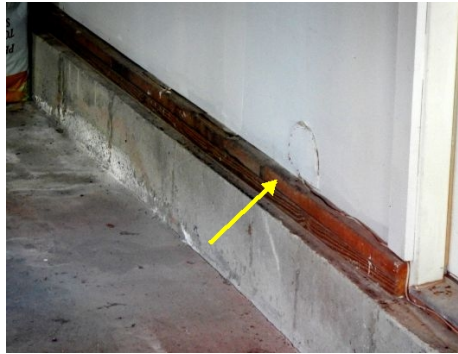
- **CORRECTION:** An access opening beneath the alarm panel had not been sealed with a fire rated material. Cardboard alone had been used. This risks fire migrating to the framing members. Correction needed.

Cardboard patch

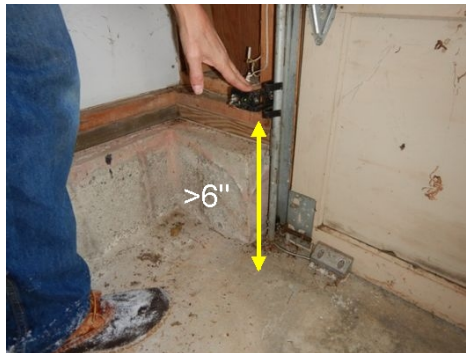
- **CORRECTION:** Electric eye positioned higher than customary. The recommended height is 6" Recommend repositioning.

Excessive electric eye elevation
