## VICTORIA HILL DEPRECIATION REPORT

**THE OWNERS  
STRATA PLAN BCS 1676  
14 East Royal Avenue  
NEW WESTMINSTER, BC**

**INSPECTION DATE: MARCH 2015**

**ACE FILE NUMBER: # 15702**

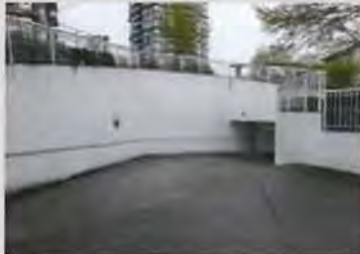
Item # : 1.2.4		<b>Paint - Concrete at Parkade Entrance</b>
		Latex

Year Installed:		2014
Condition		Good
Estimated Replacement Cost		Operating Budget Item

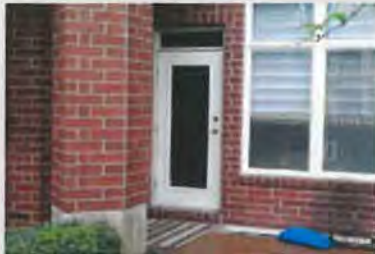
Item # :	1.3.2	<b>Swing Doors</b> <b>Balcony/Patio</b> <b>Glazed Units</b>

Glazed swing doors at balconies appear in satisfactory condition. Life expectancy is 35 years.

Year Installed:	2005	
Condition	Good	
Estimated Life Remaining	25 Years	
Estimated Replacement Cost	\$59,062

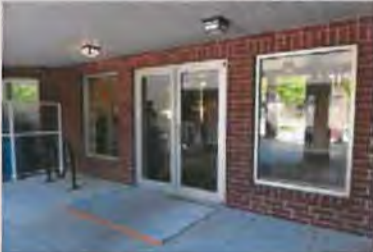
Item # :	1.3.4	<b>Main Entrance Doors</b>
		Storefront Aluminum DBL Door with 2 Aluminum Side Windows

The main entrance aluminum framed storefront glazing units remain in satisfactory condition. Life expectancy is 35 years from time of installation.

Year Installed:	2005	
Condition	Good	
Estimated Life Remaining	30 Years +	
Estimated Replacement Cost	See Comment Above

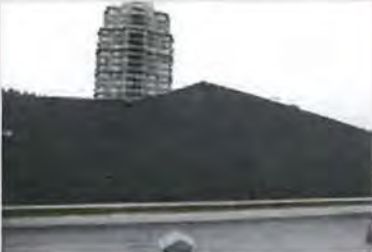
Item # :	1.4.1	<b>Sloped Roofs</b>
		Asphalt Shingle

Year Installed:	2005	
Condition	Good	
Estimated Life Remaining	10 Years	
Estimated Replacement Cost	\$329,128

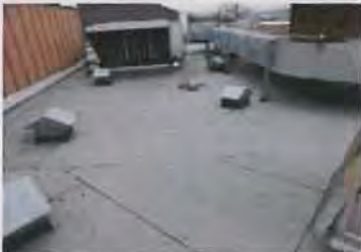
Item # :	1.4.2	<b>Central Flat Roof</b>
		2-Ply SBS

2-Ply torch-on SBS membranes are found in a central area of the upper roof, 2 roof top decks and the small eyebrow roofs above 5<sup>th</sup> floor windows. The central flat roof was installed in 2013 while the roof-top decks and eye-brow roofs remain original. Life expectancy of this type of roof membrane is estimated at 20 years from time of installation.

Year Installed:	2013	
Condition	Good	
Estimated Life Remaining	18 Years	
Estimated Replacement Cost	\$39,420

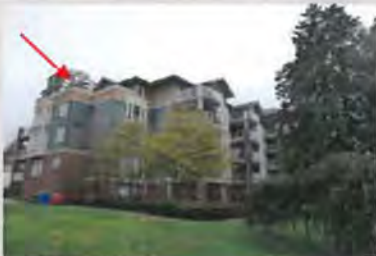
Roof Top Decks	
Item # :	1.4.5
2-Ply SBS with Concrete Paver Wearing Surface

Year Installed: 2005	
Condition: Good	
Estimated Life Remaining: 15 Years	
Estimated Replacement Cost: \$34,320

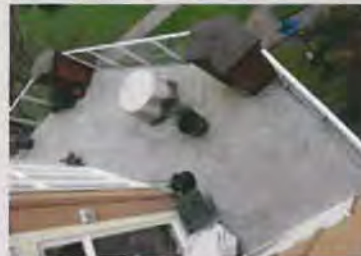
Balcony Membranes	
Item # :	1.4.7
Liquid Applied Polyurethane

Balconies are covered with a liquid applied decking membrane. It is reported that 9 decks have been recoated. The membranes viewed remain in satisfactory condition. Life expectancy is 15-20 years from time of installation.

Year Installed: 2005	
Condition: Good	
Estimated Life Remaining: 20 Years	
Estimated Replacement Cost: \$95,101

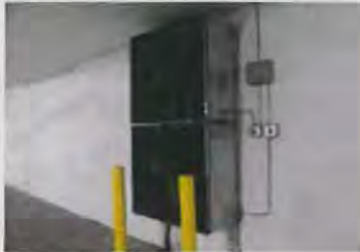
<b>Parkade Exhaust Fans</b>	
Item # :	3.3.2 Greenheck Wall Mounted 2 HP Model SBE-3L30-20

The parkade exhaust fans are operated by the parkade gas fume monitoring system. Parkade exhaust fans maintenance typically includes belt tightening, motor replacement along with greasing of bearings. The 2 large parkade fans are not expected to be replaced in the next 30 years however, refurbishment can be expected. All fans are recommended to be serviced through the Operating Budget.

Year Installed:	2005
Condition	Good
Estimated Replacement Cost	Operating Budget Item

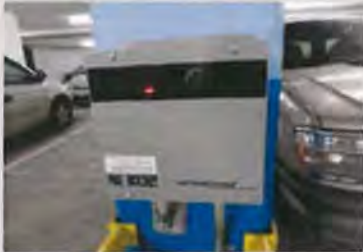
<b>Parkade Gas Detectors</b>	
Item # :	3.3.9 Armstrong

Year Installed:	2005
Condition	Good
Estimated Replacement Cost	Operating Budget Item

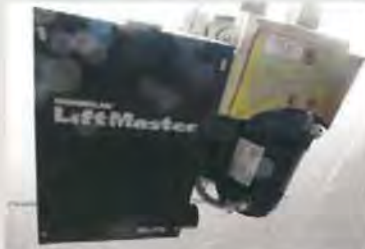
Gate Motor and Lift Assembly #1	
Item # :	3.4.2
Lift Master 1/2 HP Motor and Lift Assembly

Year Installed: 2011 Condition: Good Estimated Replacement Cost: Operating Budget Item

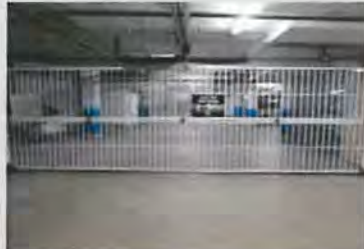
Parkade Entry Gate #2	
Item # :	3.4.3
20' 2-Panel Metal Picket

Year Installed: 2005 Condition: Good Estimated Life Remaining: 30 Years Estimated Replacement Cost: \$15,397

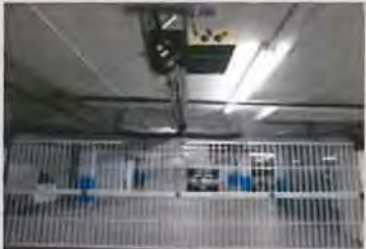
Gate Motor and Lift Assembly #2	
Item # :	3.4.4
Elite 1/2 HP Motor and Lift Assembly

Year Installed: 2011 Condition: Good Estimated Repair Allowance: Operating Budget Item

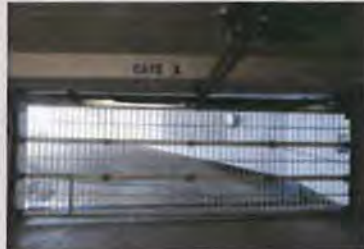
Parkade Entry Gate #3	
Item # :	3.4.5
20' 3-Panel Metal Picket

Year Installed: 2005 Condition: Good Estimated Life Remaining: 30 Years Estimated Repair Allowance: \$15,397

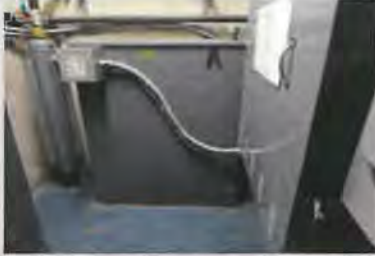
Item # :	5.1.1	<b>Elevator #1</b>
		Richmond Elevator

The building includes 2 hydraulic elevators. The Elevators remain in operational order. It is expected that the elevator will require modernization every 30 years and is included in the Contingency Reserve. Annual inspections and regular maintenance is recommended through the Operating Budget.

Comments: Modernization:		
- Control System		
- Electrical Wiring		
- Tank (pump, motor, valve, muffler)		
- Door Opener		
- Car and Hall Fixtures (position indicator, buttons)		
Year Installed:	2005	
Condition	Good	
Estimated Life Remaining	20 Years	
Estimated Replacement Cost	\$89,157

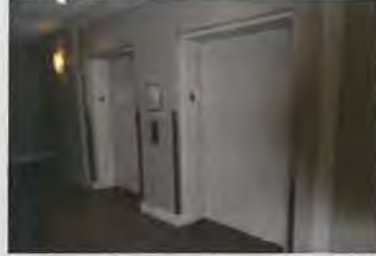
Item # :	5.1.2	<b>Elevator Car #1</b>
		Richmond Elevator

Comments: Modernization:		
Panels & Cosmetics		
Year Installed:	2005	
Condition	Good	
Estimated Life Remaining	20 Years	
Estimated Replacement Cost	\$14,859

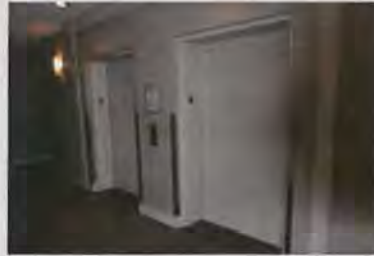
Item # :	5.1.4	<b>Elevator Car #2</b>
		Richmond Elevator

Comments: Modernization:		
Panels & Cosmetics		
Year Installed:	2005	
Condition	Good	
Estimated Life Remaining	20 Years	
Estimated Replacement Cost	\$14,859

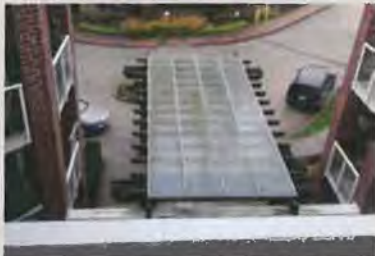
Item # :	8.3.2	<b>Main Entrance Pergola</b>
		Wood Pergola and Glass Canopy

Comments: Replace Wood and Glass		
Year Installed: 2005		
Condition: Good		
Estimated Life Remaining: 25 Years		
Estimated Replacement Cost: \$8,203

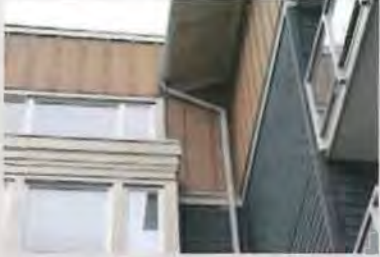
Item # :	8.3.6	<b>Gutters &amp; Downspouts</b>
		Aluminum

Comments:		
Year Installed:	2005	
Condition	Good	
Estimated Life Remaining	30 Years	
Estimated Replacement Cost	\$58,326

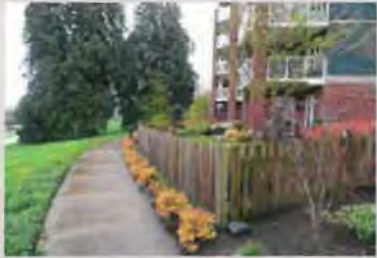
Item # :	8.3.9	<b>Cedar Fence</b>
		4' Cedar Picket

Comments:		
Year Installed:	2005	
Condition	Good	
Estimated Life Remaining	10 Years	
Estimated Replacement Cost	\$10,971
