**Report:** wells2northstar

**Confidential Inspection Report**  
**123 Anywhere Lane**  
**Nantucket, MA 02554**

**August 4, 2021**

**Prepared for: Sample Customer**

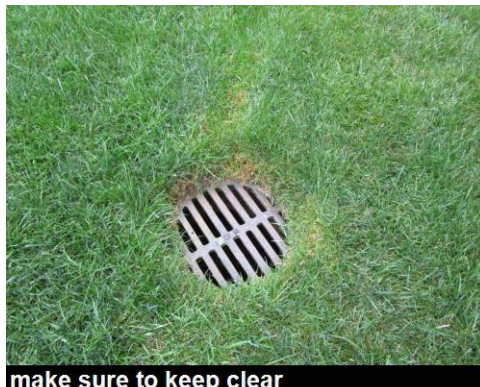
Analysis: The storm drain appears to be for seasonal water collection. The operational condition of the storm drain and any discharge piping are undetermined as they are not **readily accessible** and **observable** for inspection, further investigation is advised. Annual cleaning maintenance will be needed.

make sure to keep clear

Recommendation: You should review the seasonal need for the storm drain and its maintenance with the owner. Ask if there is a town easement for the storm drain. Ask if the yard and the storm drain ever flood or back-up? Ask if the storm drain has an outlet pipe and where it discharges, and when the storm drain was last opened and cleaned?

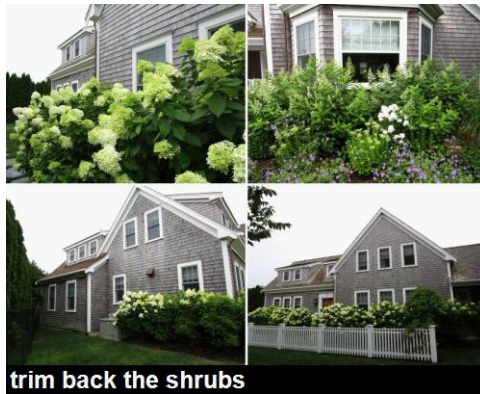
Observation: The shrubs along the perimeter of the foundation are overgrown and are in contact with the home.

Analysis: The shrubs **obstructed** access for inspection of the grading, foundation and siding & trim. There is a risk of concealed problems that were not **readily accessible** at time of inspection - further investigation is needed. Yard maintenance appears to have been postponed. Be advised that overgrown shrubs in contact with the home prevent proper ventilation for the drying of wood siding & trim, and that continuous damp conditions promote mildew, mold, damp rot and wood boring insect infestation. Repair is also needed.

Recommendation: You should hire a landscaper to prune, remove or replace the shrubbery as required to provide a working clearance (24") between the shrubs and the home. Once the problem is corrected, the foundation, basement windows and lower siding & trim should be re-inspected for defects that were **obstructed** at the time of inspection. Be advised that major trees should be at least 20 feet from the home to prevent storm damage and siding and trim should have a minimum 6" clearance from the soil. **WARNING** - be on alert for hidden bees nests. If through your negotiations access becomes possible, components become **readily accessible**, repairs are done or systems are restored, you may desire to schedule a "return visit" inspection with this office, at an additional charge, prior to purchase.

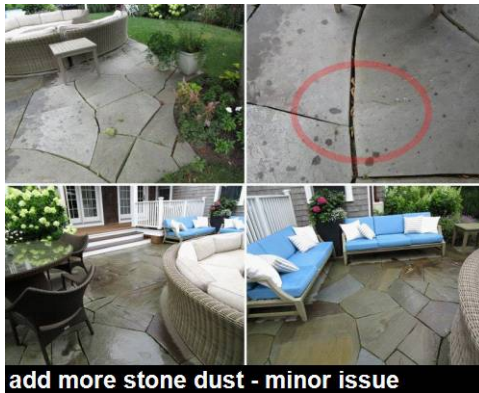
Observation: Where readily accessible at time of inspection, inspection of the patio revealed the following problems:

Analysis: The above listed problems are in need of repair to restore function.

Recommendation: You should ask a licensed and insured contractor to provide a repair cost estimate **NOW**, in order to determine the impact on your budget.

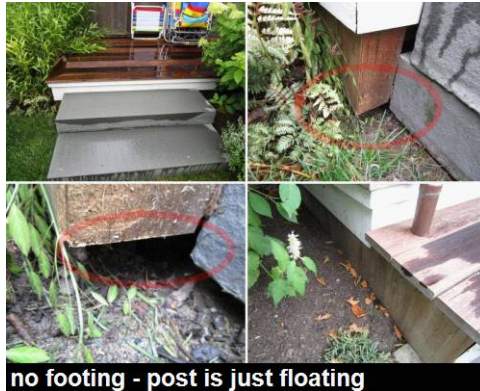
- Missing footings
- Wood stringers are in Earth contact. (Note: Even treated lumber is conducive for decay or pest infestation).
- The wood support posts are not mechanically fastened to the footings to prevent movement.

Analysis: The above listed problems are part of the means of egress from the dwelling and must be maintained in a safe and functional condition to prevent personal injury to anyone using the entrance. **URGENT** safety repairs are needed.

Recommendation: You should ask a licensed and insured contractor to further investigate the entrances and to provide a cost estimate for repairs or replacement **NOW**, in order to determine the impact on your budget. All repairs should be done in accordance with the requirements of the building code.

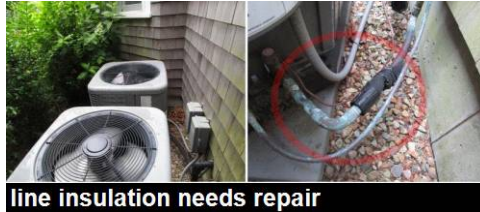
**line insulation needs repair**

Recommendation: All aged, missing or damaged insulation should be replaced as needed.

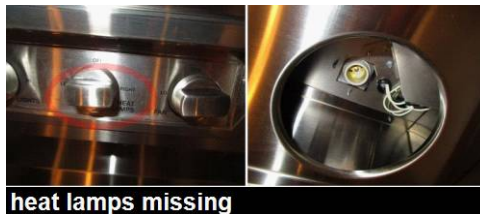
\*\* **Functional with EXCEPTIONS noted below:** Notice: Testing of microwave ovens is **EXCLUDED** from this report.  
Observation: Inspection of the range hood or exhaust fan revealed the following problems:  
 • Missing light bulb, operational condition undetermined.  
Analysis: Repair is needed to restore function.  
Recommendation: You should ask a licensed and insured electrician to provide a repair/replace cost estimate **NOW**, in order to determine the impact on your budget.  
 Note: Professional inspection by a electrician may reveal additional problems not documented in this report.

heat lamps missing

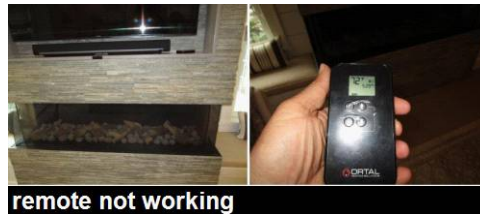
remote not working

Recommendation: Have the owner show the proper use of the gas fireplace.
