Test Report For:
SPIG Industries, LLC
SGET End Terminal

TESTED TO:
Manual for Assessing Safety Hardware (MASH 2016)
Test 3-30

TEST REPORT NUMBER:
TR-P38034-01-NC

REPORT DATE:
August 20, 2018

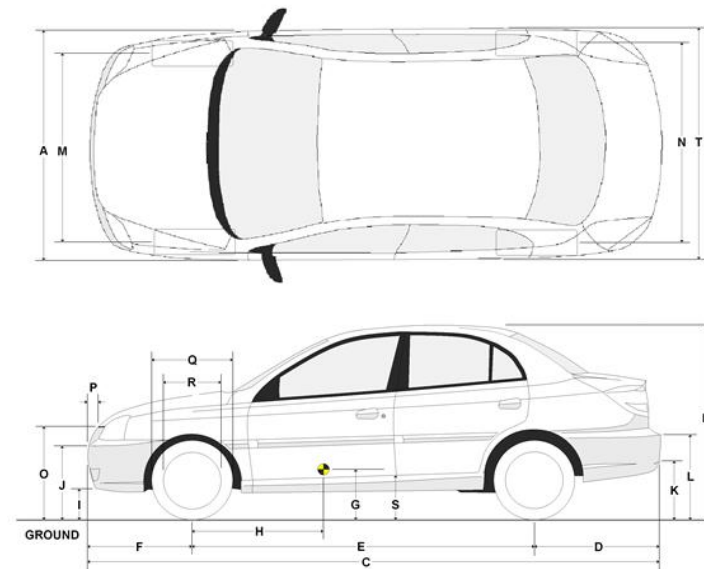
The vehicles hood height and average track width were out of tolerance as specified in MASH. MASH recommends that the hood height be between 20.0 in. (508 mm) and 28.0 in. (711 mm). The recorded hood height was 29.7 in. (755 mm). MASH also recommends that the average track width be between 54.0 in. (1,372 mm) and 58.0 in. (1,473 mm). The test vehicle's track width was recorded as 59.4 in. (1,509 mm).

Despite the hood height dimensions falling out of the MASH tolerance, KARCO utilized the test vehicle because it was determined that the dimension would not have a significant effect on the performance of the system for this test. For Test 3-30, the impact head engages the front end of the vehicle. The hood and grill are constructed of sheet metal and plastic with little structural integrity. These components crush during impact and do not significantly affect the vehicle dynamics during the impact event.

In summary the out of tolerance average wheel track and hood height were deemed to have an insignificant effect on the outcome of the test. The test vehicle information can be found in Figure 1.

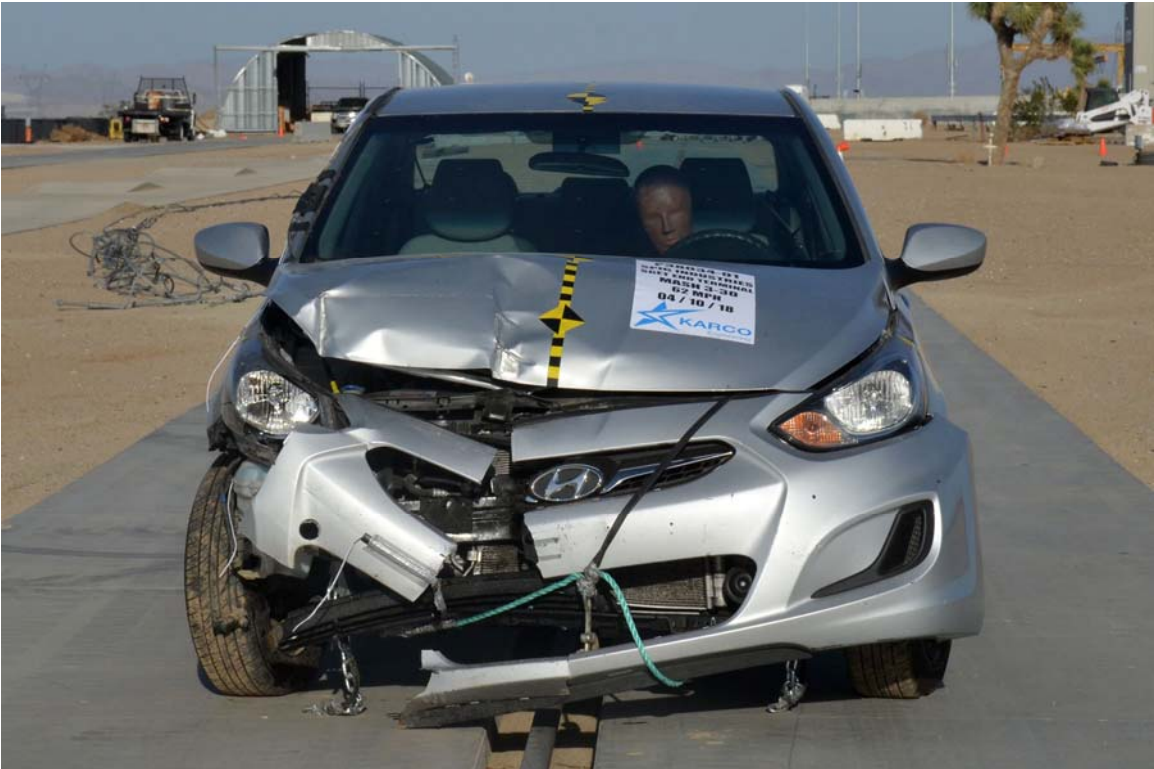
The vehicle's damage was concentrated at its front end. The front bumper beam was crushed at its center and pushed back into the radiator. The radiator and its support were deformed. The hood was deformed and the sheet metal was separated at the right-front side. The bumper fascia and right headlight were also damaged. The occupant compartment was not penetrated and the deformation limits were not exceeded.

FIGURE 42. Post-Test Front View of Test Vehicle
