Test Report For:  
**SPIG Industries, LLC**  
**SGET End Terminal**

TESTED TO:  
**Manual for Assessing Safety Hardware (MASH 2016)**  
**Test 3-30**

TEST REPORT NUMBER:  
**TR-P38034-01-A**

REPORT DATE:  
**August 20, 2018**

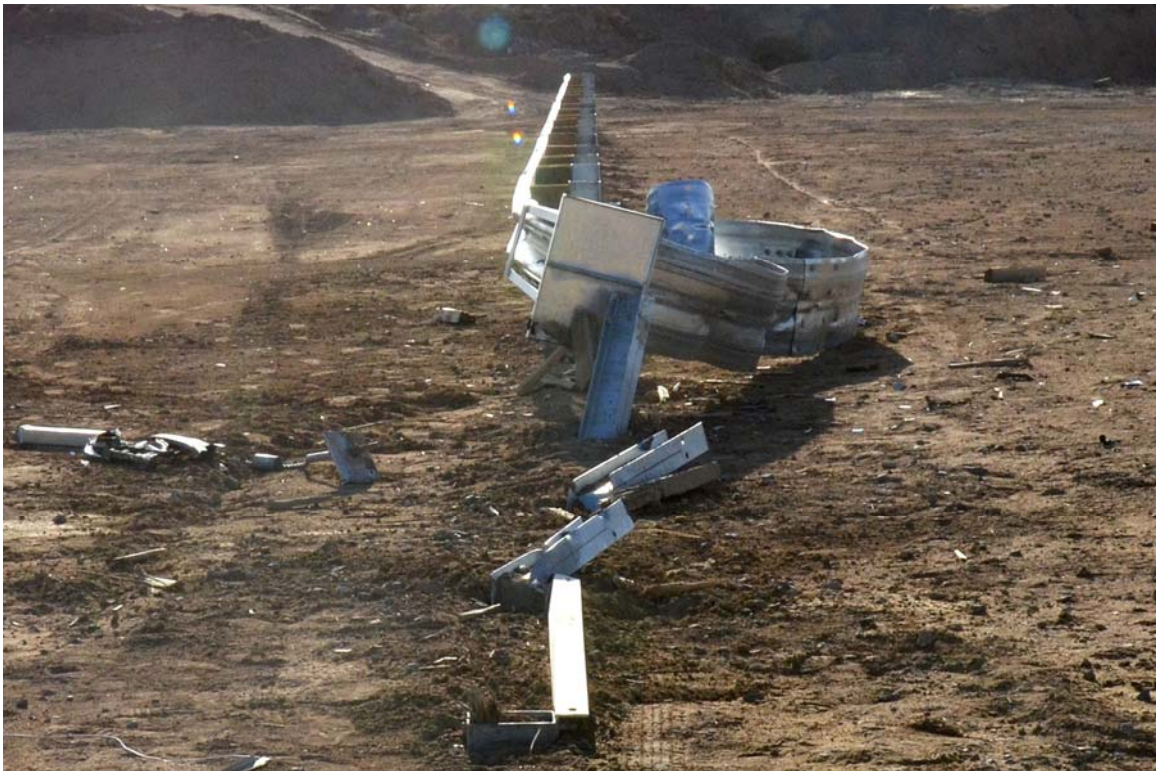
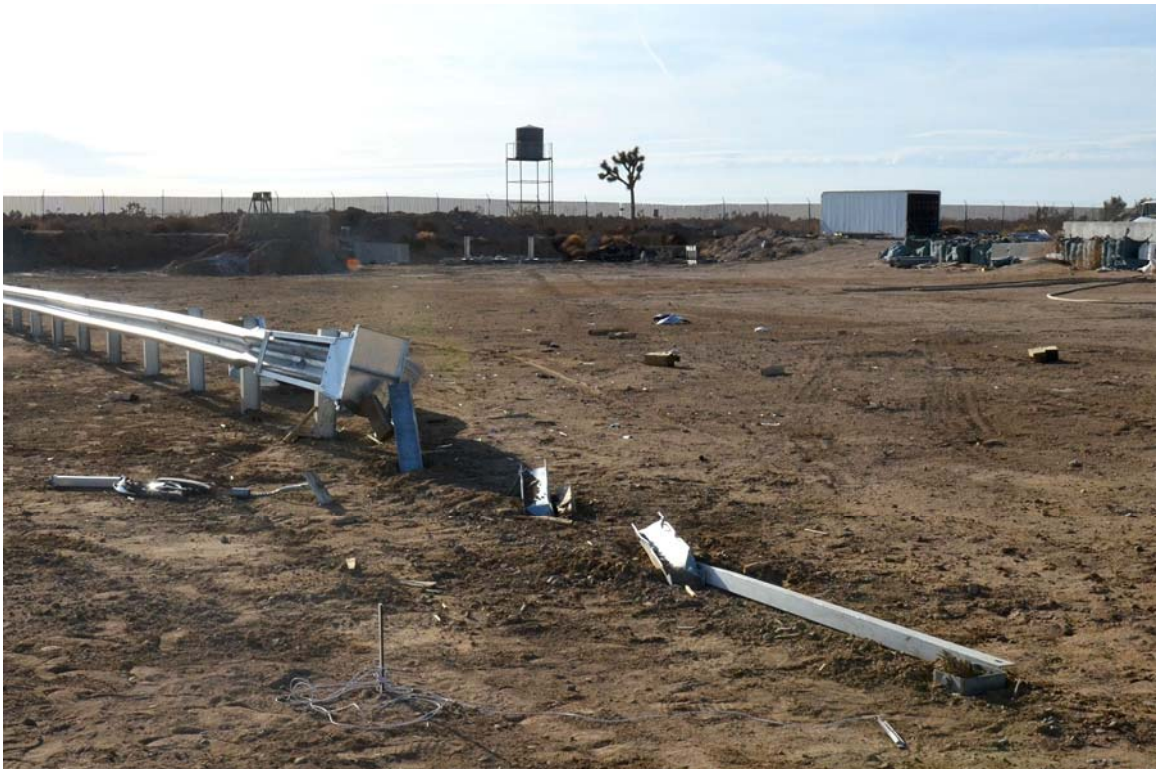
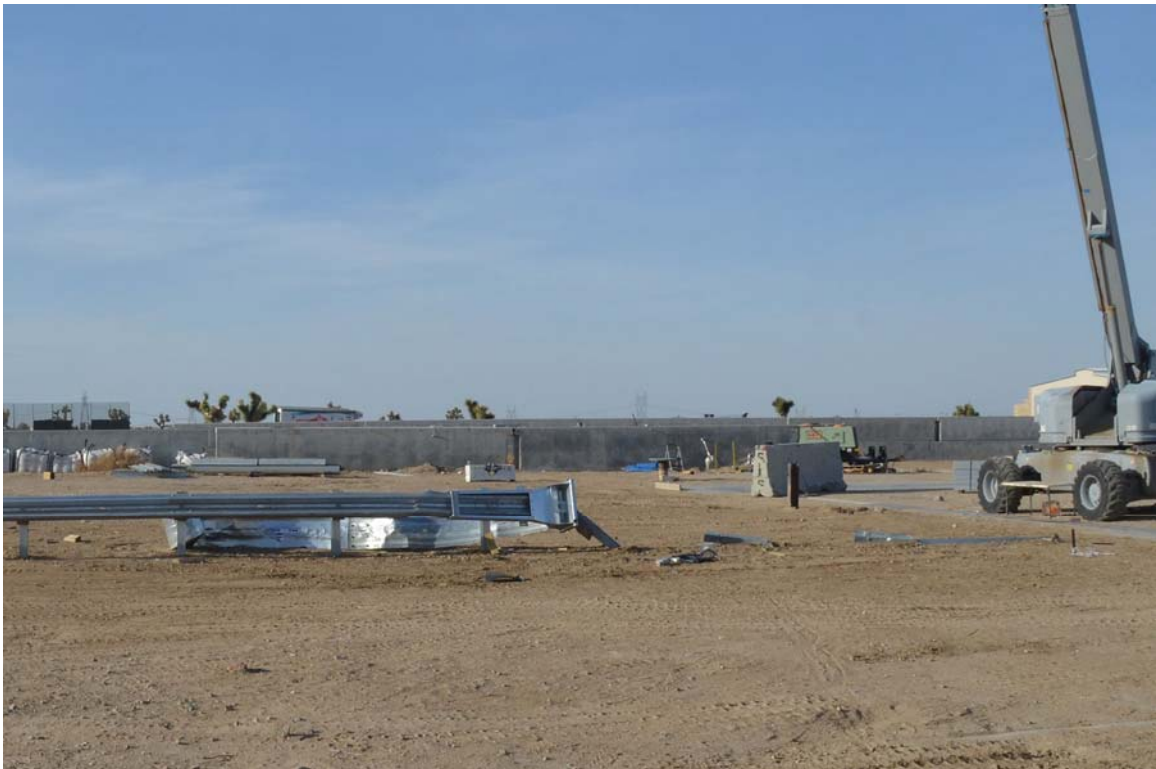
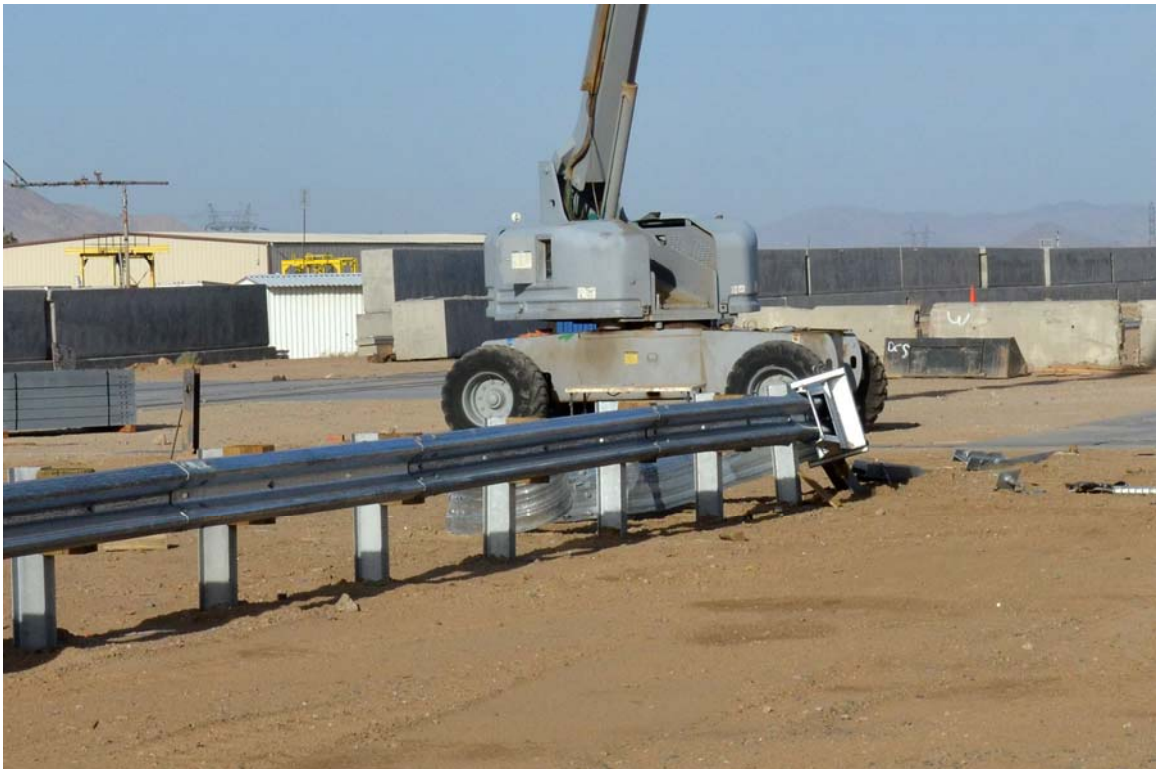
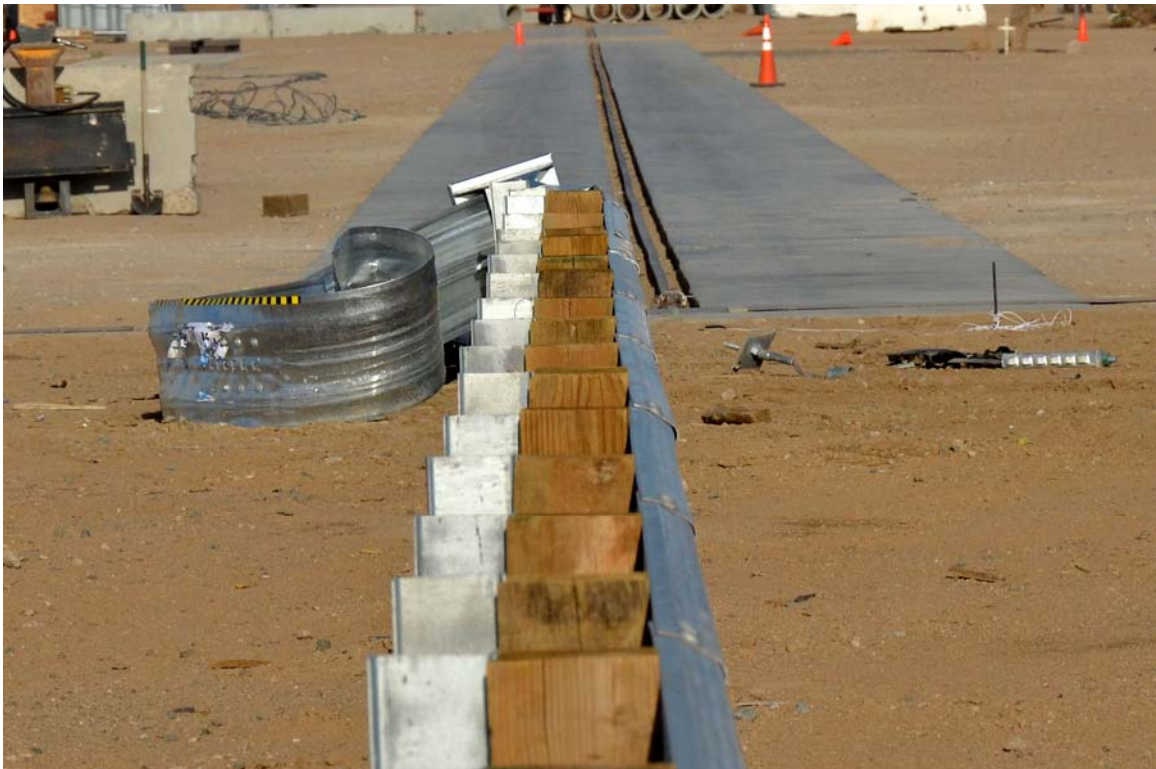
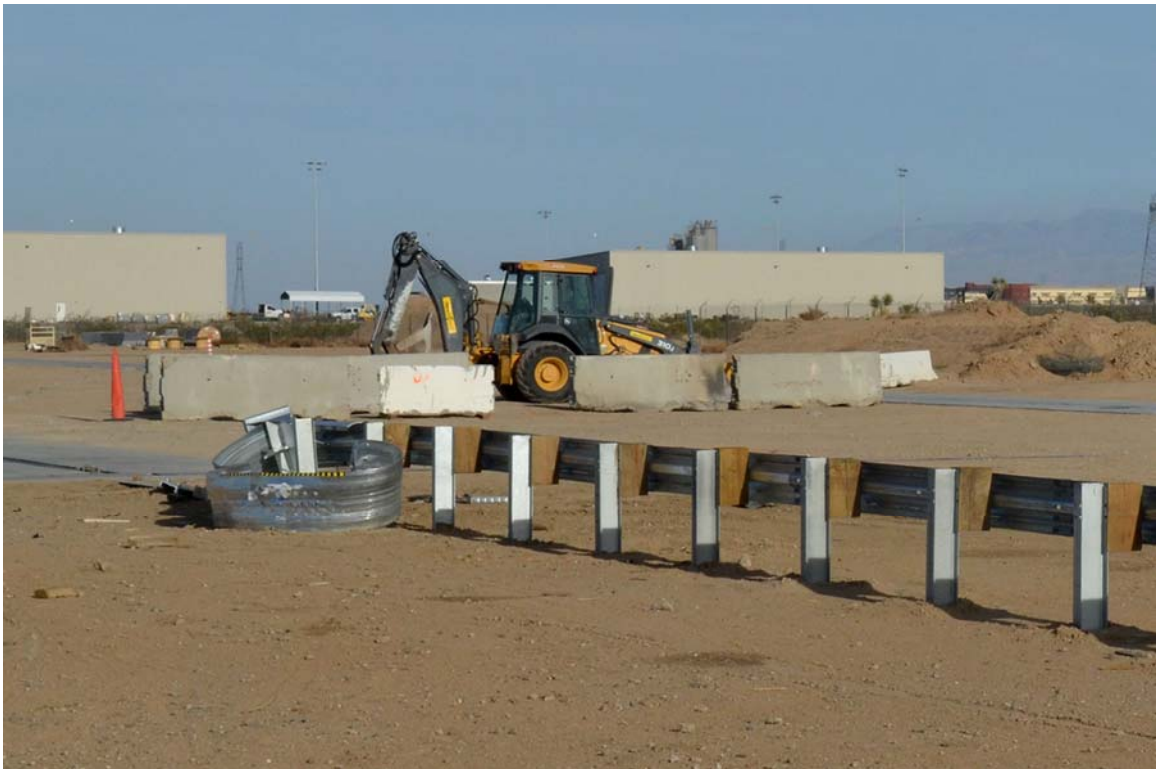
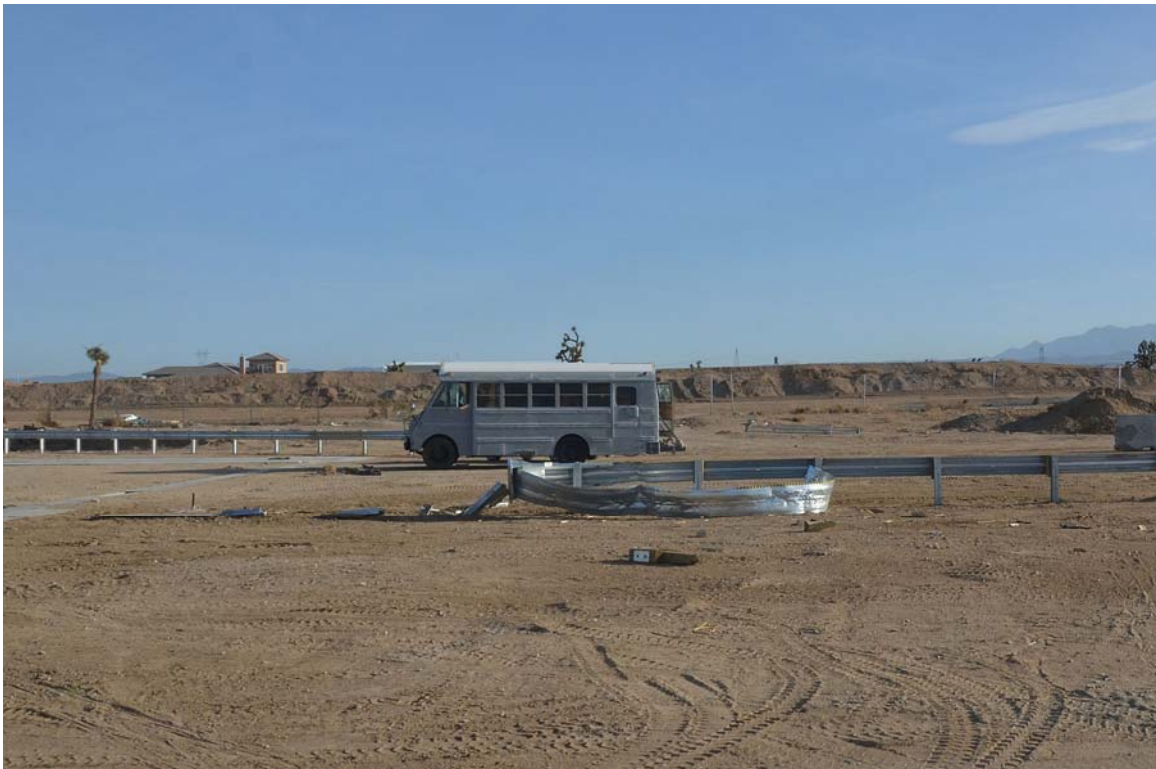
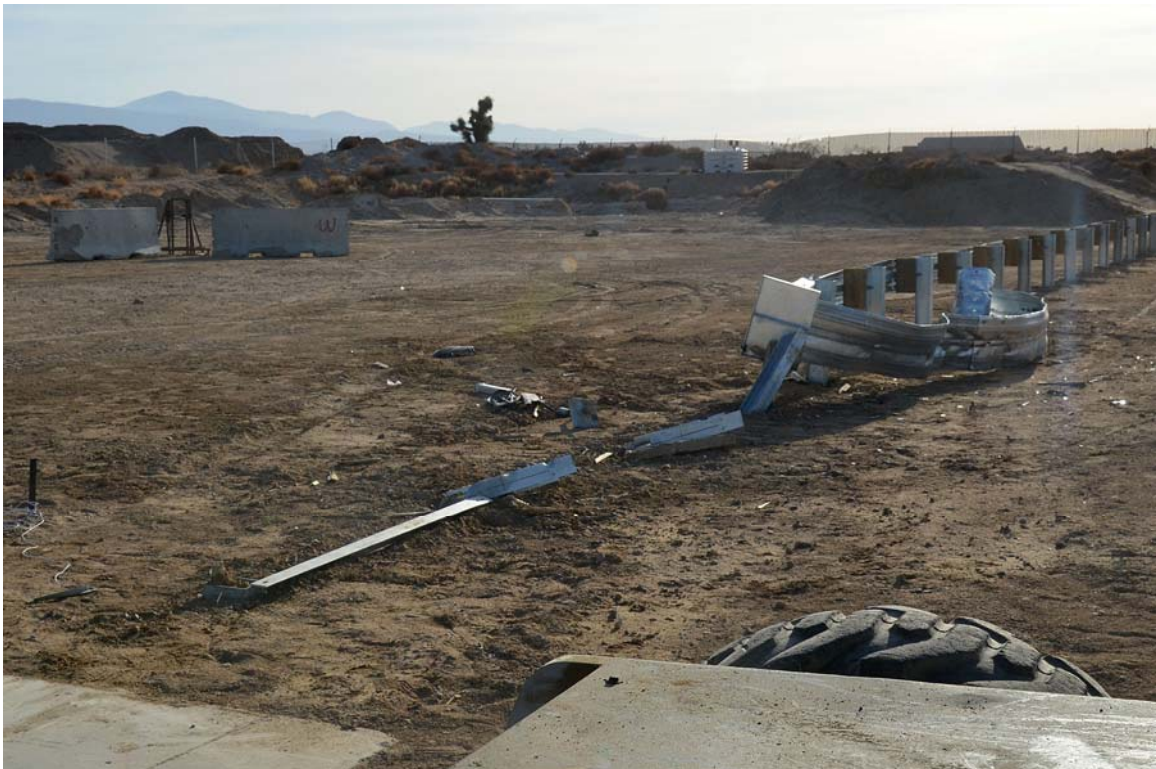
The system was damaged from post 1 through post 5 and there was approximately 28.1 ft. of damaged guardrail. The strap on the downstream end of the impact head broke at its welds and detached from the head. The guardrail grabber had a dent at its upstream end from the contract with the impact head. The ground strut had no visible damage.

FIGURE 16. Post-Test Front View of Test Article

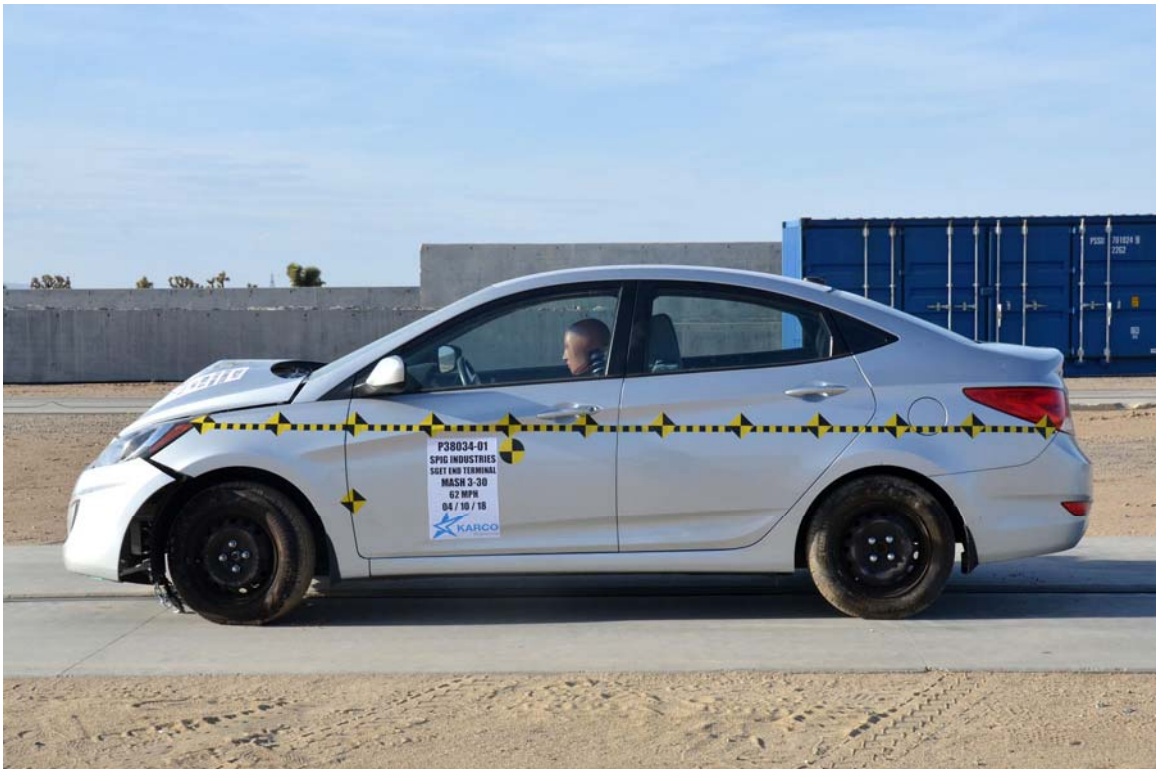
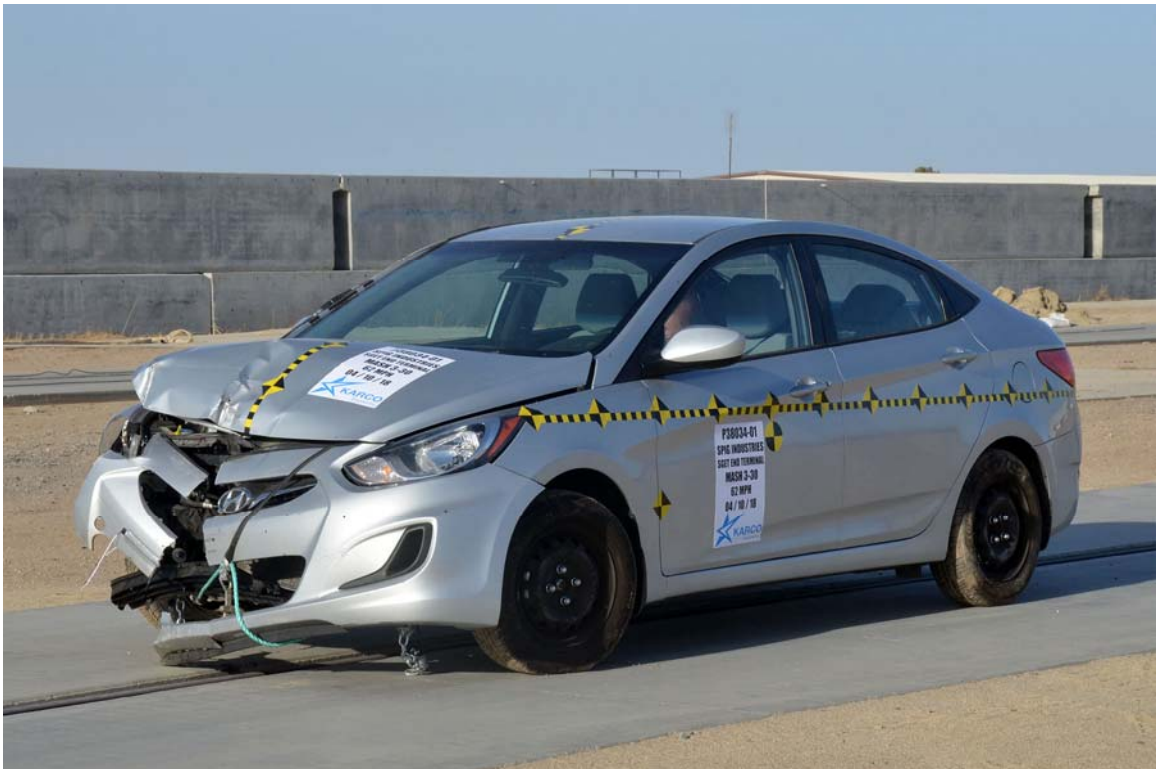
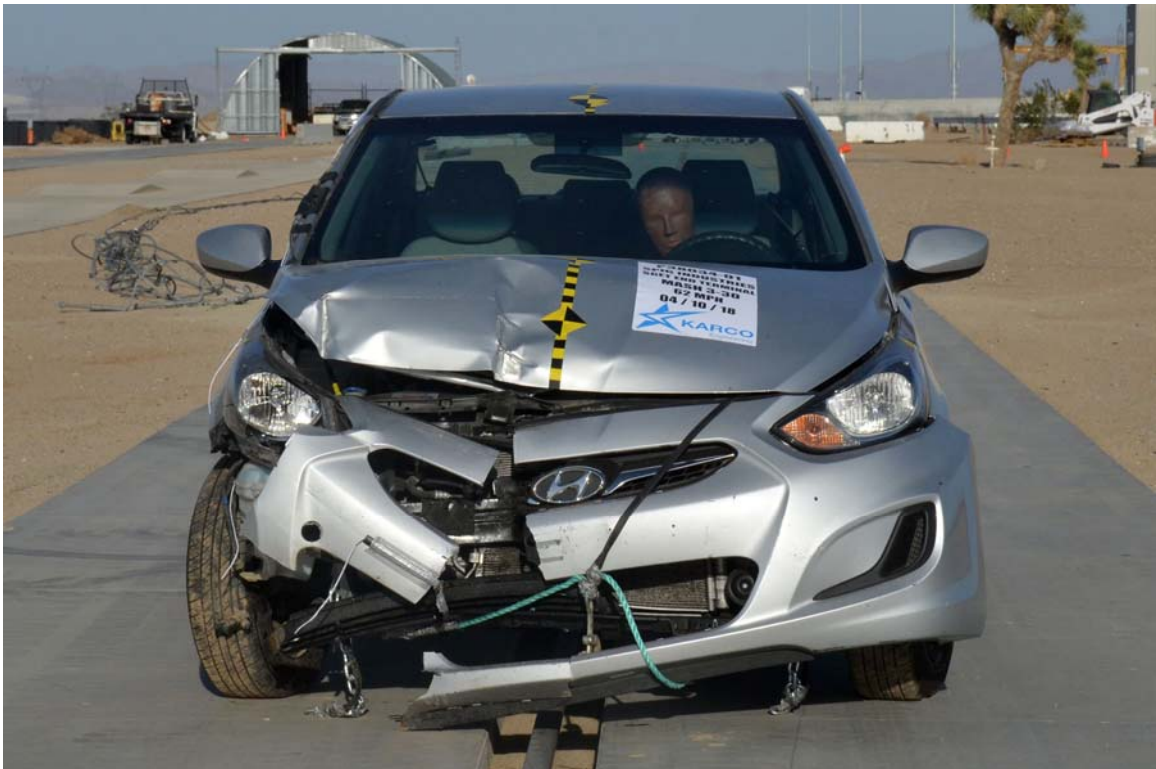
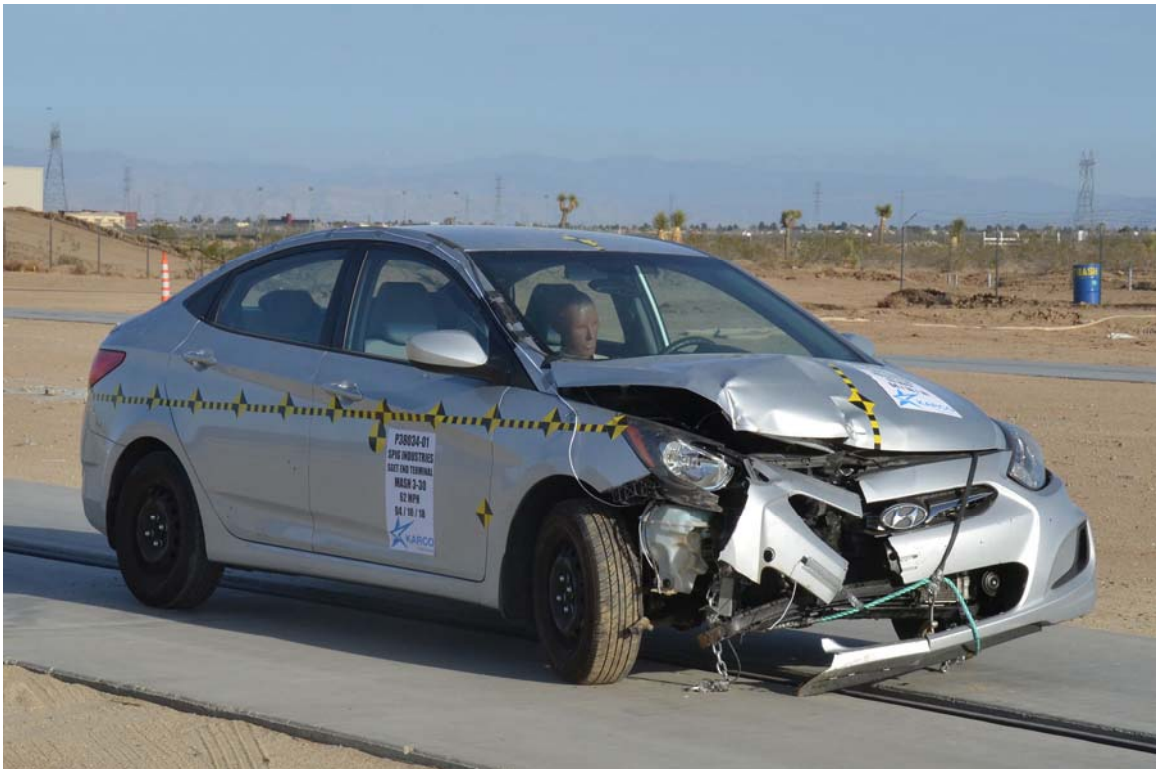
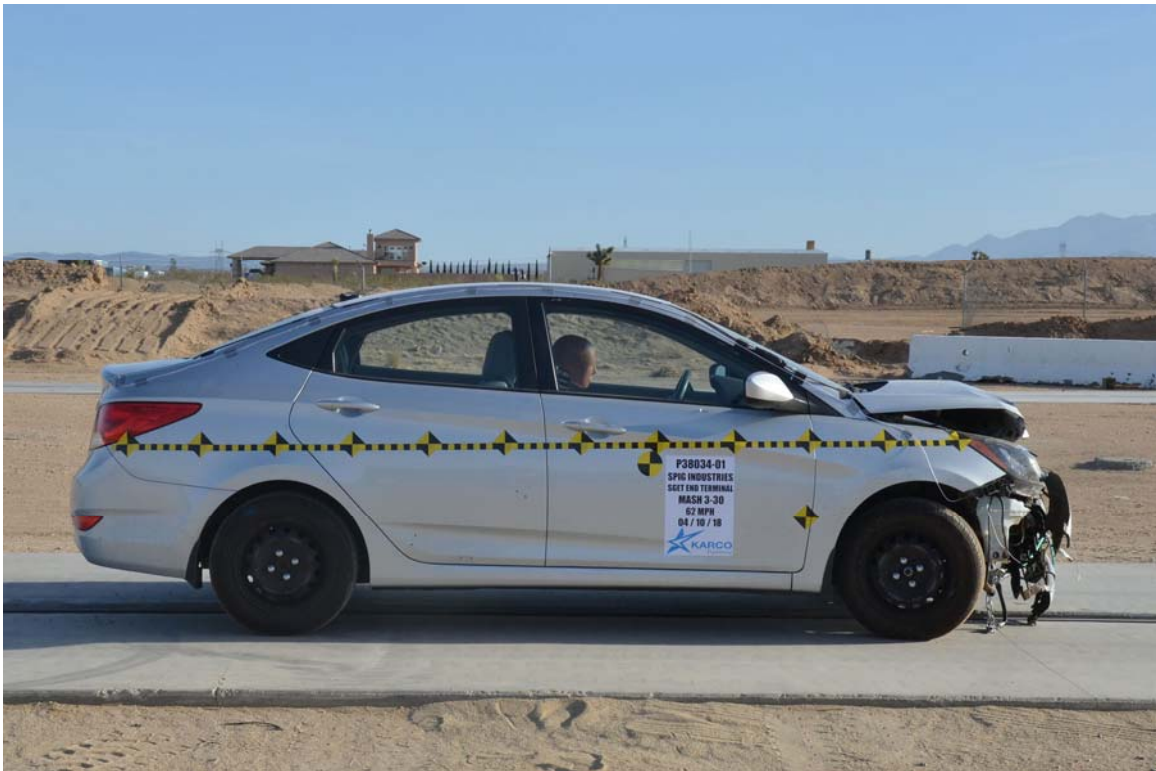
The vehicle's damage was concentrated at its front end. The front bumper beam was crushed at its center and pushed back into the radiator. The radiator and its support were deformed. The hood was deformed and the sheet metal was separated at the right-front side. The bumper fascia and right headlight were also damaged. The occupant compartment was not penetrated and the deformation limits were not exceeded.

FIGURE 38. Post-Test Left View of Test Vehicle
