Test Report For:  
**SPIG Industries, LLC**  
**SGET End Terminal**

TESTED TO:  
**Manual for Assessing Safety Hardware (MASH 2016)**  
**Test 3-32**

TEST REPORT NUMBER:  
**TR-P38107-01-NC**

REPORT DATE:  
**August 20, 2018**

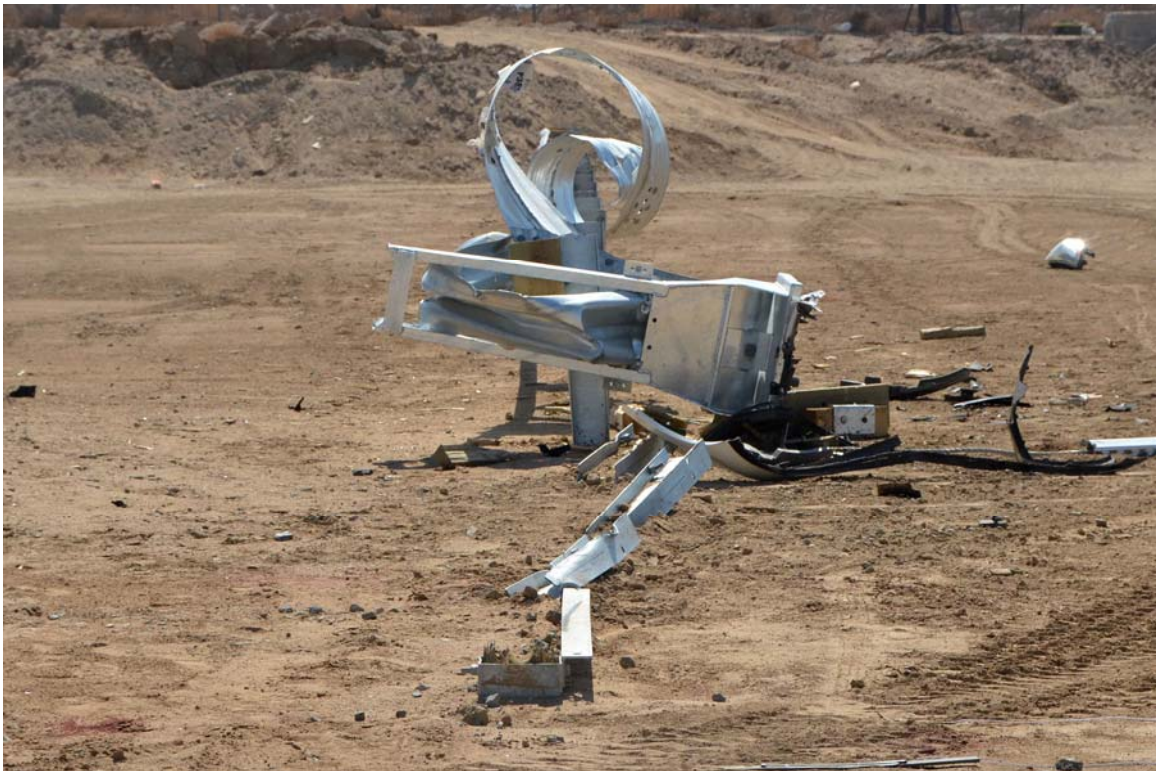
The system was damaged from post 1 through post 5 and there was approximately 31.3 ft. (6.5 m) of damaged guardrail. The mounting tabs were bent on the impact head and there was no other visible damage. The guardrail grabber had a dent at its upstream end from the contract with the impact head. The ground strut had cosmetic damage.

FIGURE 16. Post-Test Front View of Test Article

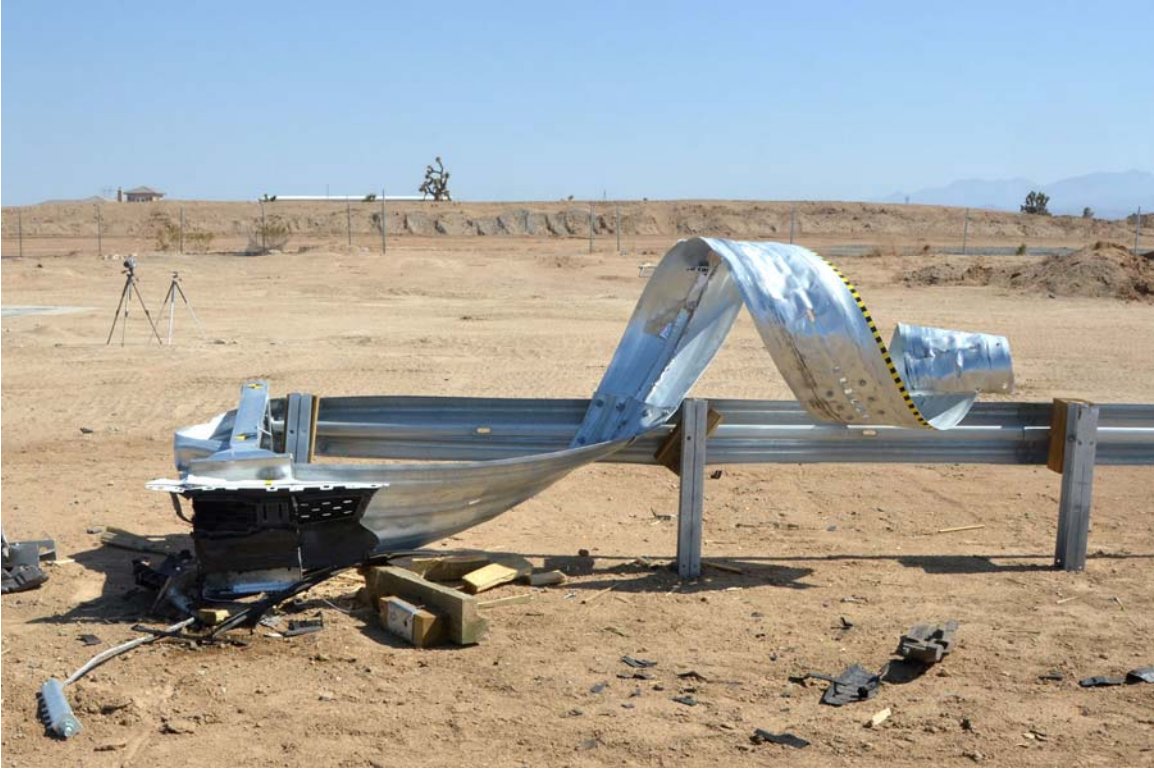
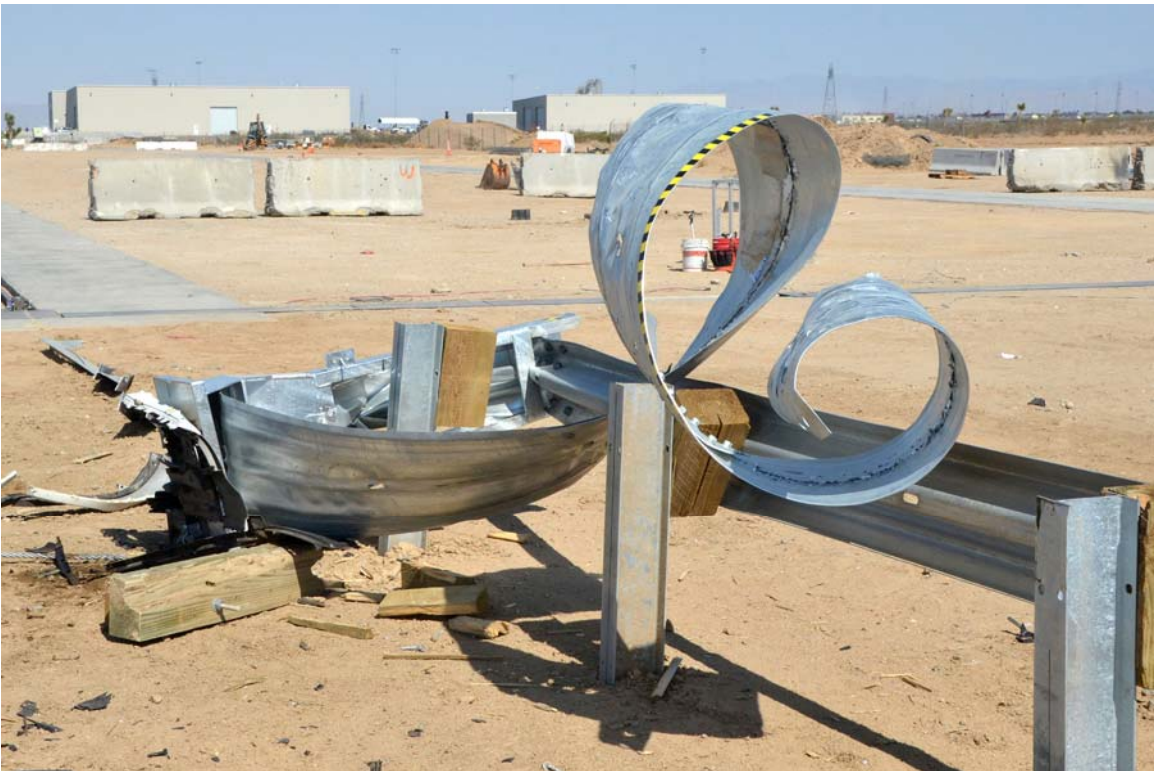
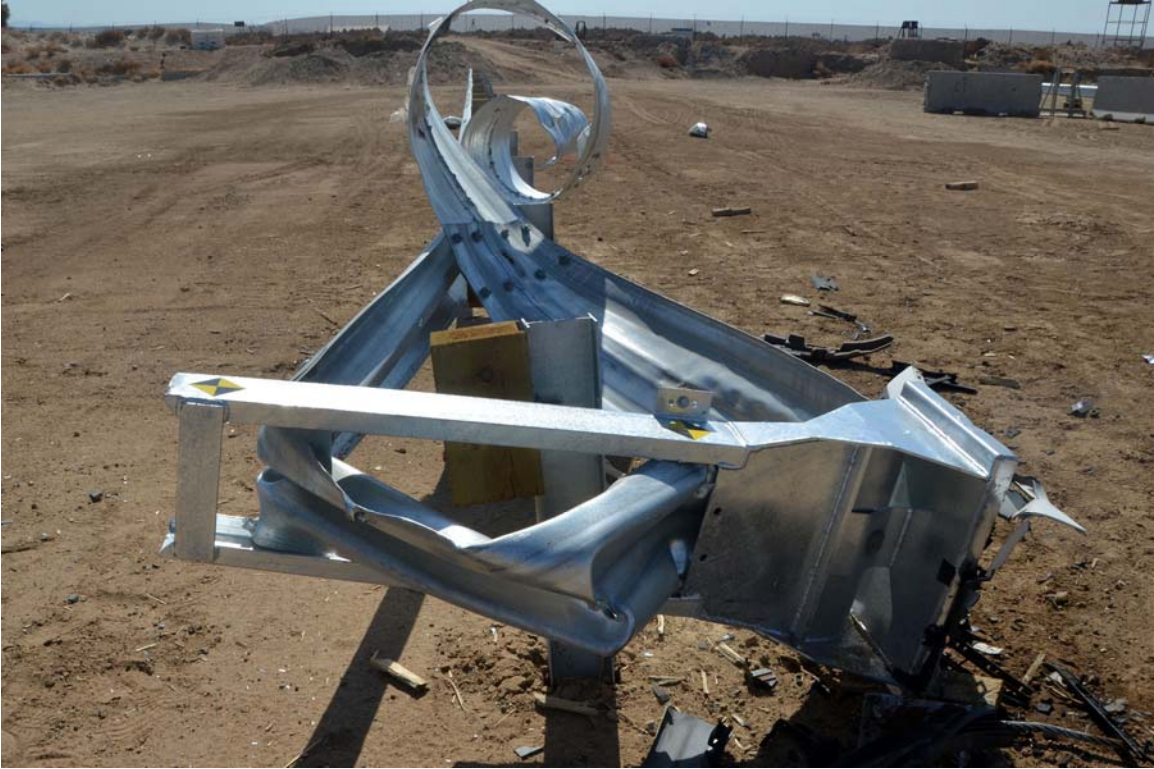
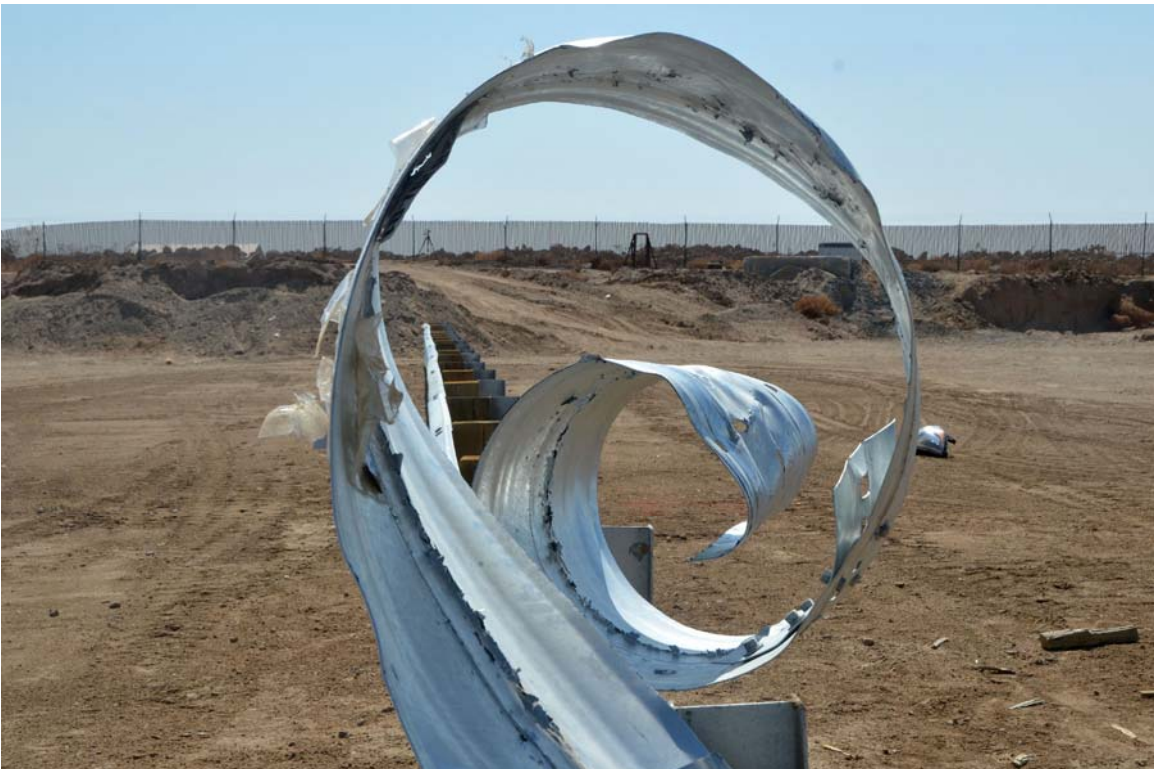
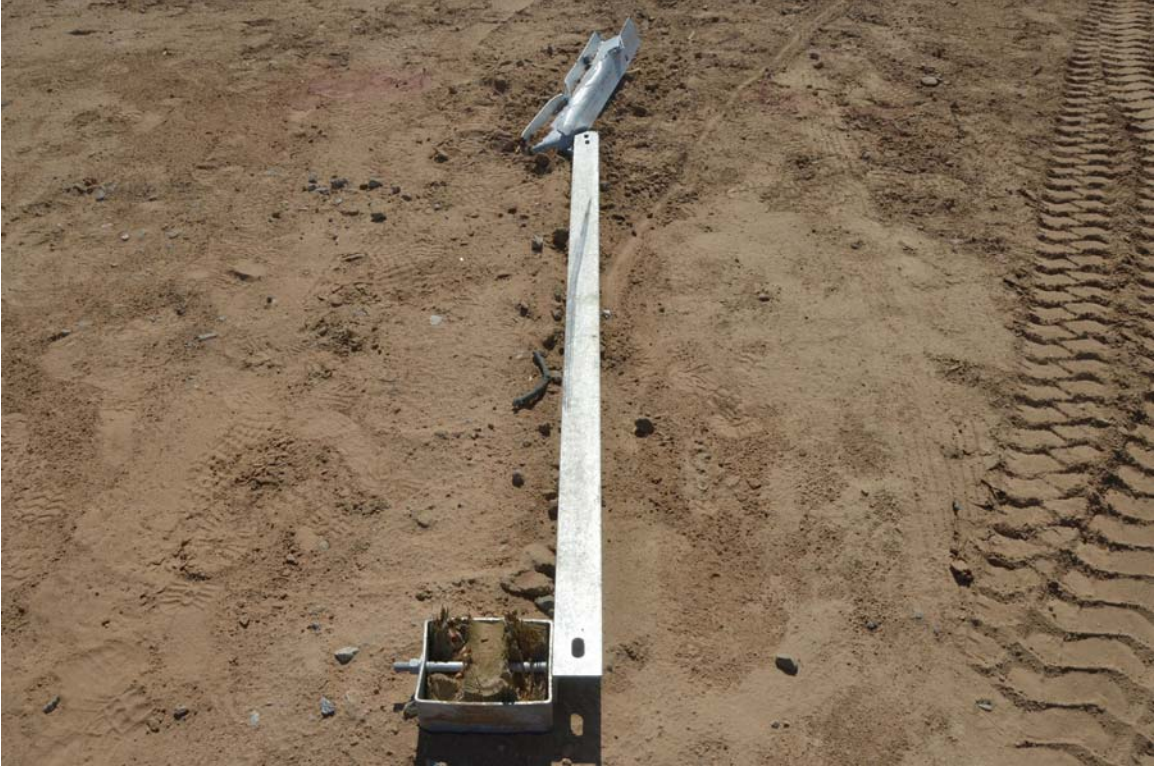
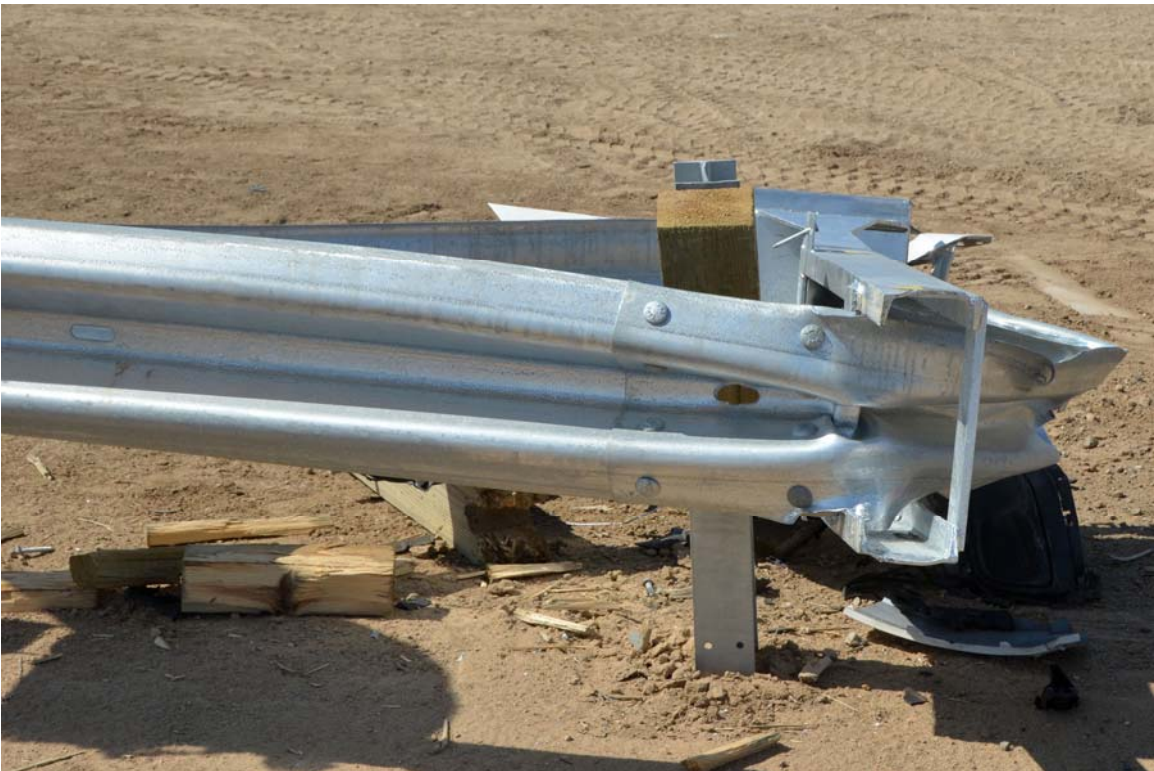
- Post 1 – wooden portion broke away at base
- Post 2 – tore at ground line yielding holes, front bolt hole torn, and deformation of flanges
- Post 3 – tore at ground line yielding holes, front bolt hole damaged
- Post 4 – tore at upstream yielding holes and was leaning downstream
- Post 5 – leaning in soil and detached from rail

FIGURE 31. Test Article Damage

FIGURE 32. Test Article Damage

FIGURE 33. Test Article Damage

FIGURE 34. Test Article Damage

FIGURE 35. Test Article Damage

FIGURE 36. Test Article Damage

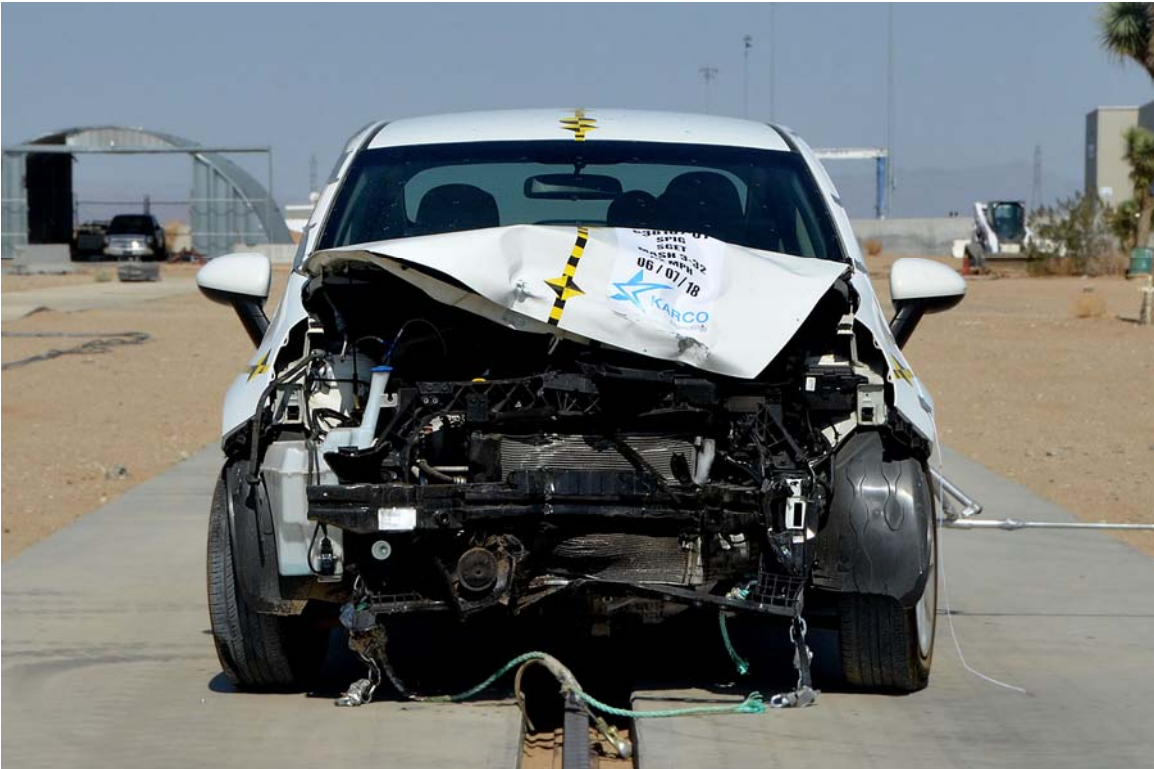
The vehicle's damage was concentrated at its front end. The front bumper beam was crushed at its center and pushed back into the radiator. The radiator and its support were crushed. The hood was deformed and the sheet metal was separated at the right side. The bumper fascia and right headlights were also damaged. The occupant compartment was not penetrated and the deformation limits were not exceeded.

FIGURE 42. Post-Test Front View of Test Vehicle
