Test Report For:  
**SPIG Industries, LLC**  
**SGET End Terminal**

TESTED TO:  
**Manual for Assessing Safety Hardware (MASH 2016)**  
**Test 3-32**

TEST REPORT NUMBER:  
**TR-P38107-01-A**

REPORT DATE:  
**August 20, 2018**

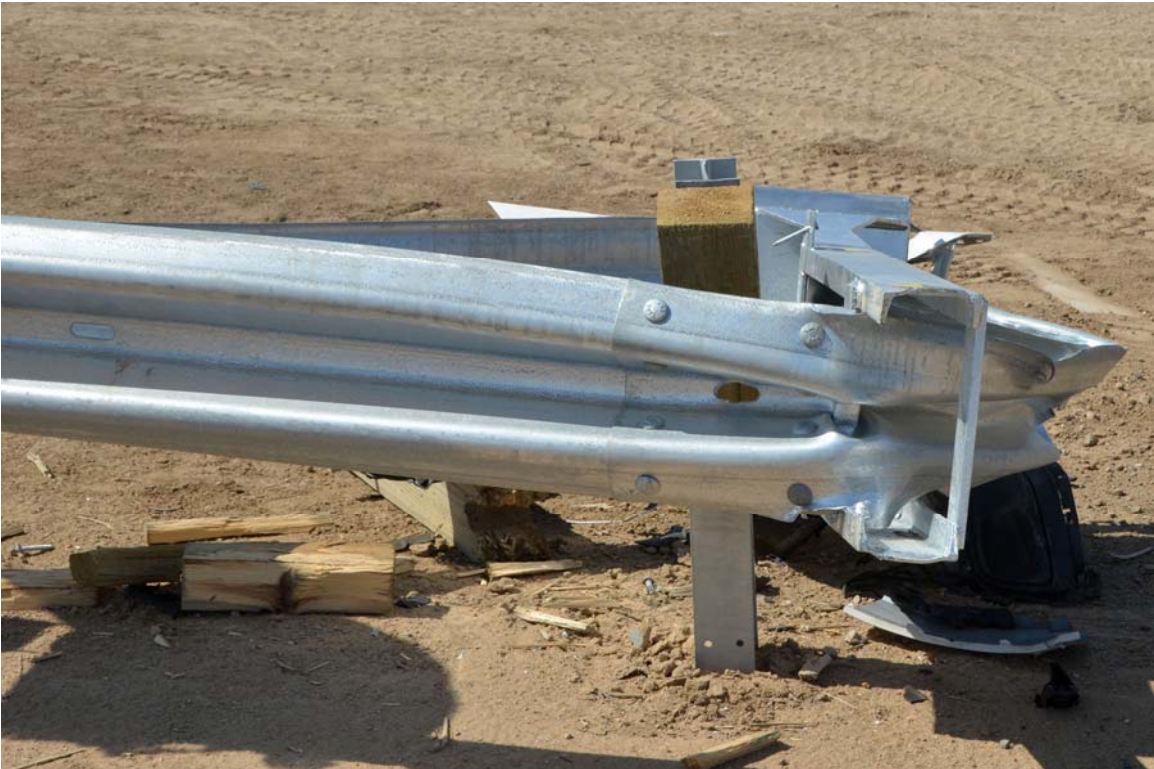
The system was damaged from post 1 through post 5 and there was approximately 31.3 ft. (6.5 m) of damaged guardrail. The mounting tabs were bent on the impact head and there was no other visible damage. The guardrail grabber had a dent at its upstream end from the contract with the impact head. The ground strut had cosmetic damage.

- Post 1 – wooden portion broke away at base
- Post 2 – tore at ground line yielding holes, front bolt hole torn, and deformation of flanges
- Post 3 – tore at ground line yielding holes, front bolt hole damaged
- Post 4 – tore at upstream yielding holes and was leaning downstream
- Post 5 – leaning in soil and detached from rail

FIGURE 31. Test Article Damage

FIGURE 32. Test Article Damage

FIGURE 33. Test Article Damage

FIGURE 34. Test Article Damage

FIGURE 35. Test Article Damage

FIGURE 36. Test Article Damage

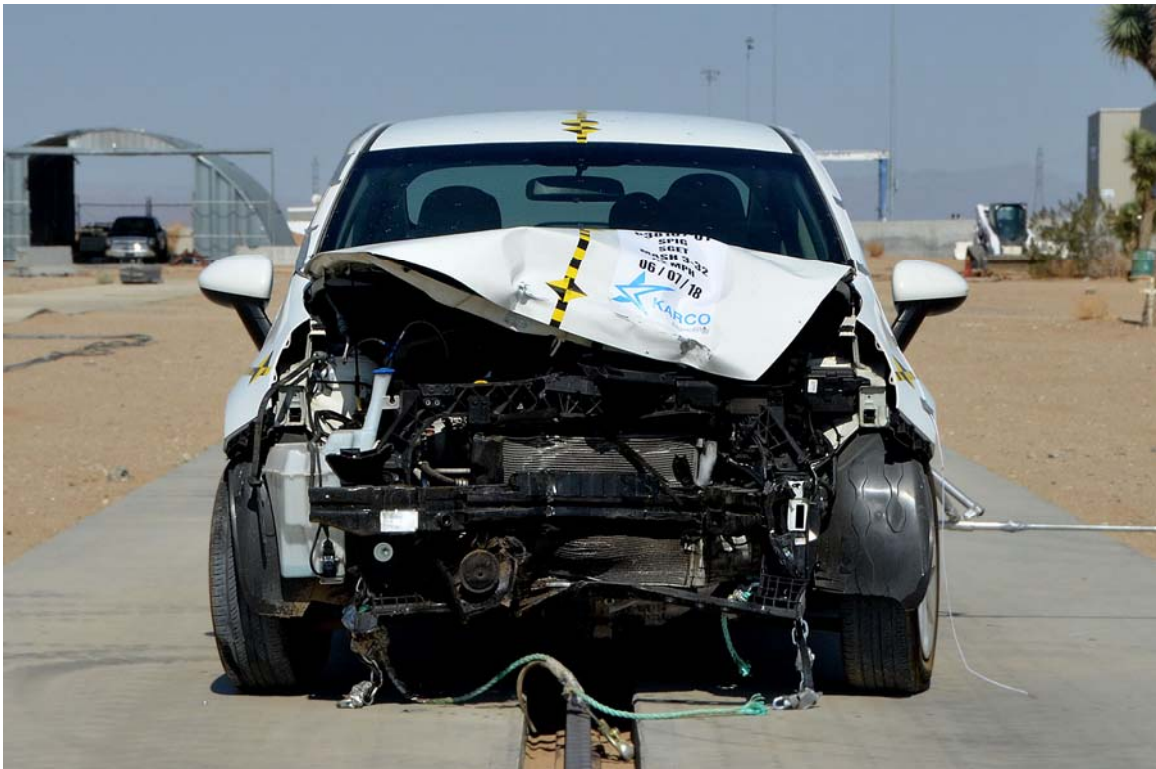
FIGURE 42. Post-Test Front View of Test Vehicle

The vehicle's damage was concentrated at its front end. The front bumper beam was crushed at its center and pushed back into the radiator. The radiator and its support were crushed. The hood was deformed and the sheet metal was separated at the right side. The bumper fascia and right headlights were also damaged. The occupant compartment was not penetrated and the deformation limits were not exceeded.
